**ACCIDENT REPORT  
OF THE A/C 4X-CWN  
AT Mt. AINOS OF KEFALONIA  
28<sup>TH</sup> APRIL 2009**

**Report no 02 / 2011**

**Accident of the a/c 4X-CWN  
at Mt. AINOS of Kefalonia on  
28<sup>TH</sup> April 2009**

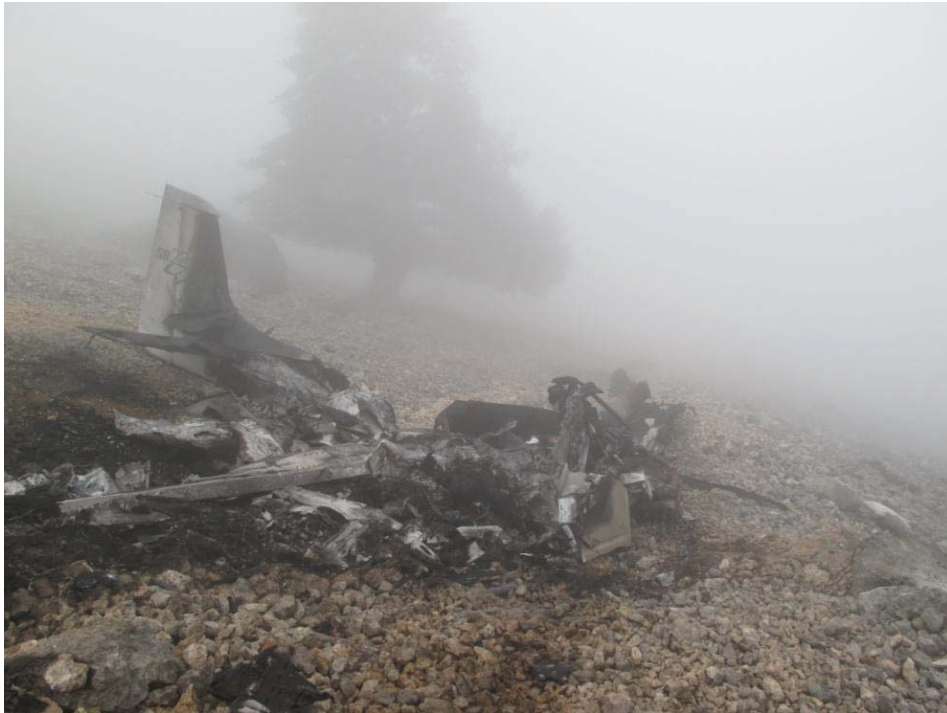
**Photo 1**

At 21:30 h on 28.04.09 the scene of a small fire was located in a hard-to-access area of Mt. Ainos of Kefalonia by policemen who were conducting a ground search. A unit of the Special Forces of the Fire Fighting Services arrived from Patra on a C-130 a/c and, together with men of the Special Forces of the Hellenic Air Force, climbed in the above mentioned area and at 02:30 h on 29.04.09 located the wreckage of the a/c on the SW side of Mt. Ainos, on a hard-to-access area with coordinates 38° 08' 05.29'' B, 020° 39' 43.65'' E, an approximately 45% slope, and an elevation of 4,460 ft. Based on markings on the ground, the aircraft climbing impacted the ground in a NNE direction.

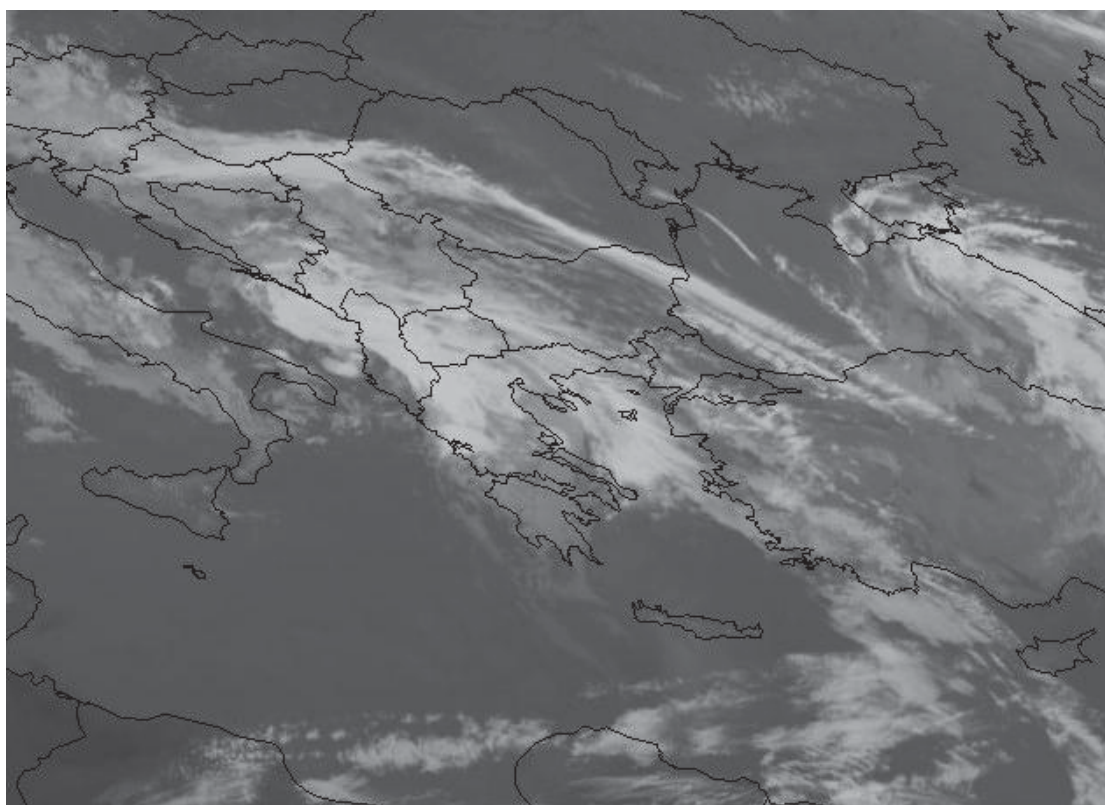
MSG IR Ch9, 28.04.09, 16:45 UTC

The low stratiform clouds are depicted in satellite pictures (Appendix B) and in the METAR remarks of the surrounding airports and especially the reports of the Kefalonia airport (FEW015-SCT018-BKN025-BKN080). At the same time, the small difference in temperature with a Dew Point (17/14) reinforces the possibility of larger volumes of clouds with even lower bases (below 1,000 ft) downwind, and restricted visibility (5,000 m) because of the high relative humidity (>80%).
