**ACCIDENT INVESTIGATION REPORT  
OF THE AIRCRAFT SX-DIA  
AT THE AIRPORT OF RHODES 'DIAGORAS'  
ON 2 FEBRUARY 2015**

# **ACCIDENT INVESTIGATION REPORT**

**03/2018**

**Aircraft SX-DIA (Jetstream 41)  
at the Airport of Rhodes ‘Diagoras’ on 02.02.2015**

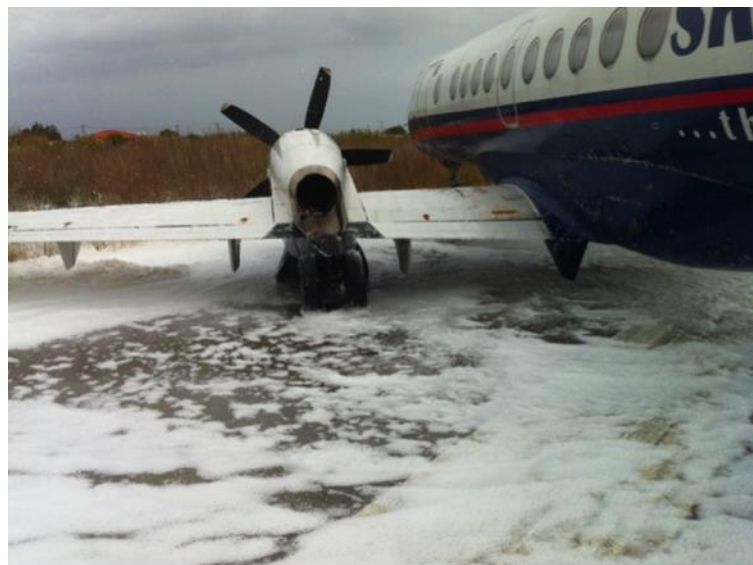
Fig. 2

Upon a first visual inspection at the accident site and before the left wing of the aircraft was raised on jacks, it appeared that the left main landing gear folded back resulting in the aircraft's left side dragging the runway (the left main landing gear and its housing into contact with the runway) and stopping at the left edge of the runway facing to the east.

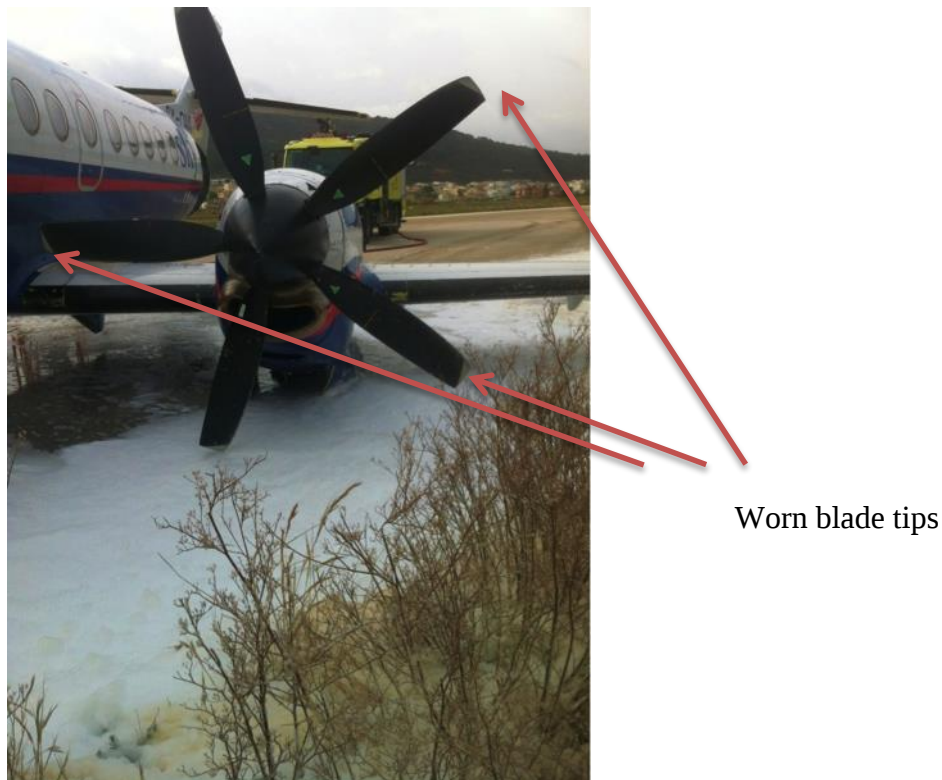
Fig. 4. Left Propeller

The left main landing gear's folding rearward resulted in the blade tips of the left propeller of the aircraft coming into contact with the runway while the propeller was turning, which led to the blade tips sustaining serious structural damage (Fig. 4).

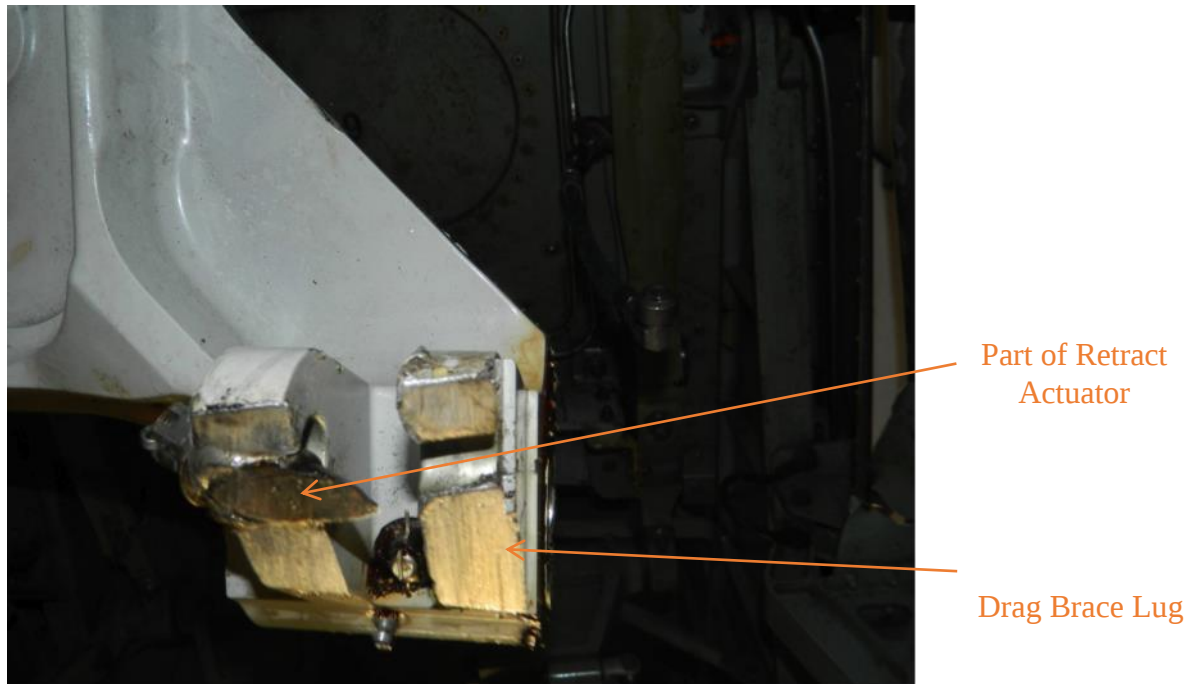
**Fig. 5 - Drag Brace**

- The hydraulic lines at the back of the shock strut were deformed, consequent to impact, possibly due to the gear collapsing and folding.
- Ribs 7 and 8 where the two trunnion pins of the Drag Brace as well as the two respective pins of the Shock Strut are housed were found to be broken (figures 12-13). Rib 7 (inboard structural element relative to the undercarriage) had broken at its rear segment, directly above the well of the inboard pin of the shock strut, whereas Rib 8 (outboard structural element relative to the undercarriage) had broken at its forward segment directly above the well of the outboard trunnion pin of the drag brace.
- The Drag Brace Lug at the lower segment of the inboard pin well, where it is attached to the Retract Actuator, part of which was within the lug, presented wear due to friction (Fig. 5).

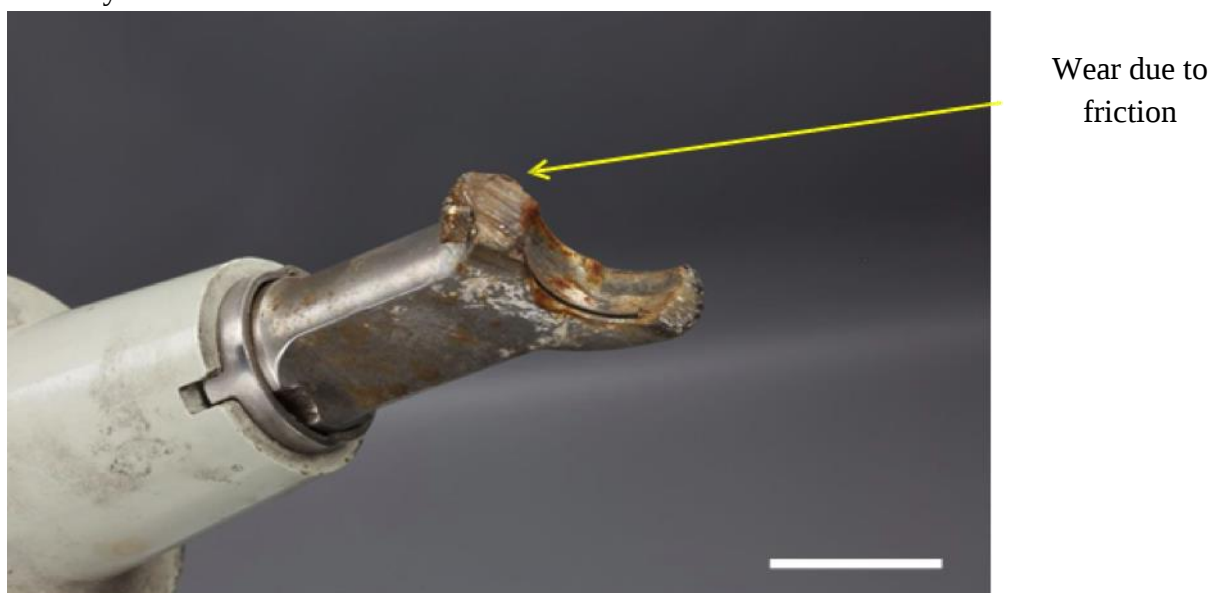
**Fig. 6. Retract Actuator**

- The edge of the Retract Actuator (Fig. 6), where it is attached to the Drag Brace, presented wear due to friction in the same manner as seen in the Drag Brace Lug.
- The inboard trunnion pin of the Drag Brace attaching it to Rib 7 had fractured (Fig. 8-9-10).
- Damage was found to the landing gear bay, due to its having been dragged on the runway.

The edge of the retract actuator, where it attaches to the drag brace, showed signs of friction wear, in a manner matching the wear observed in the drag brace lug. This indicates that the retract actuator was attached to the drag brace even after it was disengaged from the main landing gear.

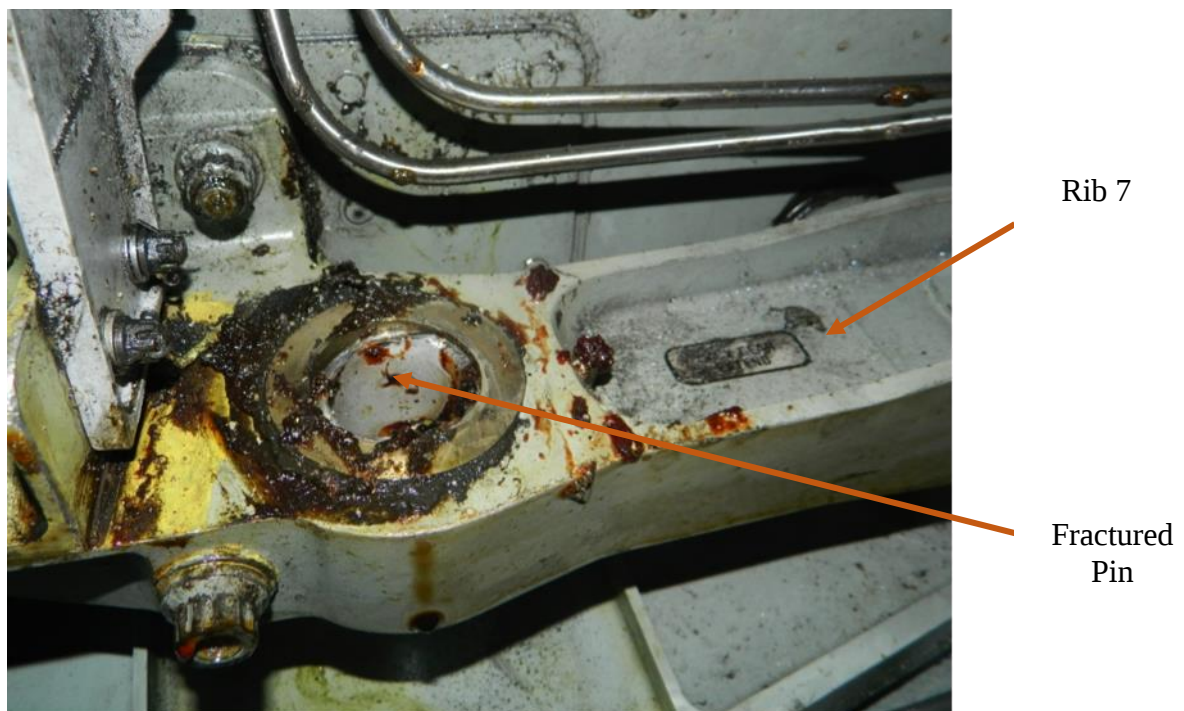
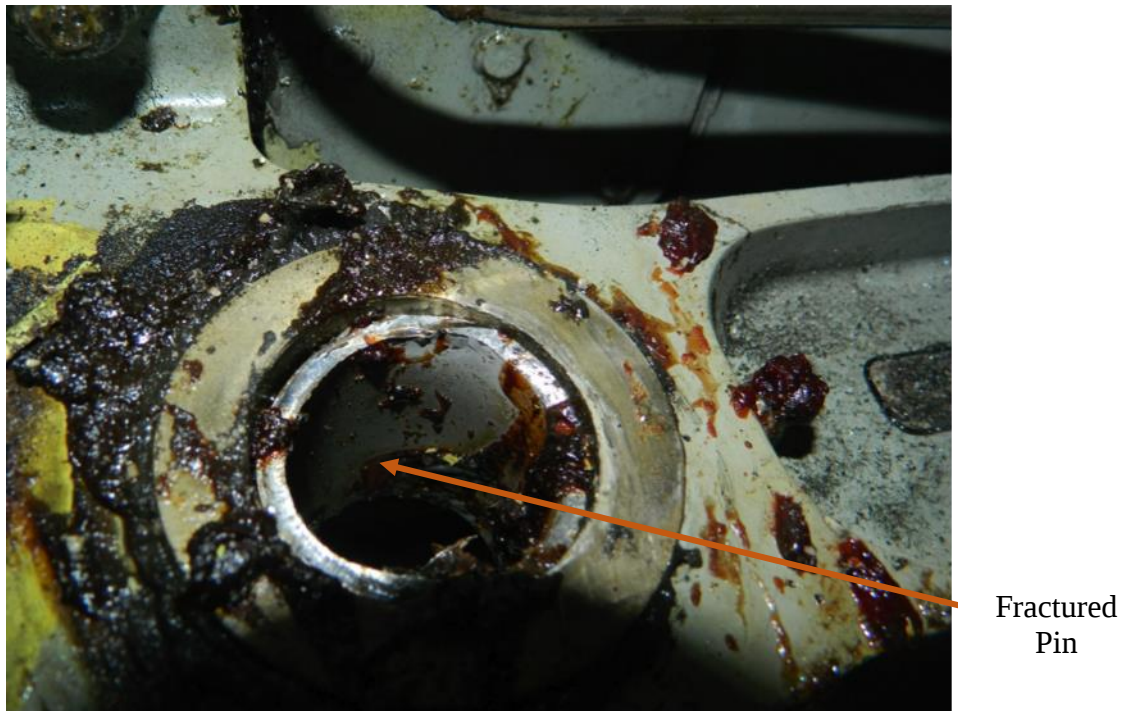
**Fig. 8 Rib 7**

- Upon examination, the surface of the crack in Rib 7 was matt and fibrous, typical of the failure of an aluminum alloy as a result of overload. Also, there was no evidence of progressive cracking, such as fatigue or corrosion cracks.

As the shock strut folded to the back, the lug located at its rearward section forced Rib 7 upwards (the findings show that the fractured rear segment of the Rib has a dent, matching in size with the mark on the lug), resulting in the rupture of the Rib.

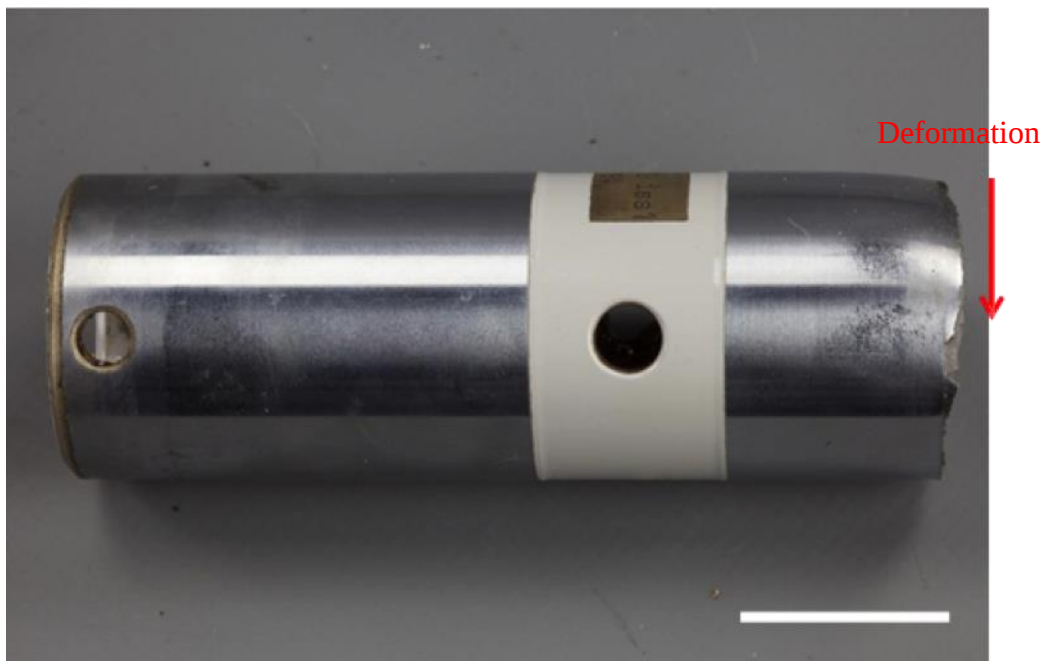
Fig. 10 Fractured Pin

- Upon examination, the surface of the crack in the inboard pin removed from the drag brace was shown to have sustained major damage, possibly as a result of its contact with the bushing in Rib 7 (presenting similar damage) as the drag brace and the inboard pin segment within moved away from Rib 7 following the fracture of the inboard pin.

- Upon examination, the surface of the crack of the inboard pin of the drag brace removed from Rib 7 had lesser damage than that of the segment removed from the drag brace. Half of the surface was smooth and perpendicular on the pin axis, whereas the other half of the surface was rougher and not perpendicular on the pin axis, and more deformed in general. The findings are characteristic of fracture due to overload.

The smooth surface of the crack was examined using electron microscopy and was found to present shear dimples with the surface being characteristic of shear overload and also presenting mechanical wear (spots). Shear angle was between 25° and 50° to the horizontal.

The rough surface of the crack was also examined using electron microscopy, and was found to present ductile dimples in random directions with the surface being characteristic of fracture due to tensile overload without evidence of shear.

On the surface of the crack of the inboard pin there was no evidence of progressive cracking, such as fatigue or corrosion cracks.

The load on the inboard pin of the drag brace appears to be greater than the designed maximum, resulting in the pin's fracture. The pin originally fractured as a result of shear and, with the progressing fracture there was tensile overload.

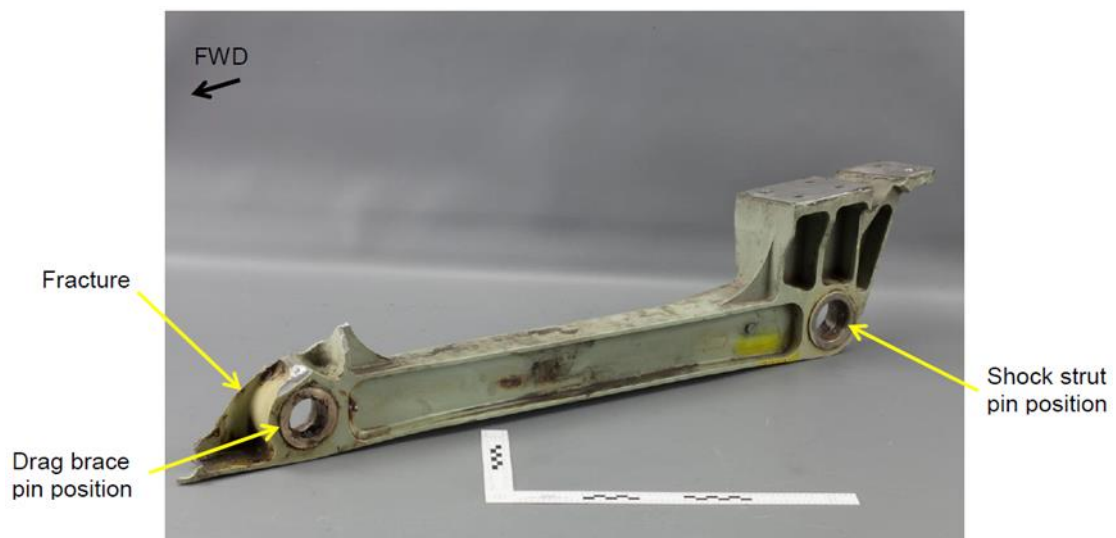
Fig. 13. Rib 8

- Upon examination, the surface of the crack in Rib 8 was identical to that in Rib 7, matt and fibrous, typical of the failure of an aluminum alloy as a result of overload. Also, there was no evidence of progressive cracking, such as fatigue or corrosion cracks.

After the inboard pin failed, the load was taken up by the outboard pin of the drag brace resulting in the drag brace link bending inwards, as indicated in the evidence, which in turn resulted in the fracture of the Rib 8 section directly above and facing the seating of the drag brace's outboard pin. Deformation of Rib 8 was observed at the site of the fracture, suggesting that the rear of Rib 8 containing the outboard pin had moved inwards resulting in the outboard pin leaving its seating, thus, without action by the drag brace, the shock strut folded

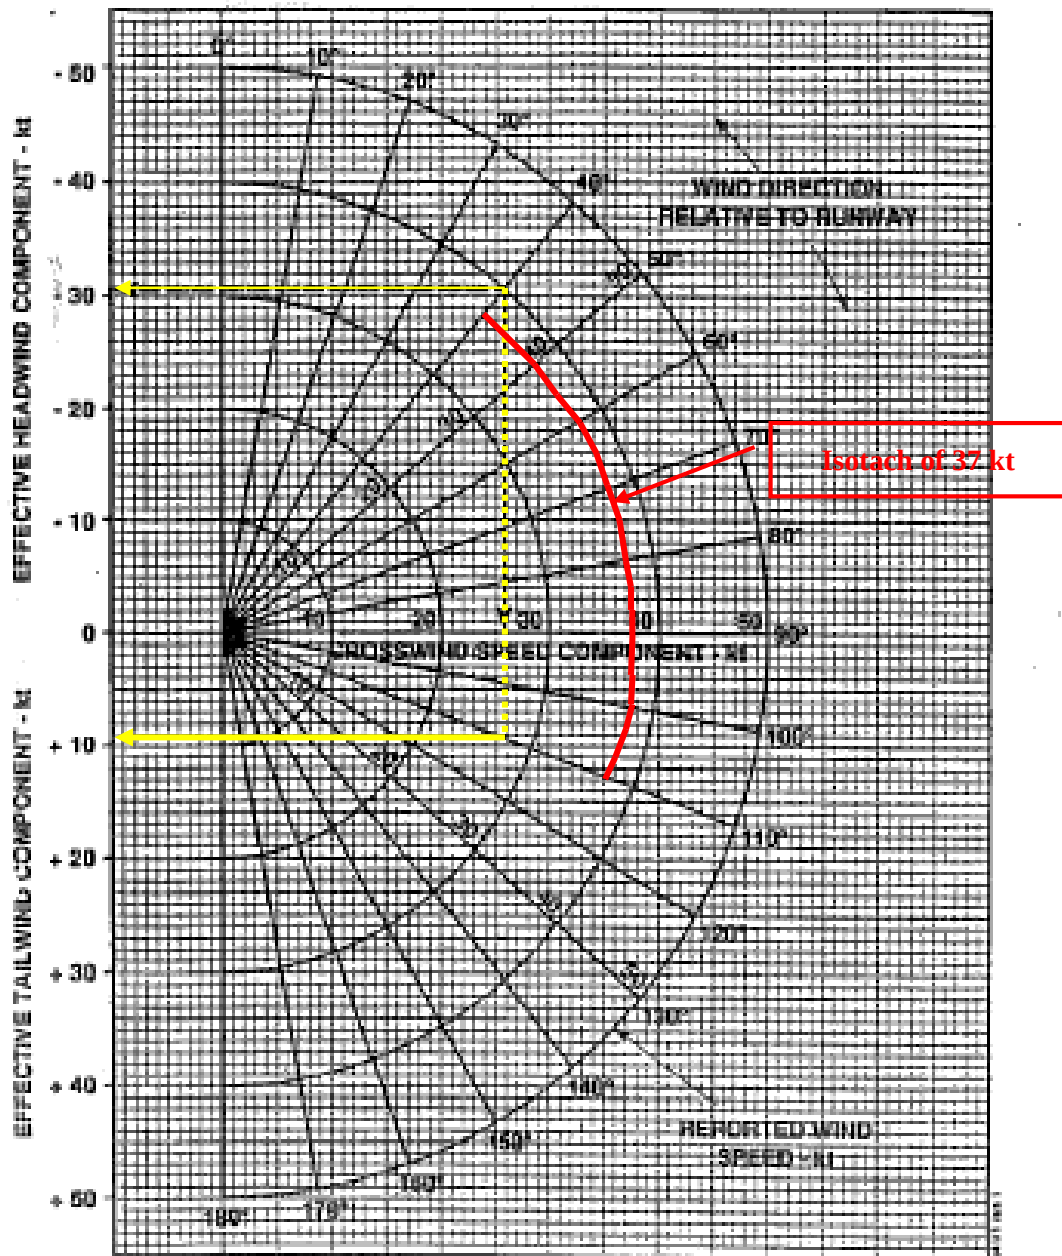
### Wind Component Chart

Moreover, pursuant to the Wind Component chart in Annex B hereto, it is noted that with a wind on the 37 kt isotach the wind from 110° and 180° has a crosswind component greater than 30 knots over almost the entire arc. Pursuant to the Wind Limits, the maximum demonstrated crosswind component is 30 knots.
