**HELLENIC REPUBLIC  
MINISTRY OF INFRASTRUCTURE AND TRANSPORT**

**AIR ACCIDENT INVESTIGATION AND AVIATION  
SAFETY BOARD  
(AAIASB)**

**INVESTIGATION REPORT  
OF AIRCRAFT ACCIDENT 5B-CLB  
ON OCTOBER 16th, 2016,  
AT KALAVRYTA AREA**

**AIRPLANE C 172P, Reg. Nbr 5B-CLB**  
**ON OCTOBER 16th, 2016 AT KALAVRYTA AREA**

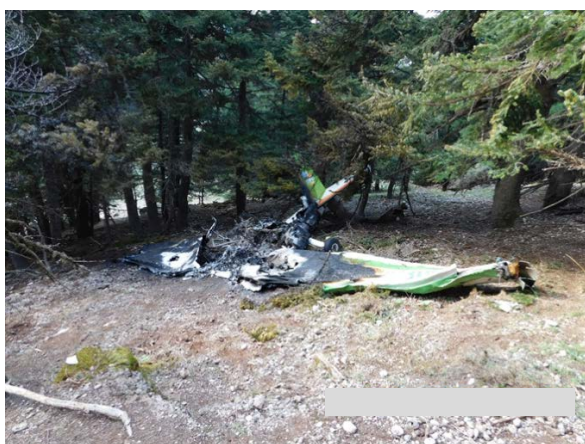
At 17:26:27 h in daylight conditions, the airplane struck the terrain at an elevation of about 4965 ft, with 75 kt airspeed, 2000 ft rate of descent and 30° bank at the point with coordinates 38° 01' 46'' N, 22° 11' 52.4'' E. The terrain slope at the impact point was 40° and the airplane struck the ground with an angle of about 65°, while the angle between the airplane longitudinal axis and the horizontal level was 73°.

**Fig1. Airplane at the impact point (view looking from above)**

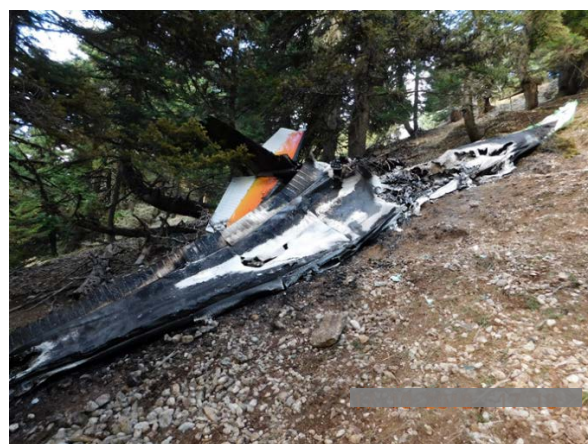
**Fig2. Airplane at the impact point (view looking from lower)**

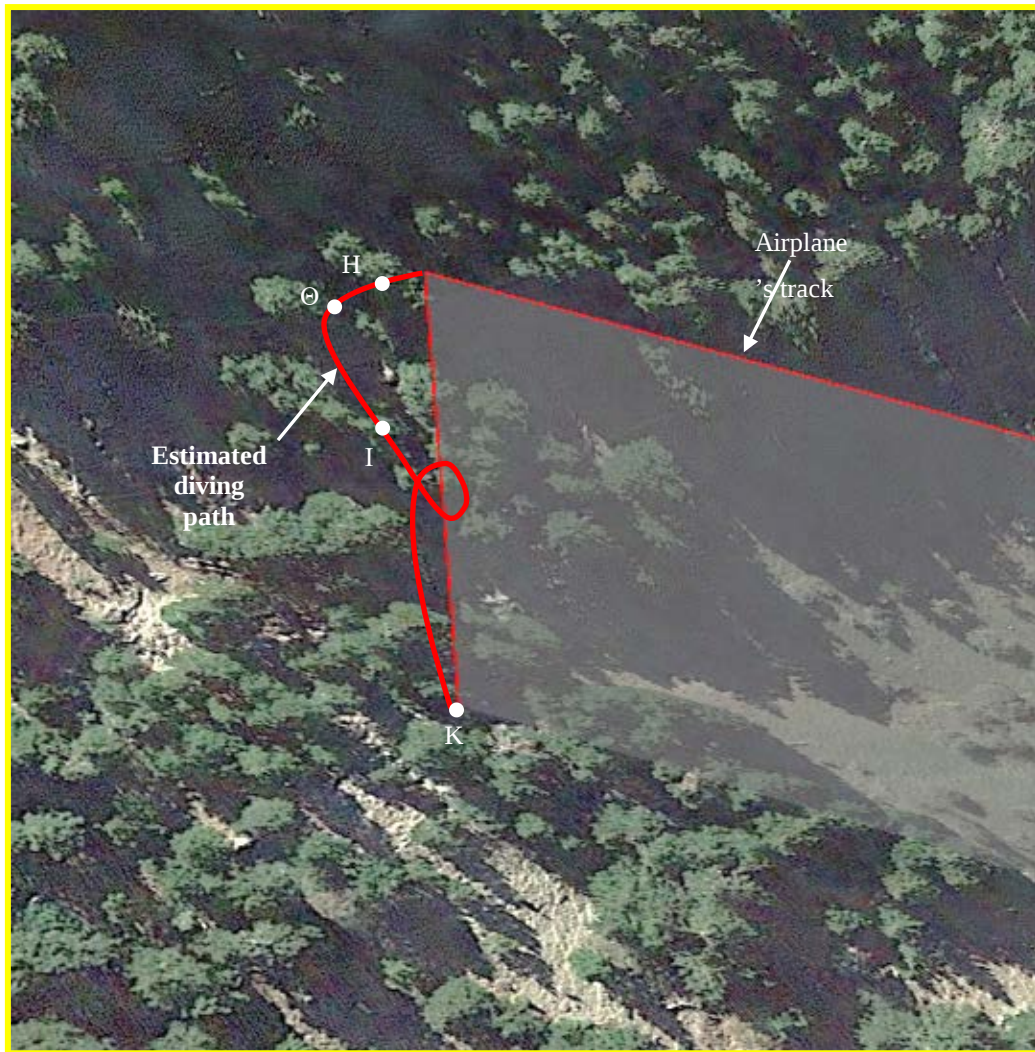
Fig.5 Detail B, estimated diving path at impact point

- At 17:26:24 h, point H: The airplane reached an altitude of about 5100 ft, the airplane reached its minimum airspeed of 50 kt and the rate of climb of about 100 fpm. The airplane reached an approximate 80° left-bank.

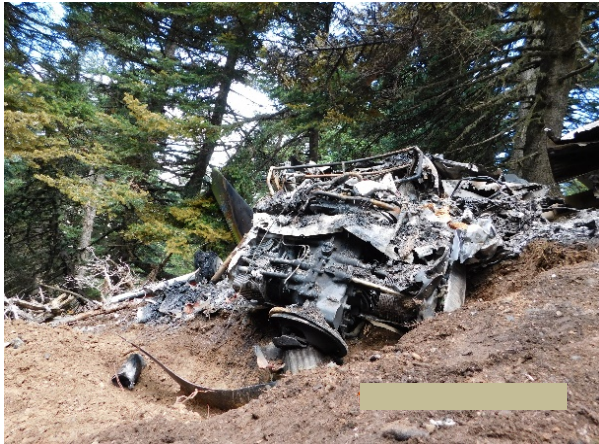
found about 55 cm under the ground (fig. 4), while the leading edge of left wing tip was deformed (fig. 5). The empennage remained intact while some tree branches were damaged along the airplane's path.

**Fig.4 The accident airplane' wreckage were showed  
The engine's position**

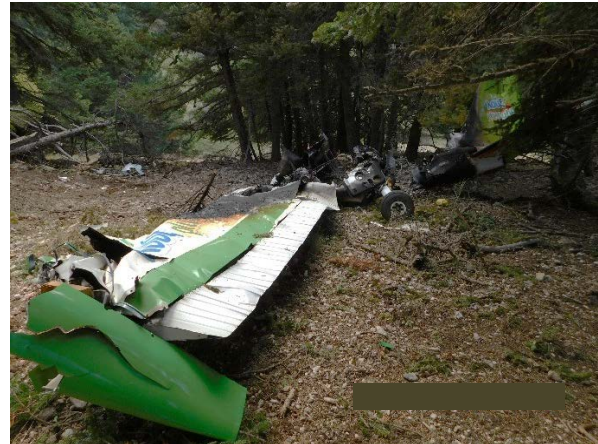
**Fig. 5 The deformed airplane's left wing tip**

The half upper side of the left wing from the root revealed extensive damage from the postimpact fire. Its wing tip was compressed as the airplane crashed on the slope terrain. Examination of the accident airplane revealed extensive damage to the bottom of the left wing from wing root up to the end of the trailing edge flap. The remaining portion of the wing bottom was compressed from the postimpact forces.

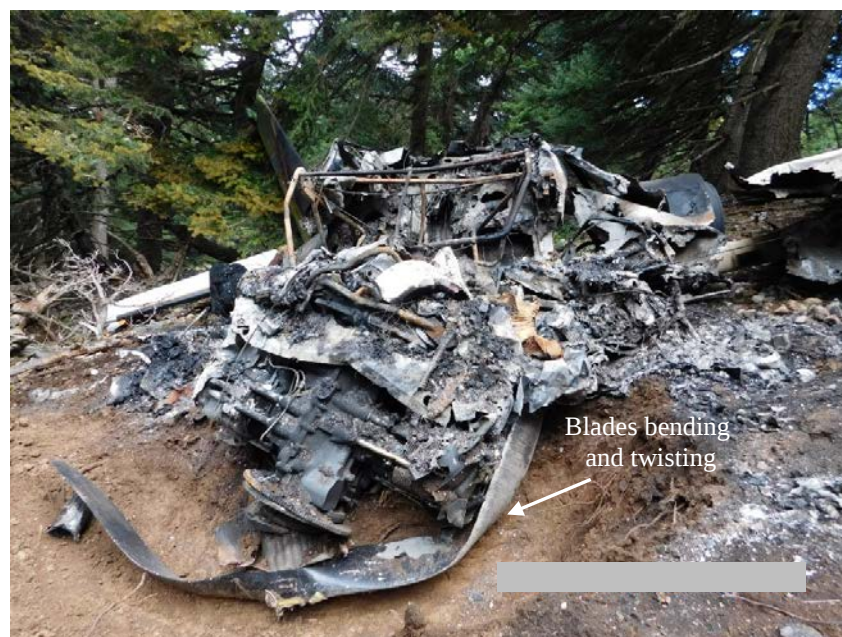
The airplane impacted the terrain and the propeller was found about 55 cm into the ground. The propeller blades exhibited bending, while the left hand blade exhibited twisting and sweeping back (fig.6).

The engine's shaft in relation to the propeller's shaft exhibited an angle of about  $39^\circ$  and two of the six propeller bolt connectors with engine were broken. The propeller blades surface exhibited scratching while the propeller blades leading edge were found with dents to the whole length.

The engine's body was fractured and an engine piston showed at the aft section of the engine.

**Fig.6 The airplane's engine**

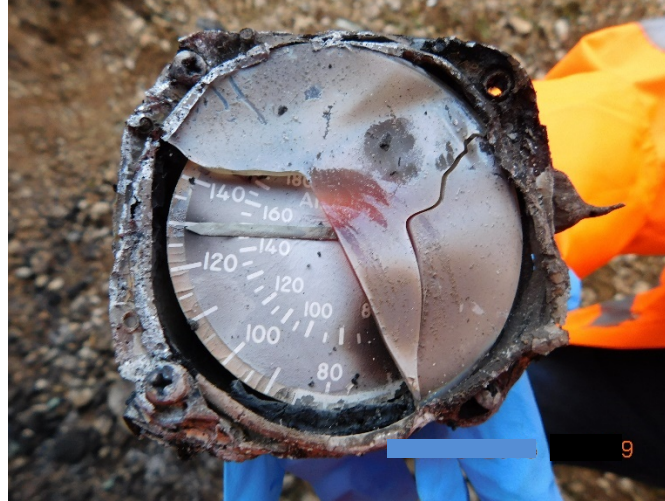
The airplane's airspeed indicator, was found and recovered on the impact point, in front of the right wing's leading edge. At the recovery point, the airspeed indicator had an indication of 130 kt.

Fig.7 the recovered airspeed indicator

The instrument's outer case was deformed as a result of crash and postimpact fire, while the front glass cover part of the instrument was broken by half.

From the recording video it is shown that the air speed indicator was pointing 75 kt at impact. The specific instrument was found and collected at the crash site with the indicator stuck at 130 kt.

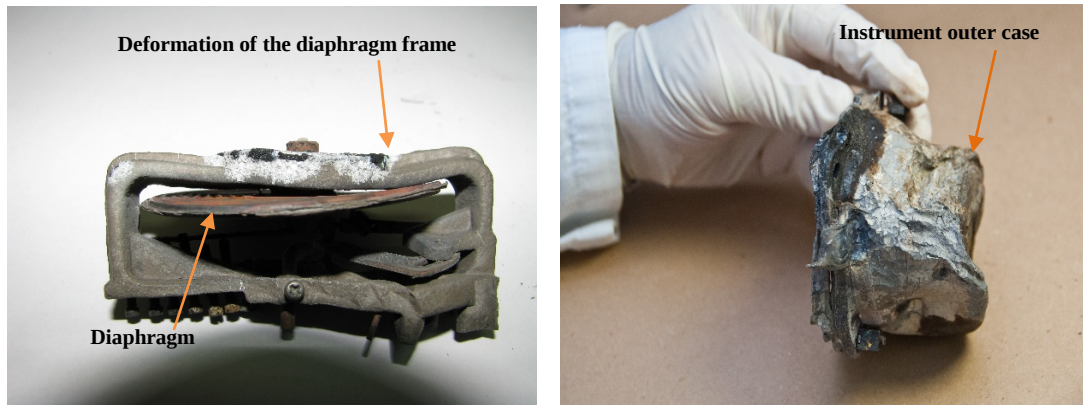
After the recovery of the airspeed indicator an examination and disassembly performed by specialists. The examination of the ASI revealed that the instrument was in very good condition and there was no evidence that any component was absent while the indicated airspeed of 130 kt was corresponding to the position of the internal mechanism components.

Fig. 1 The deformed ASI from postimpact forces

Also after the above instrument examination, the airspeed pointer and the indicator display were sent to a specific laboratory for macroscopic and stereomacroscopic examination for identification of any mark over the indicator display from the airspeed pointer.

According to the above examination results, no useful conclusion could be reached due to the condition of the indicator display.
