**AIR ACCIDENT INVESTIGATION AND  
AVIATION SAFETY BOARD  
(AAIASB)**

**ACCIDENT INVESTIGATION REPORT  
INVOLVING A PARAGLIDER  
AT THE AREA OF AGIOS SPYRIDONAS  
IN KOLIAKI, EPIDAUROS  
ON THE 23<sup>rd</sup> OF APRIL 2018**

**ACCIDENT INVESTIGATION REPORT**  
**03 / 2019**

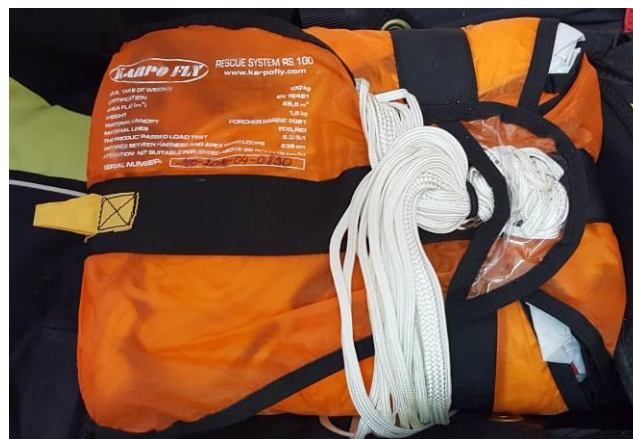
**Fig. 2:** The emergency parachute

The visual inspection conducted on the emergency parachute revealed no findings or wear in its materials or its lines. Furthermore, in the operation manual its manufacturer specifies that proper maintenance requires consistent and regular checks, and re-packing to be performed on an annual

- 3.1.13** The visual inspection conducted on the emergency parachute has not revealed any findings or wear in its materials or its lines.
- 3.1.14** The pilot did not deploy his emergency parachute.

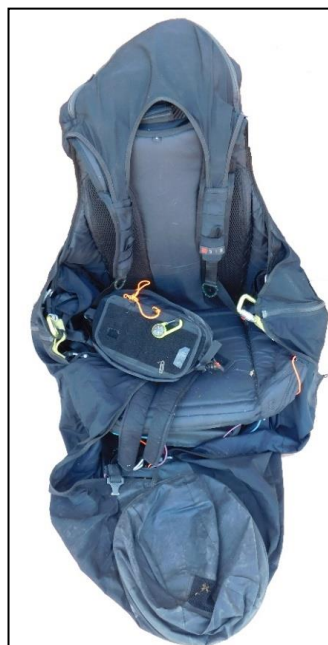
**Fig.3: The harness**

Moreover, the visual inspection of the harness revealed minor abrasions and tears beneath it most probably as a result of the impact.

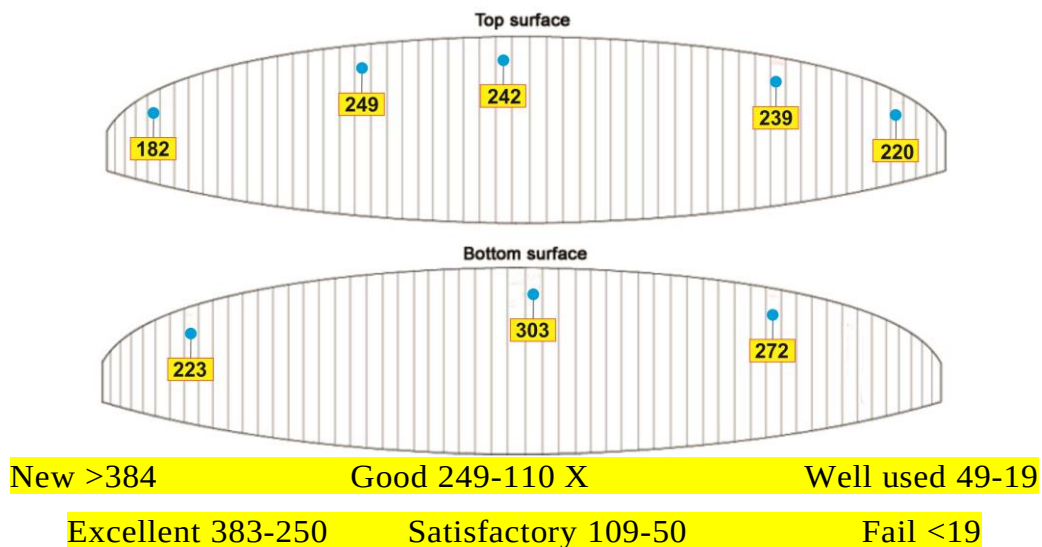
**Fig. 11:** Porosity test locations and values

Porosity testing demonstrated that the glider wing, both at its top and its bottom surface presented no significant porosity. It is noted that the readings presented in **Fig. 11** refer to the time required (in seconds) for a certain volume of air to permeate the canopy fabric through a given surface and under a given pressure. Therefore, the smaller the porosity readings are (in sec) the easier a certain volume of air passes through a given surface under a given pressure and therefore the greater the wing porosity is. As an indication, the values for a brand-new wing are around 400 sec or close to it, whereas values below 19 sec indicate a wing that is not serviceable. For the paraglider wing in this accident, the lowest reading (182 sec) taken was at the top surface of the left half-wing.

As above stated, a visual inspection was performed on the paraglider, as well as porosity testing at several locations on the canopy fabric, together with lines measurements. Pursuant to the results of the visual inspection and the porosity test, it is considered that the fabric of the glider canopy in general was in a good condition, at both its top and its bottom surface; the highest porosity reading, i.e. the lowest value measured (182 sec), was taken at the top left surface of the wing (*see Section 1.16.1 above*).

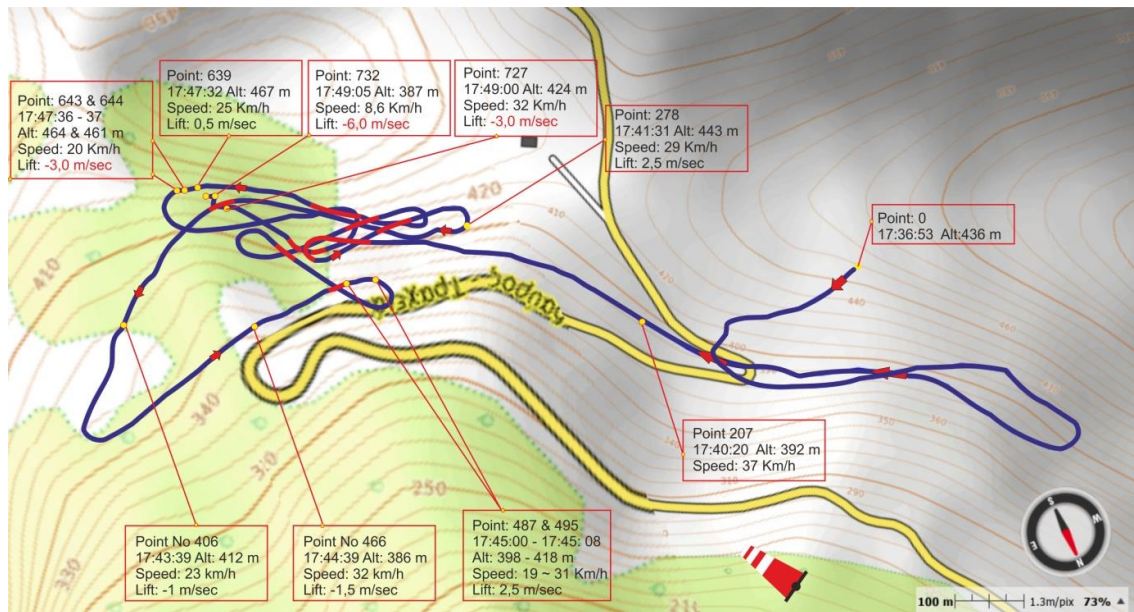
**Fig. 14:** The flight track

According to the tracklog up until point 278 (see **Fig. 14**) and considering the glider airspeeds along the flight track in relation to the direction followed, it is concluded that a weak N/NW wind was prevailing, of a variable speed up to 10 km/h. The flight could be characterized as a dynamic flight for the most part, i.e. he flew trying to maintain but also to recover height, near and parallel to the mountain slope following the terrain and exploiting the upward movement of air when hitting the slopes. Glider airspeed and altitude varied along the flight track according to direction, distance from the mountain slope and terrain. Further, the paraglider encountered very few rising thermals and those encountered were relatively weak, of a short duration and small diameter. The strongest rising thermal encountered was at point 278 (see **Fig. 14**) with a rate of ascent of +2.5 m/sec, still of a short duration and small diameter. Rising thermals of a small diameter tend to cause a steep lift to an entering paraglider and,

naturally, a steep change to its angle of attack. The reverse is true when the glider exits such a thermal. The said thermals, although not dangerous in themselves, require a heightened level of alertness and attention given the sudden change they cause to the angle of attack, whilst not offering significant gain in height.

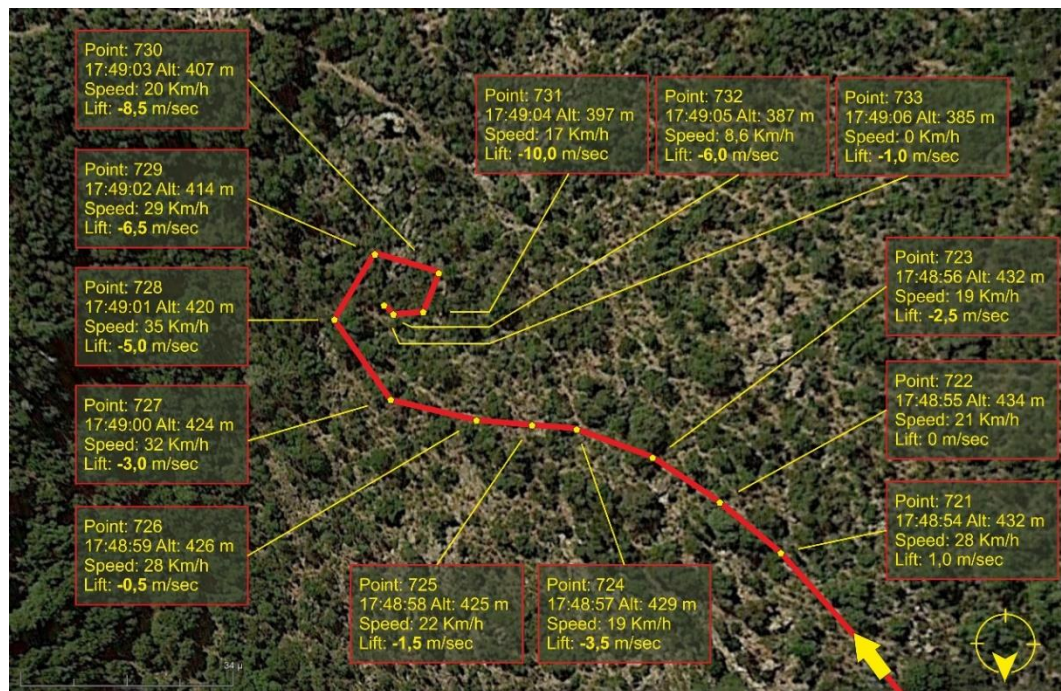
**Fig. 15:** The last leg of the pilot's course

The last leg of the pilot's course lasted very few seconds. The pilot, moving in a SE direction, at point 723 (see **Fig. 15**) encountered a sinking thermal having a sink rate of -2.5 m/sec, which (rate) increased in the next second (point 724) to -3.5 m/sec. The altitude at point 724 was 429 m A.M.S.L.,

however the pilot's height was 45 m A.G.L. Apparently, realizing his low height combined with the sinking thermal encountered, he chose to slightly change course to the east thus trying to steer away from the slope and maintain a safe height.

In the next two points 725 and 726 (see **Fig. 15**), the rate of descent decreases to -1.5 m/sec and -0.5 m/sec respectively, but this is not kept up given that at point 727 the descent rate is once again -3 m/sec. This is the starting point, as shown in the three-dimensional vertical plotting of his track (see **Fig. 15**), of his steep loss of altitude which led to the pilot's fall, seeing that in the next point 728 a high rate of descent, -5 m/sec, is observed and at the same time his course abruptly changes to a SE direction. The following points 729, 730, 731 show a clearly spiraling movement at an increasing descent rate that reaches -10 m/sec (see **Fig. 15**). This spiraling descent goes on for a further 1 sec up until the point of the glider's fall at an altitude of 387 m A.M.S.L. at a sink rate of -6 m/sec (point 732). The two next points, subsequent to the fall, probably reflect the glider being dragged on the ground as a result of its initial vertical and horizontal speed. Indeed, at these points, the altitude of the point of the original fall changed by 2 m.

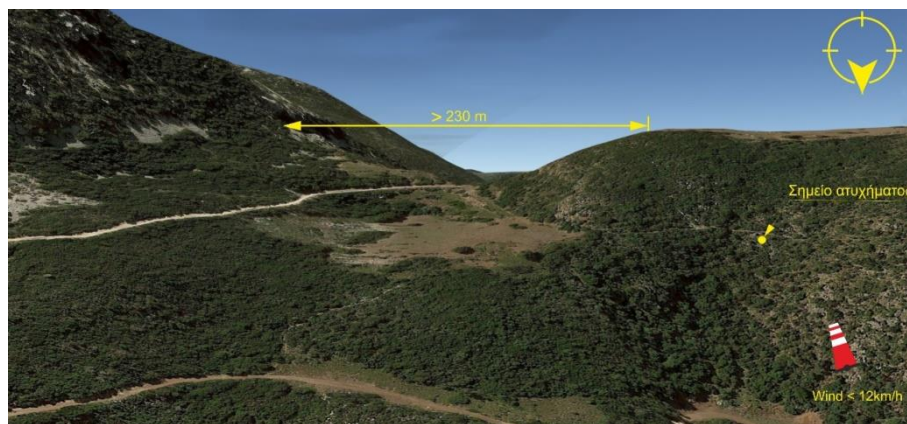
**Fig. 16:** The opening between the two peaks

However, when looking at the airspeeds of the glider throughout the flight it is established that they were never so low as to cause a problem to its forward speed and furthermore the glider was never found trapped in strong headwind. Also, the prevailing light wind, up to 10 km/h, combined with the width of the pass (greater than 230 m) (*see Fig. 16*) near the accident site, could not have created favorable conditions for the Venturi effect to occur. In conclusion, according to the above, it is not considered likely that the Venturi effect has been a cause of or a contributing factor to the accident.
