**REPORT**  
**ON THE INVESTIGATION OF A SERIOUS INCIDENT**  
**INVOLVING THE AIRCRAFT SX-IFR**  
**AT THE AREA OF AMIGDHALEON, KAVALA**  
**ON THE 2<sup>nd</sup> OF MARCH 2017**

**E 01 / 2019**

**Serious incident involving the Aircraft SX-IFR**  
**at the area of Amigdhaleon, Kavala**  
**on the 2<sup>nd</sup> of March 2017**

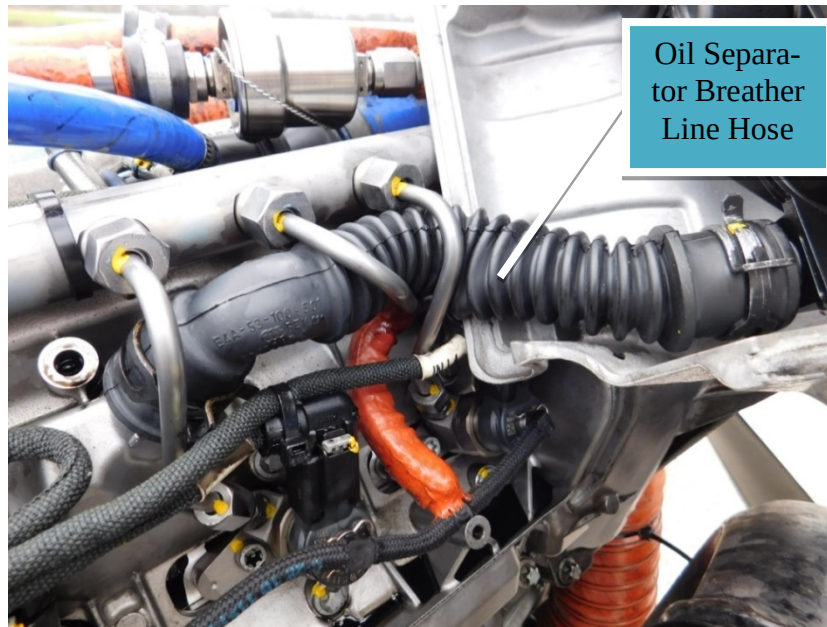
Two engineers from the aircraft's certified maintenance organization arrived onsite at Amigdhaleon military airport and after inspecting the engine they detected oil leakage from the oil separator breather line (Photo 1). After replacing the torn hose (Photo 2) with a new one, cleaning the engine and filling the engine with oil, a ground run was performed during which vibrations and white smoke from the exhaust pipe were noted; upon full power check, the engine performed at only 65% of its power rating. After the engine run, the engineers manually rotated the propeller of the aircraft and detected three rather than four compressions; therefore, one of the four cylinders had sustained damage and the engine had to be replaced.

**Photo 1:** The oil separator breather line hose

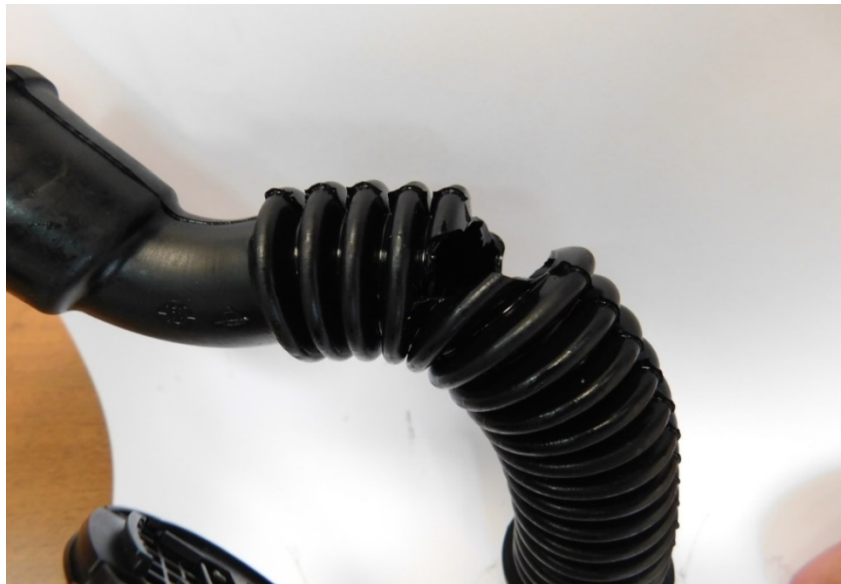
**Photo 2:** The torn hose of the oil separator breather line after its removal from the engine

After the incident, and following the replacement of the torn oil separator breather line hose with a new one and the filling of the engine with oil, a ground run was performed during which engine vibrations were noted (as experienced during the flight prior to the incident) as well as white smoke from the exhaust pipe. Such vibrations combined with the escape of combustion gases from No. 4 cylinder via the escape channel formed as a result of the piston crack and further operation of the engine, may have led to the fatigue and failure of the oil separator breather line hose.

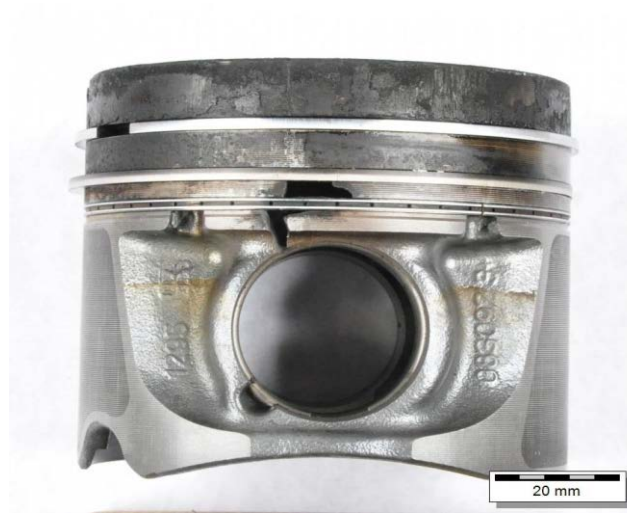
The engine was sent to the manufacturer (Austro Engine GmbH) for inspection which revealed a crack on the piston of No. 4 cylinder, as well as wear (channel for combustion gas escape from the cylinder liner through the oil groove and the ring grooves of the piston) (Photos 4 & 5). For this reason, the damaged piston was sent for further investigation to a specialized laboratory (OGI-Austrian Institute for castings) in order to identify the causes for its crack and wear (Appendix 1).

**Photo 4:** Side view of No. 4 cylinder

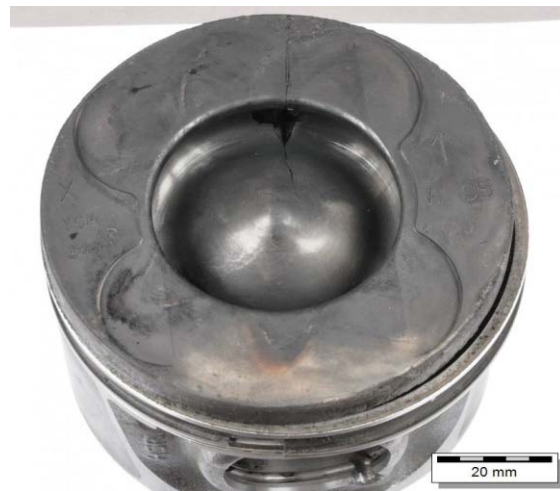
**Photo 5:** Top view of No. 4 cylinder

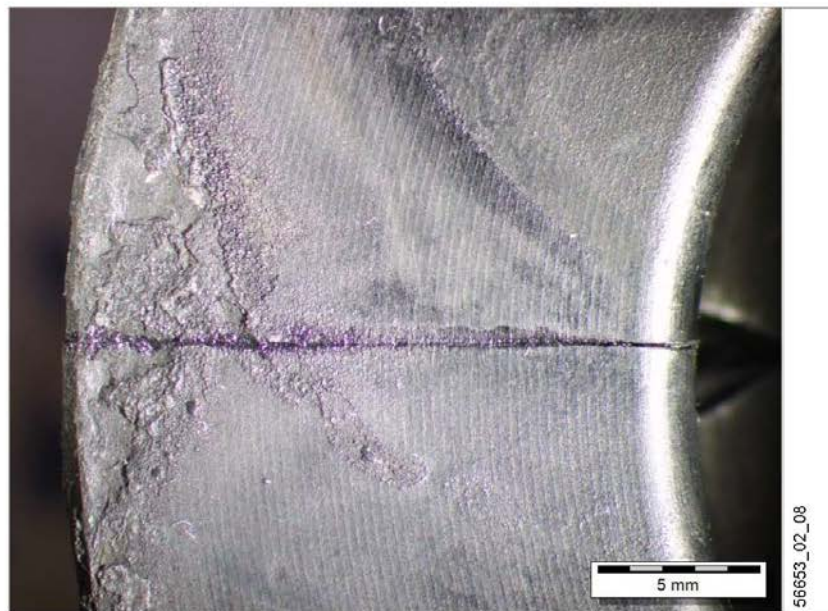
Additionally to the crack, the piston crown shows some imprints by foreign particles, which have been exemplary documented in figures 7, 8, 29 and 30. The imprints are not correlating with the fracture location (fig. 9). Additionally a gas channel has been generated between the combustion bowl and the ring grooves (fig. 7 and 10).

**Fig. 9:** Overview of the crack in the piston crown; no imprints correlate with the crack

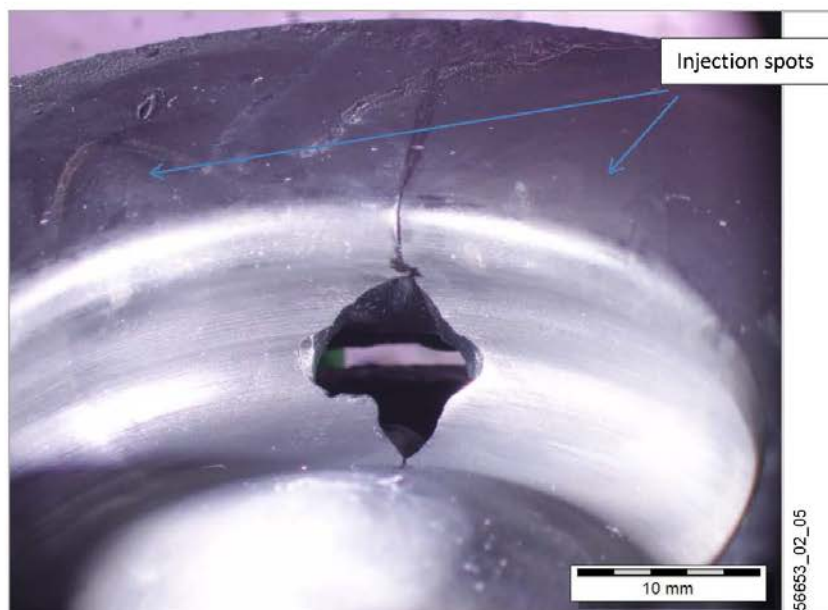
The piston suffered a crack which is orientated nearly parallel to the piston pin axis and which separated half of the piston crown between inlet-and-outlet valve pockets (fig 7). The location of the crack does not correlate with the injection spots on the crown (fig. 8 and 10).

**Fig. 10:** Overview of the crack in the piston crown and gas channel; no correlation with the injection spots

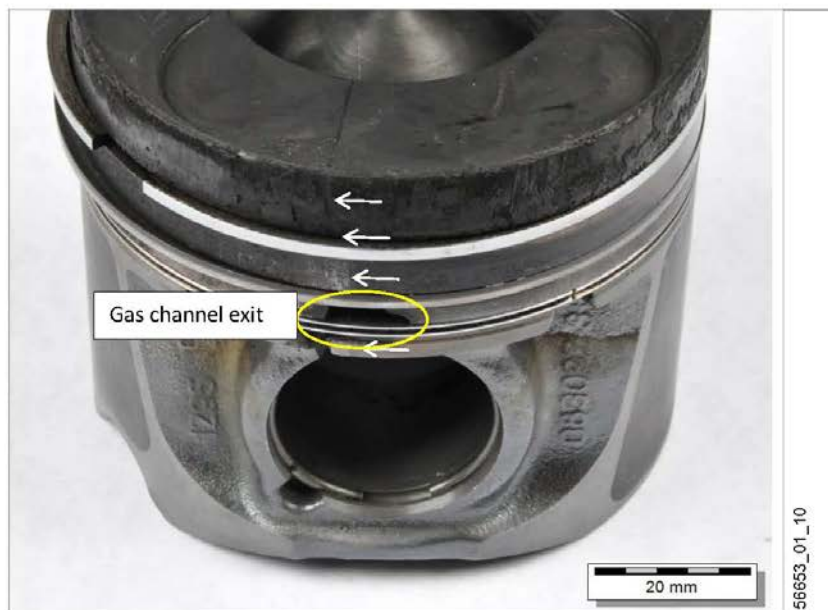
On the outer diameter of the piston, where the ring package is positioned, the crack splits the top area of the piston until the piston pin bore and follows the bore towards the centre of the piston where the crack stopped in the middle of the piston (fig. 11 and 12). There the edge of the crack can be observed in the middle of the cone of the combustion chamber (fig. 8).

**Fig. 11:** Following the crack at the outer contour until it meets the piston pin bore

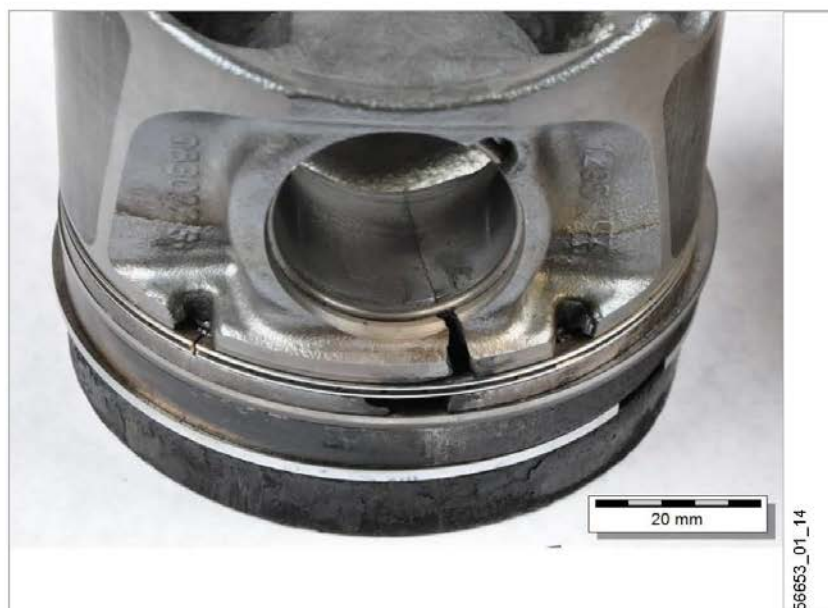
**Fig. 12:** The crack follows the piston pin bore until the centre area (central cone)

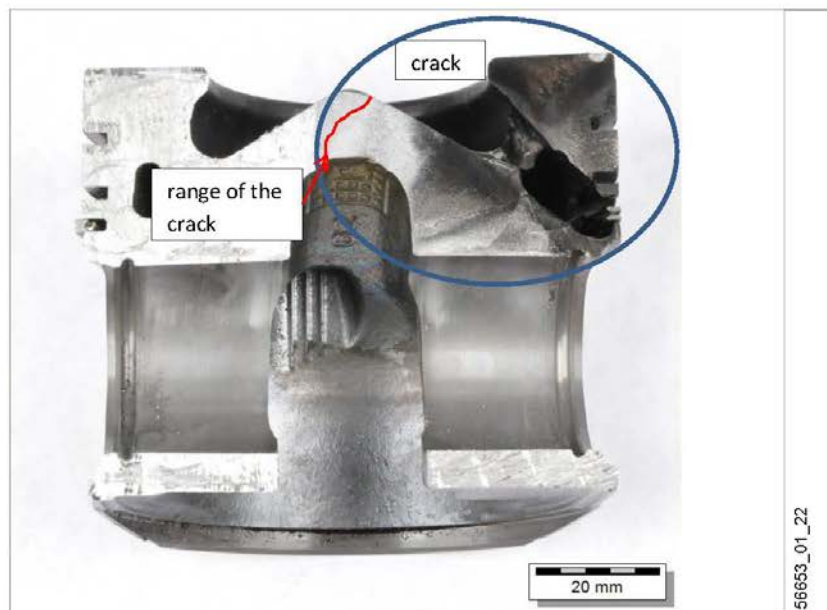
The crack of the piston has been carefully cut open in order to be able to analyse the fracture surface, which shows three individual fracture areas (Fig. 13, 14 and 21 and 22).

**Fig. 13:** Overview of the opened crack

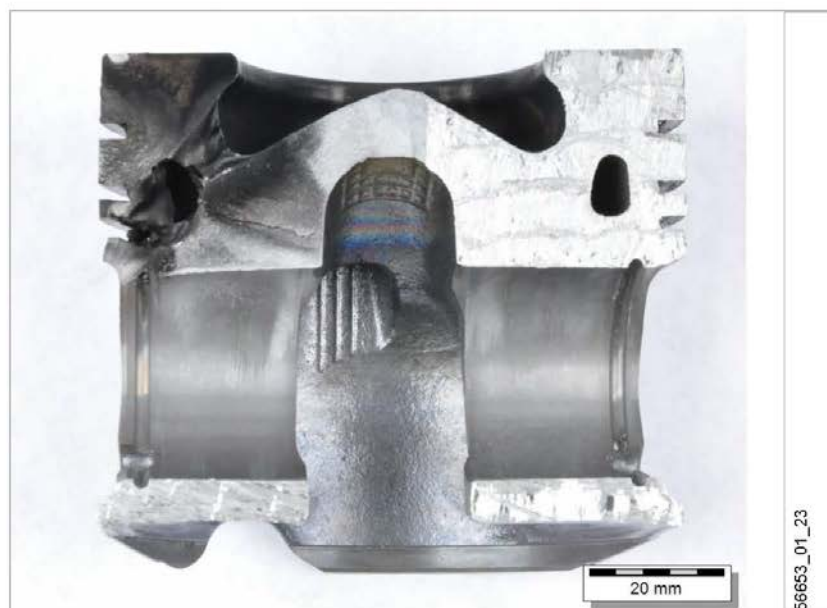
**Fig. 14:** Overview on the opened crack (counter surface to fig. 13)

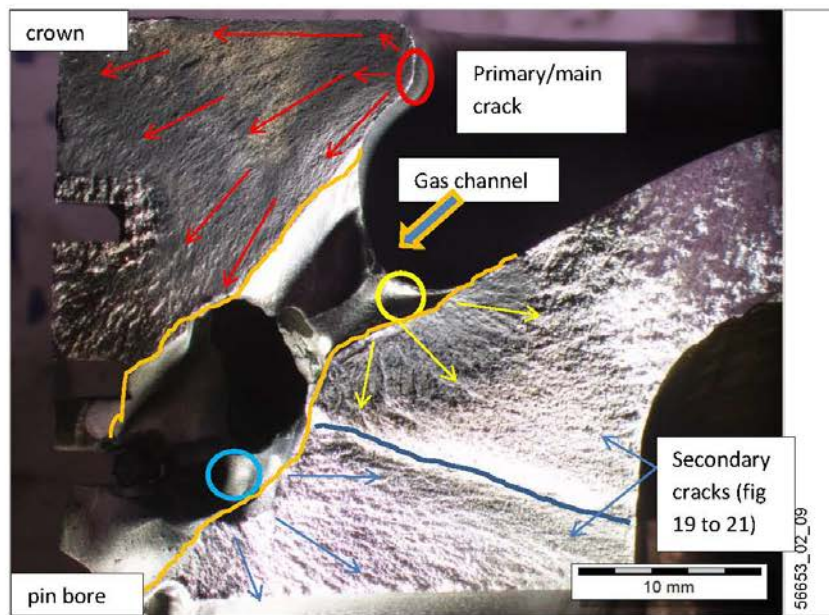
The main and primary fracture is a fatigue fracture starting at the inner radius of the crown opening into the combustion chamber bowl (at the transition radius from the crown to the bowl, fig. 15 and 16). At the fracture origin no mechanical damage or any notch-like defect can be detected (fig. 17 and 18).

From the fracture origin the crack propagated towards the piston pin bore, separating half of the piston (fig. 15). When reaching the bottom of the combustion chamber bowl the crack obviously linked the bowl with the cooling channel and (further on) the ring grooves. The hot combustion gases followed the crack and melted the aluminium in the vicinity, thereby creating a gas channel between the combustion chamber bowl and the ring grooves. Subsequently the channel was widened by hot gases blowing through the gap.

**Fig. 15:** Overview of the fracture surface, Fracture origin and –propagation are marked

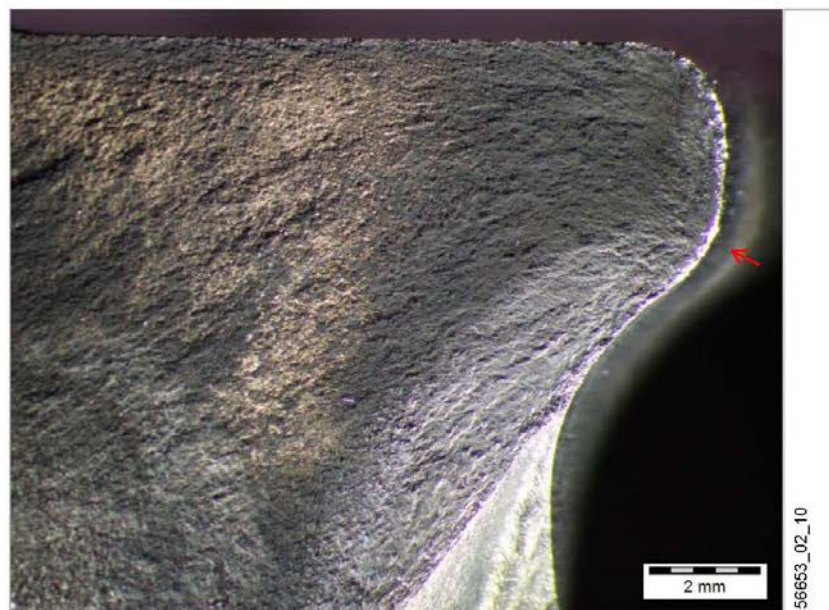
**Fig. 16:** Primary fracture induction site

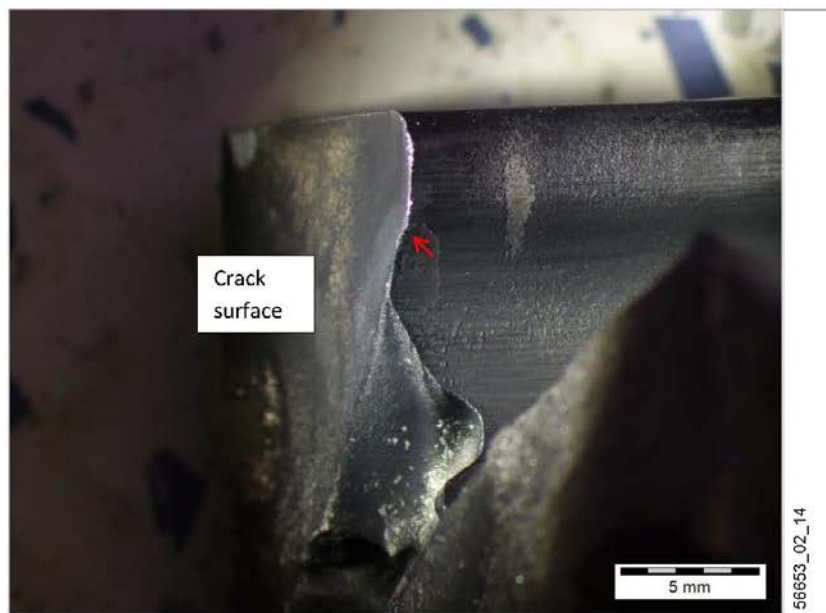
**Fig. 17:** Overview of the fracture induction, no mechanical defects detectable

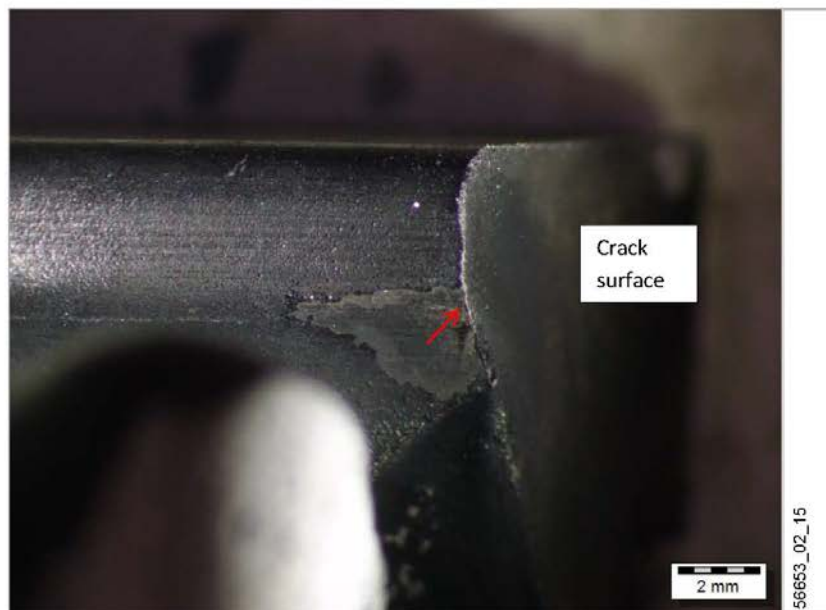
**Fig. 18:** Overview of the fracture induction, no mechanical defects detectable

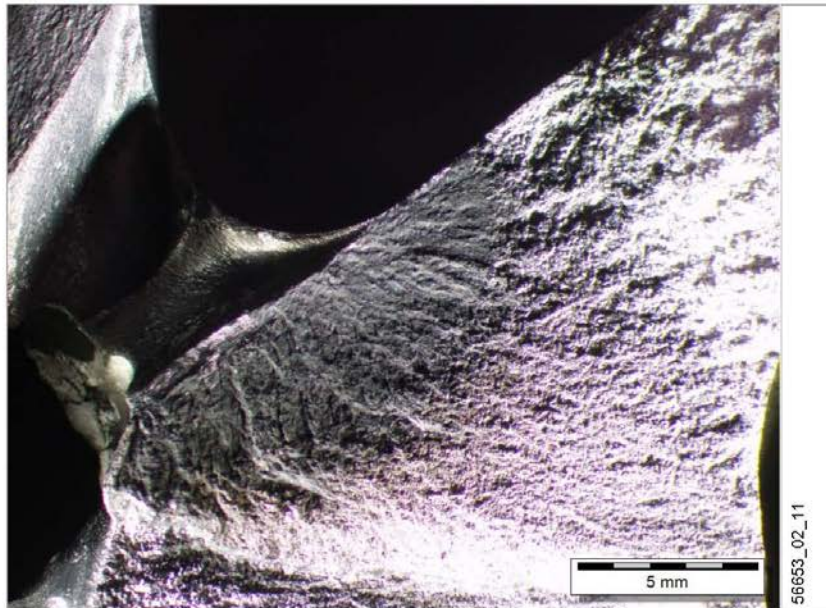
Two further fatigue fracture areas occurred between this gas channel and the piston pin bore, both showing their origin at the edges of the gas channel – one at the entrance and

the second one near the oil ring groove (fig. 19 and 20) - and therefore are interpreted as subsequent cracks.

**Fig. 19:** Overview of the fracture induction next to the gas channel entrance

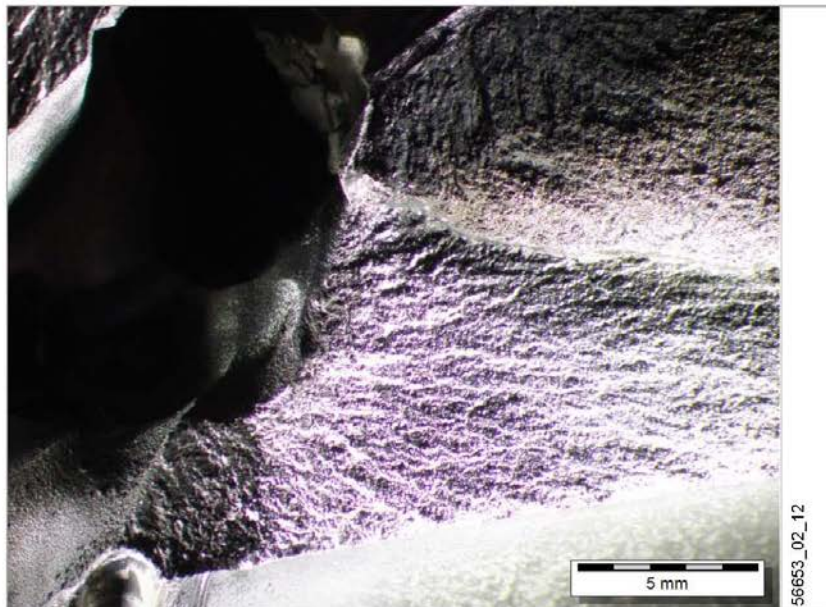
**Fig. 20:** Overview of the fracture induction at the gas channel above the piston pin bore

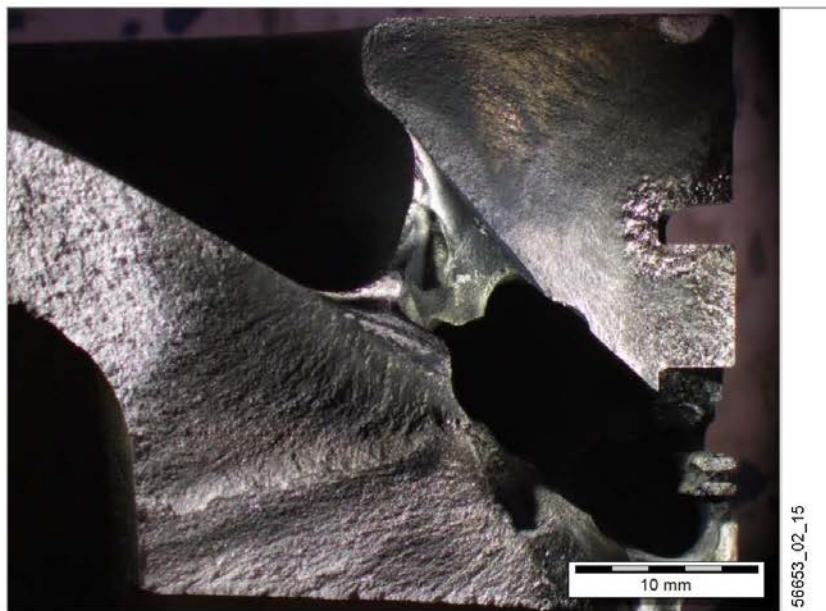
**Fig. 21:** Overview of the fracture surface (counter surface to fig.15)

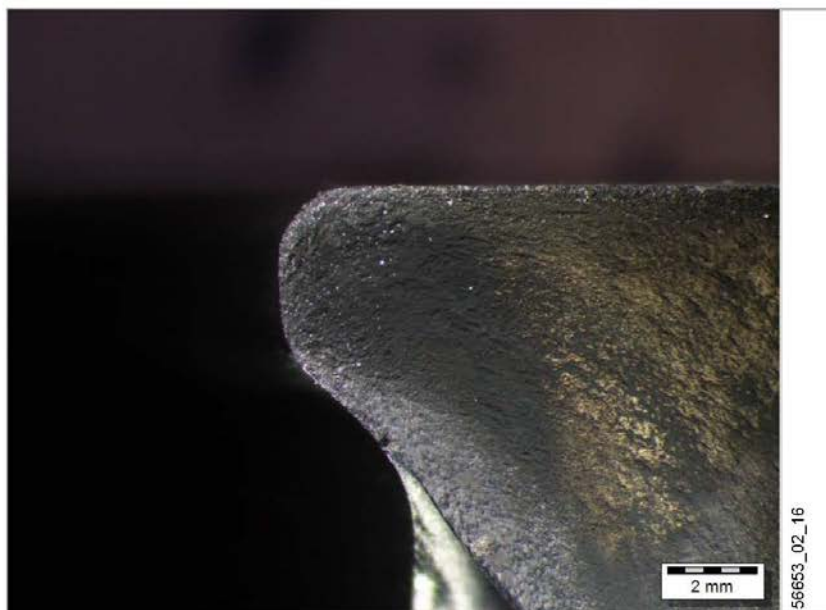
**Fig. 22:** Overview of the fracture induction at the crown (counter surface to fig.14)

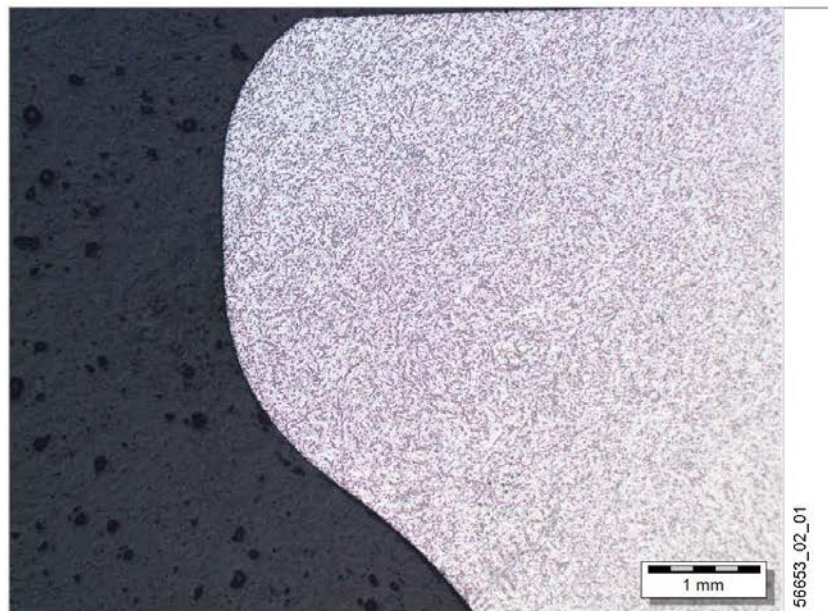
As no further damage at the surface or within the microstructure of the piston is detectable at the fracture origin (fig. 25 and 26), it is suggested, that local overloads, resulting from the bending loads described above, have introduced the fatigue fracture supported by the weakening of the material by thermal impact.

**Fig. 25:** Micro-structure next to the fracture origin

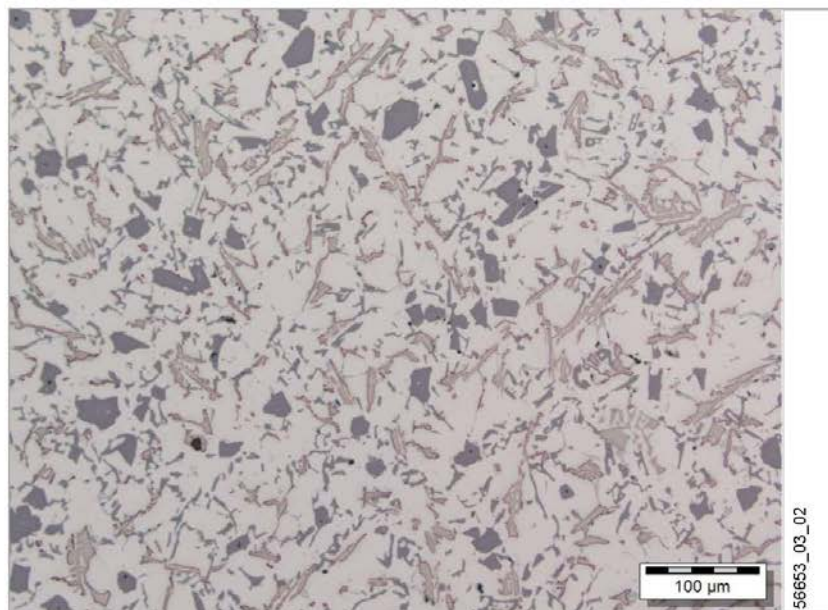
**Fig. 26:** Micro-structure

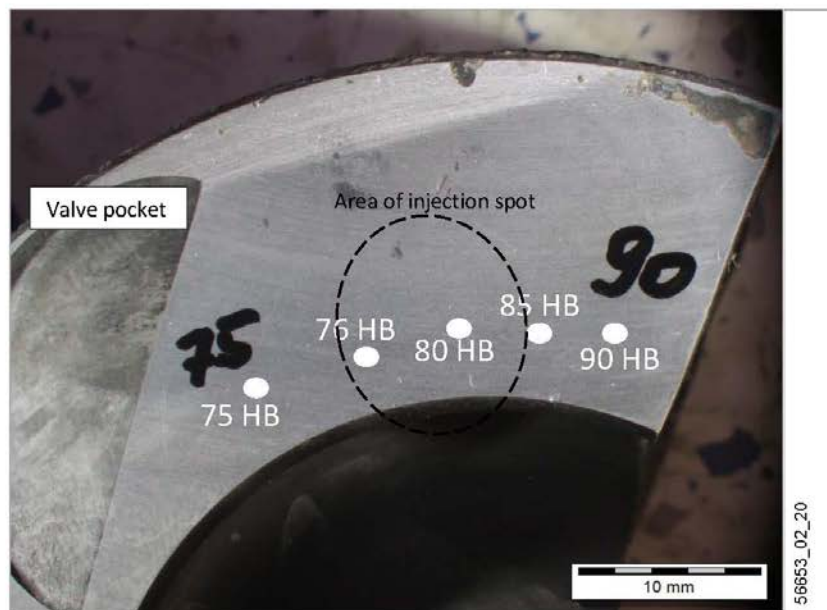
Hardness measurements have been implemented on the surface of the piston crown between the outlet valve pocket and the crack, showing a hardness of 90 HV30 (resp. approximately 85 HB) next to the crack, with a decrease of hardness within the area of the local injection spot (75 to 85 HV, 71 to 81 HB) and towards the valve pocket (75 HV30, approximately 71 HB, fig. 27).

**Fig. 27:** Hardness measurements at the crown next to the fracture origin; the surface has been ground for the hardness measurements. The hardness is increasing towards the fracture

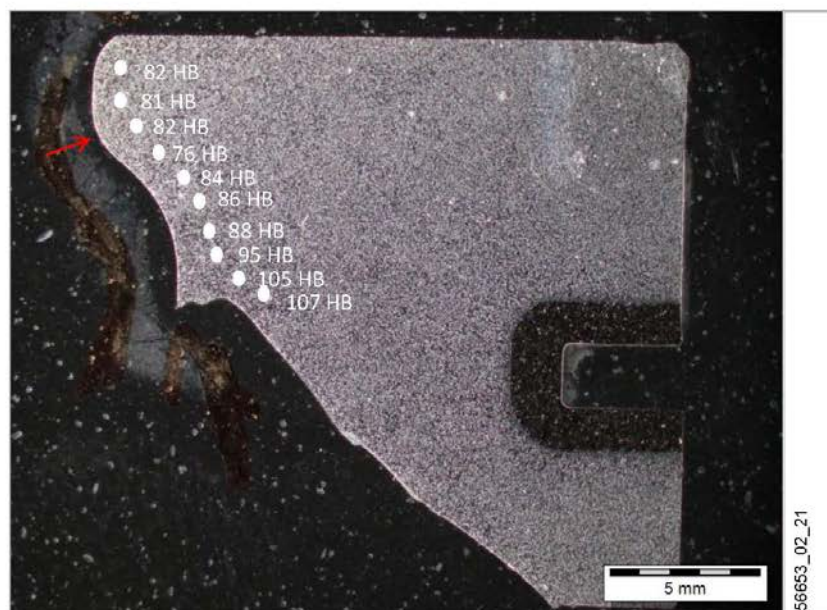
A metallographic cross section has been prepared to investigate the microstructure, which does not expose any relevant deviation concerning the crack appearance (fig. 8). On this cross section a further hardness measurement was performed to see the hardness distribution from the crown towards the piston pin bore. The results of the hardness measurements are given in figure 28.

The hardness increases from 82 HB underneath the top surface of the crown to approximately 106 HB in a distance/depth of ~ 9 mm from the top face of the crown, measured along the surface of the combustion bowl. Therefore the fracture induction took place in a region of the piston, where the hardness is decreased due to the thermal impact during operation. The local hardness measured next to the fracture induction is approximately 82 HB.

**Fig. 28:** Hardness measurements next to the fracture origin

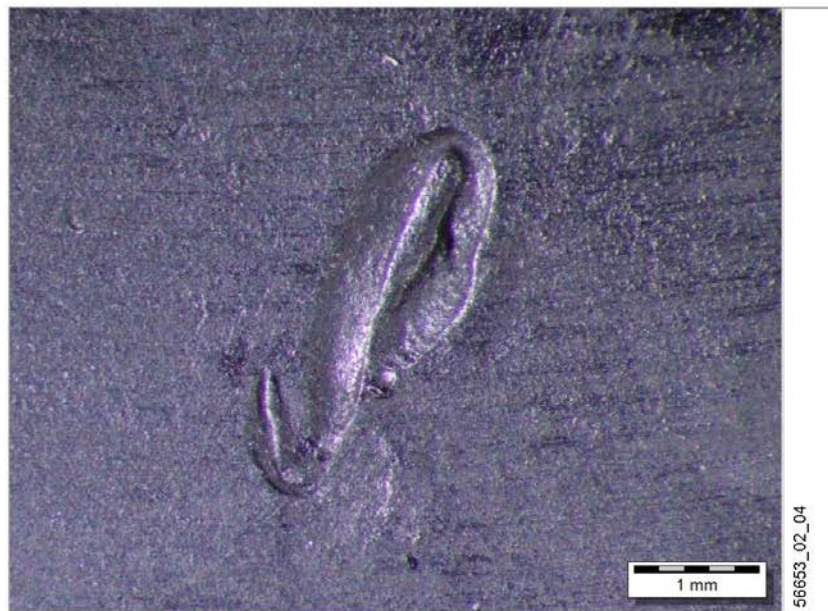
**Fig. 29:** Imprint of a foreign particle at the piston crown (see also fig. 8)

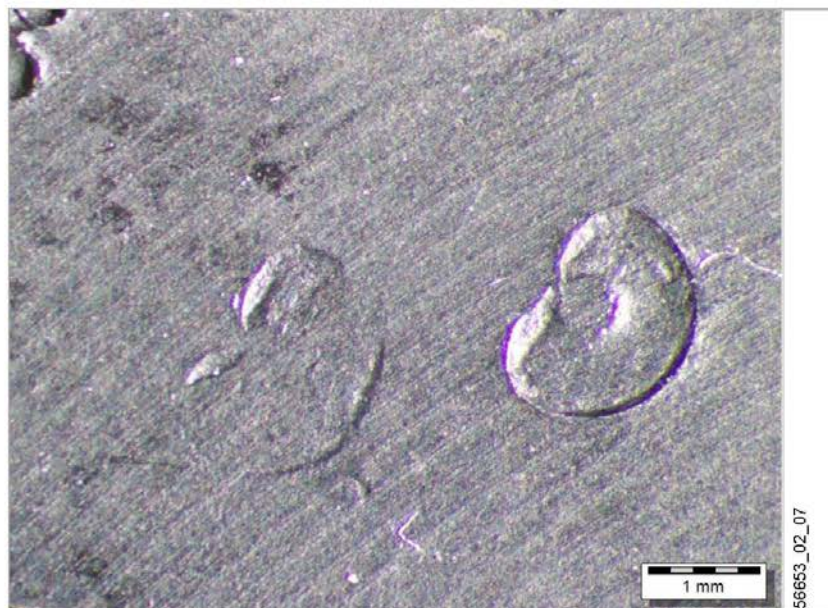
**Fig. 30:** Imprints of a foreign particle in the piston crown next to labelling (see also fig. 7)
