**AIR ACCIDENT INVESTIGATION  
AND AVIATION SAFETY BOARD  
(AAIASB)**

**ACCIDENT INVESTIGATION REPORT  
AIRCRAFT SX-SEX  
ON APRIL 21<sup>st</sup>, 2018  
AT SKALOMA FOKIDAS**

**Aircraft Piper PA-28-140 with registration SX-SEX  
on April 21<sup>st</sup>, 2018 at Skalama Fokidas**

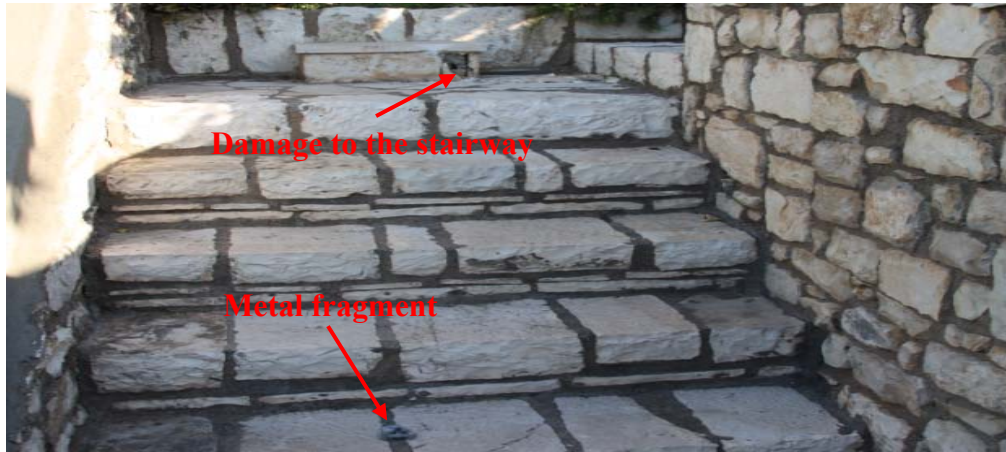
The pillars supporting cable was broken by the collision of the Aircraft. Also, a metal fuse from the pillars support line was fired at an adjacent House, located at a distance of approximately 87 m from the point of contact with the cable, causing damage to the house's stairway (Photo 1).

Photo 1: View of the metal fragment and damage caused.

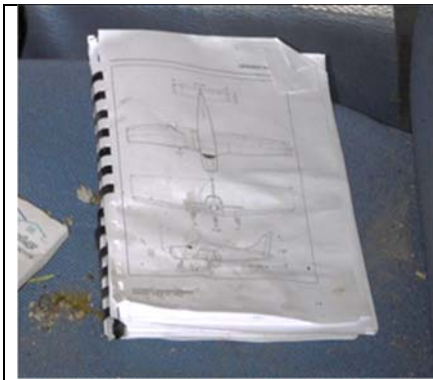
Photo 2: That POM was found inside the A/C at the accident sight

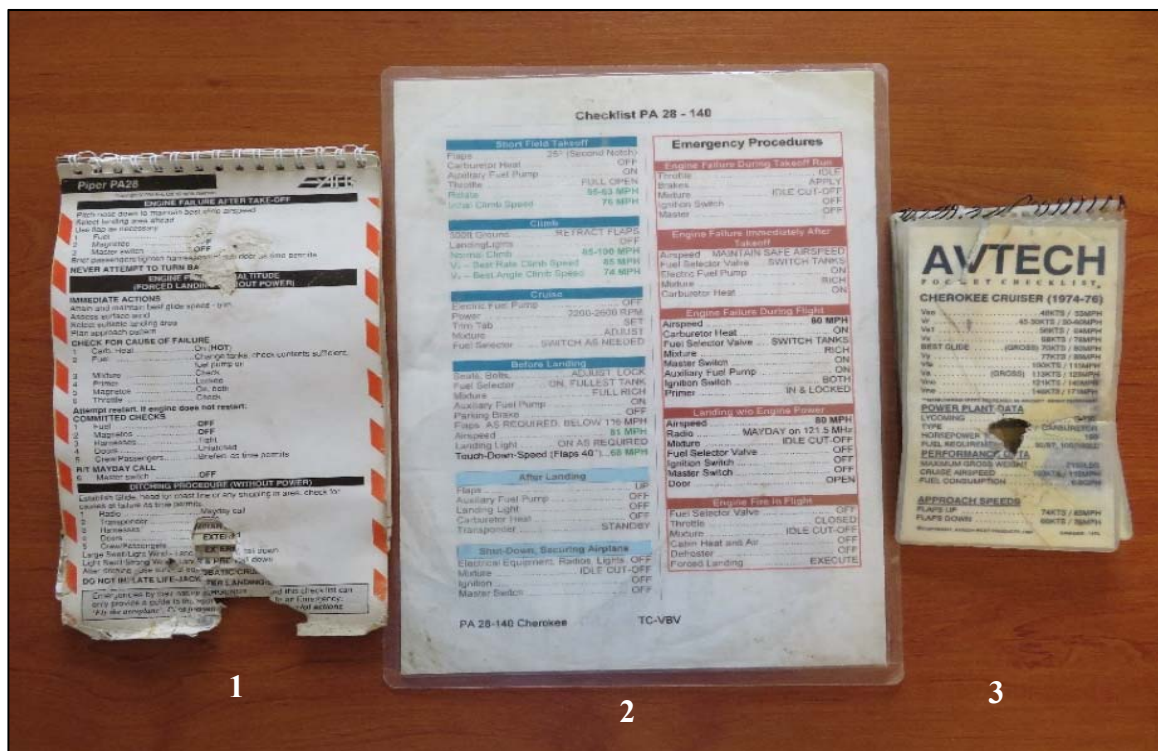
Out of the three lists, from the review of the engine failure procedure, No2 and No3 include with small differences, the same actions, while those of list No1 differ.

Of the three lists, only No.2 refers to the type of accident Aircraft and the mentioned registration TC-VBV is the previous registration of that Aircraft.

Photo 5: The three different check lists retrieved from cockpit of the accident Aircraft

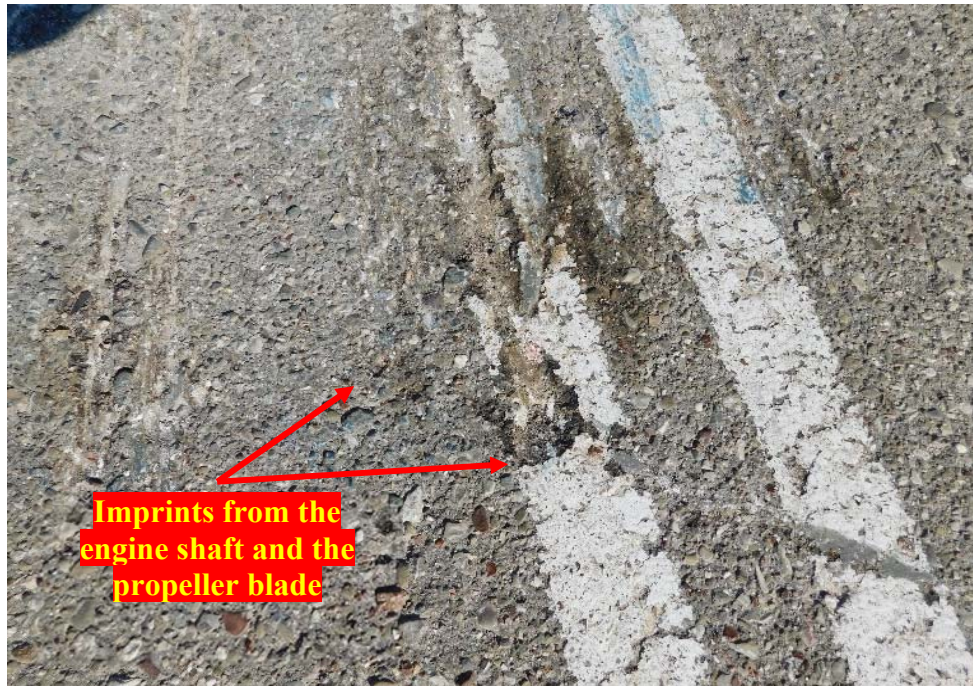
After the collision with the cable, the Aircraft followed a downward trajectory at an angle of  $13^{\circ}$  and collided with the road at a point with an altitude of 212 ft, coordinates  $38^{\circ} 24'09.7''\text{N}$ ,  $021^{\circ} 59'17.8''\text{E}$  at a horizontal distance of 59.4 m from the point of impact with the cable. At the time of the impact on the road, the course of the Aircraft was  $322^{\circ}$ , while on the road, footprints were created from the engine shaft and the right wing of the propeller as well as from the tire of the right main Landing Gear (Photos 12,13)

**Photo12: Impact point on the road**

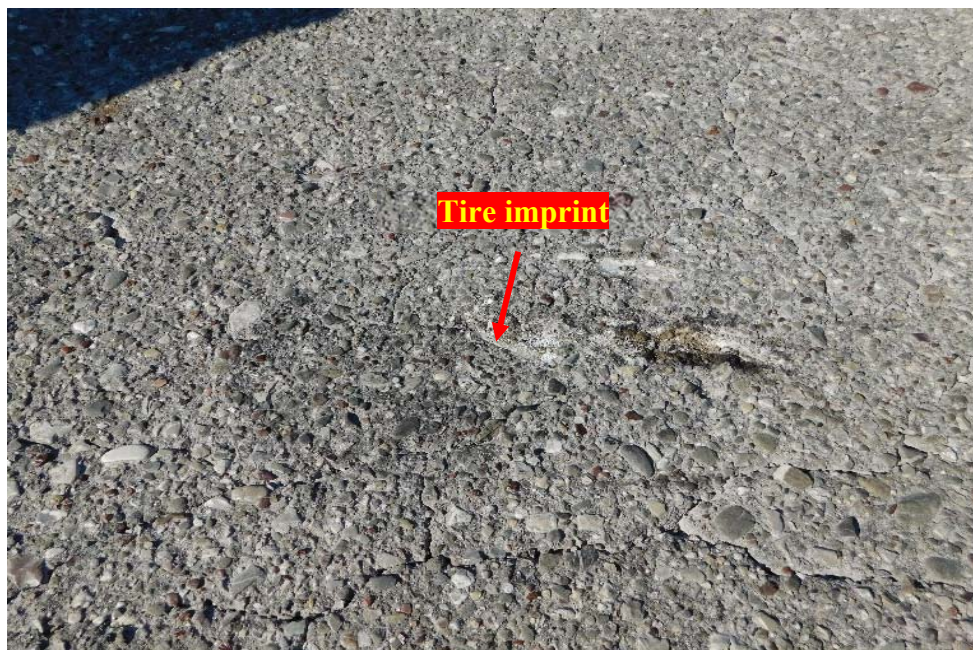
**Photo 13: Imprint of the starboard tire on the road.**

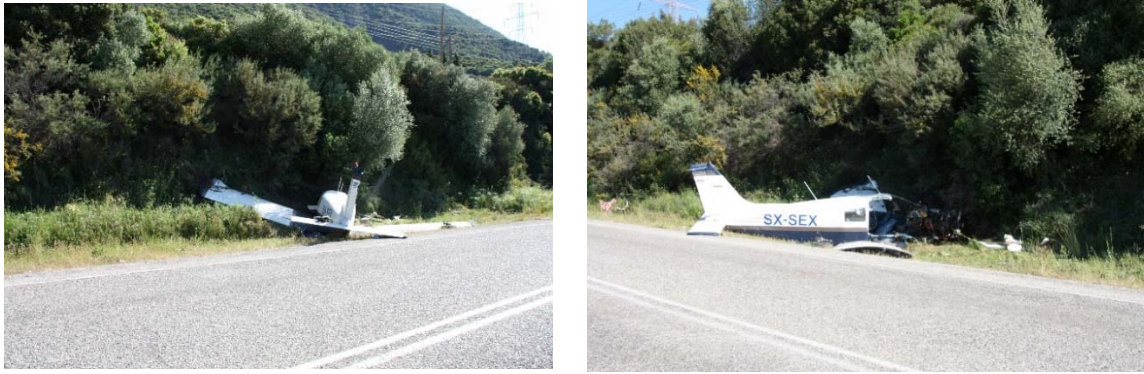
After the impact with the road, the Aircraft travelled a course of  $299^{\circ}$  for a distance of 64.5 m and was immobilized at a point with coordinates  $38^{\circ} 24'10.8''\text{N}$ ,  $021^{\circ} 59'15.7''\text{E}$  and altitude 227 ft (69.18 m) from sea Level (Photo 14).

**Photo14: The Aircraft at the point of immobilization**

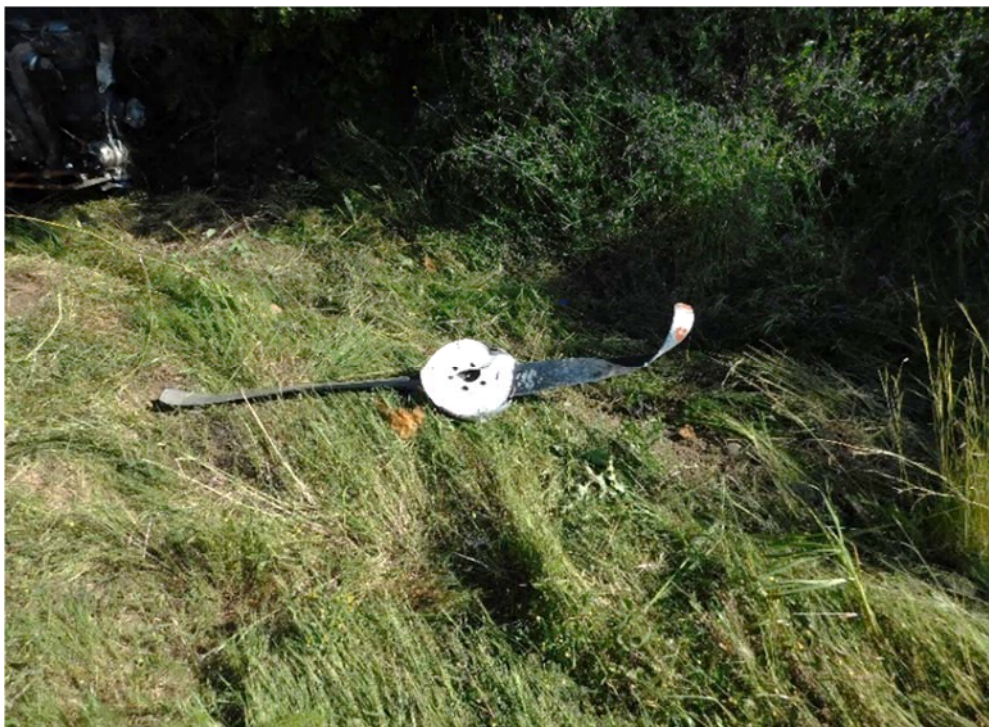
The engine propeller, Photo 15, was found next to the Aircraft with distortion and abrasions to an increased degree in one wing and to a lesser degree in the other.

**Photo 15: The engine propeller at the accident site.**

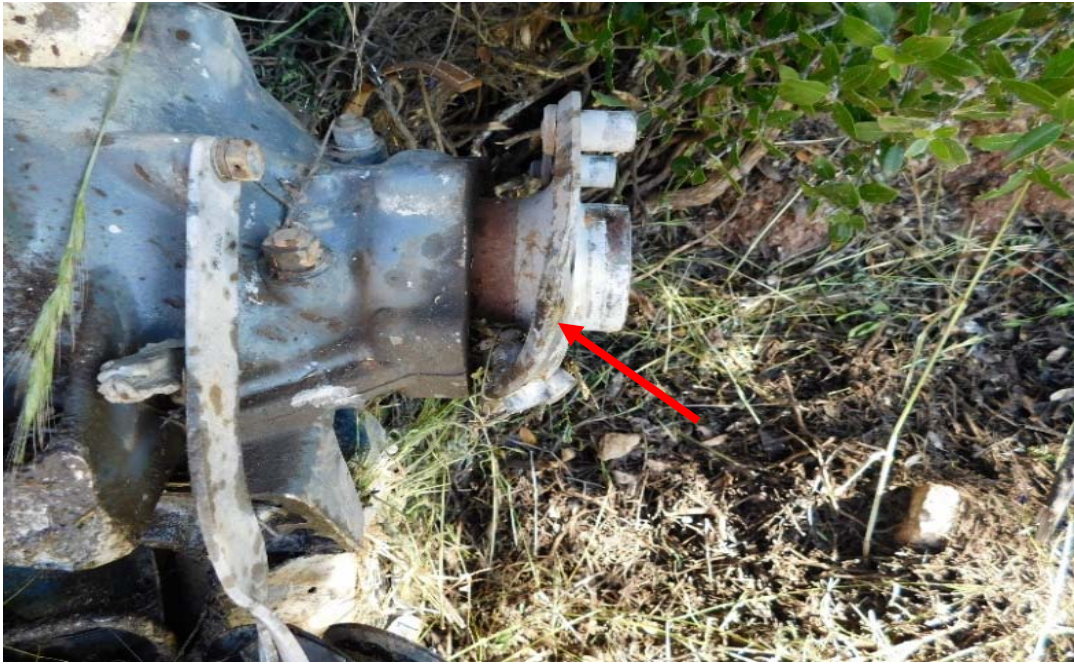
**Photo 16 : The deformation of the engine shaft at the point of connection with the propeller.**

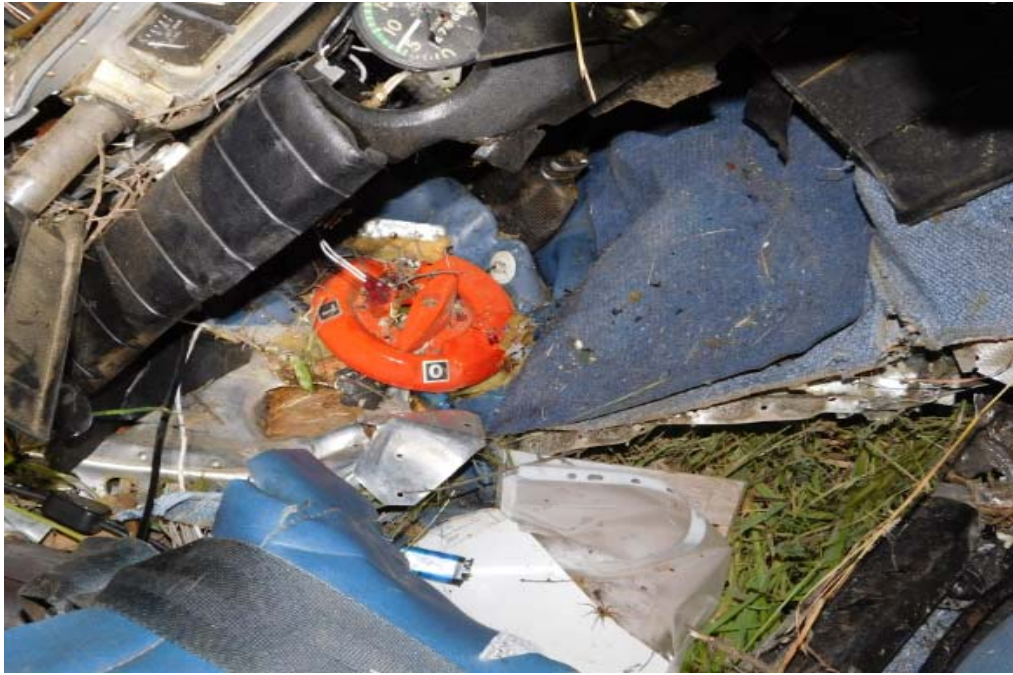
- The fuel tank selection valve was located between the “O” position and the “L” position,
- The battery power switches were in the ON position,
- The switch of the electric fuel pump was in the ON position,
- The landing lights switch in OFF position as well as and pitot heat switch,
- The power lever of the engine was distorted to the right, while the axis of its front limit was distorted to the front,
- The RPM indicator was at 600 rpm and the aircraft hours meter indicated 4796.12 h,
- The flap lever was one detent before the full down (Flaps 25 position).
- The ignition switch of the engine was in the “BOTH” position,
- The fuel mixing lever was close to the lean position,
- The carburettor heat was near to the open position,
- The air speed indicator was at 110 kts.
- The Fuel priming lever was in full in position.

**Photo 17: Fuel selection valve position**

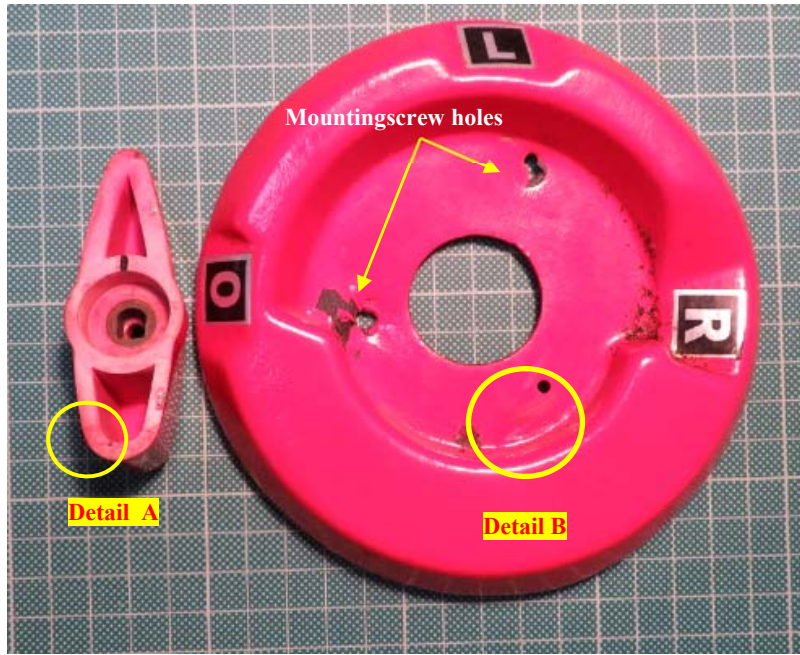
As mentioned in paragraph 1.12.3.1, the tank selection valve was between the “O” position and the “L” position. During the examination of the Aircraft and the removal of the tank selector, deformations were observed on the surface of the display disc in the holes of its support screws, as well as abrasions on the surface of the disc and the selector.

Photo 18: Fuel selector (Left) and the display tray (Right)

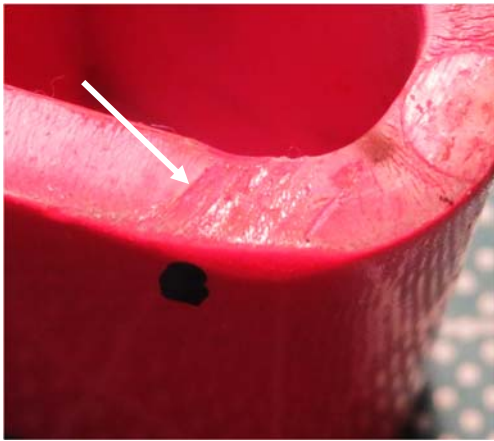
Photo 19: Detail A, abrasions in valve selector.

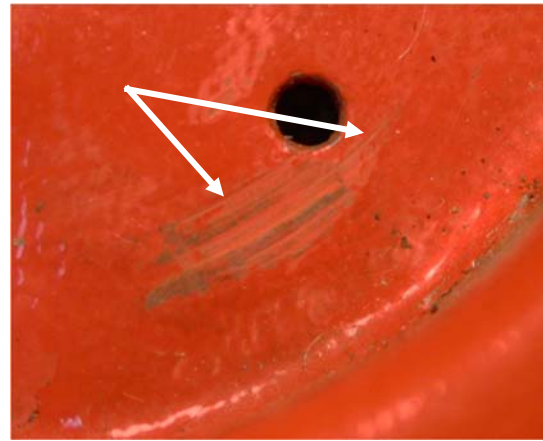
Photo 20: Detail B, the abrasions on the disc indications.

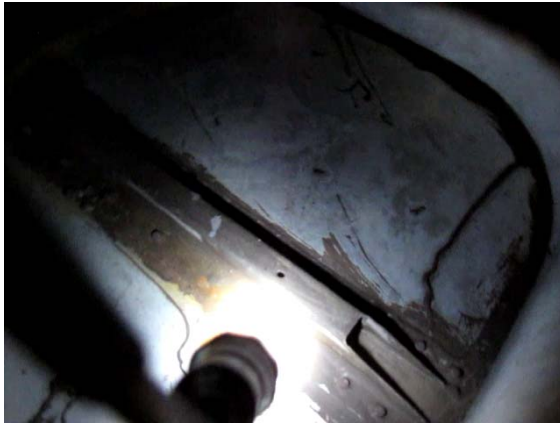
From the initial examination of the two fuel tanks, it was found out that they were closed and intact without the smell of fuel at the accident site. Examination of the abdomen of the left tank showed no signs of leakage while the drain valve was operating normally without a trace of leakage. Of the two tanks, the left one was empty (Photo 21), without the existence of the unusable amount of 1.1 US gal (4.16 lt) being detected, while the right tank contained a quantity of fuel (Photo 22), where after the its drainage was found to be 20 lt.

**Photo 21: Left tank at the original examination**

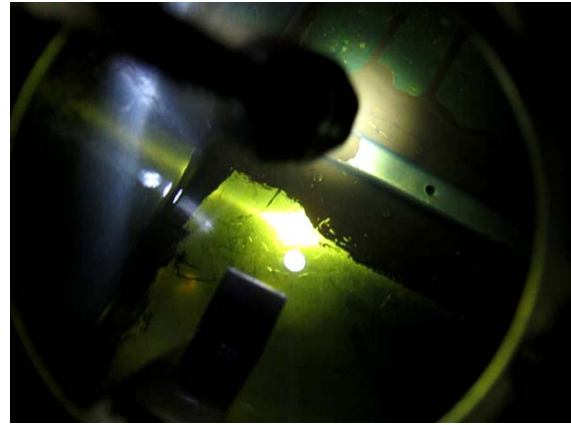
**Photo 22: Right tank at the original examination**

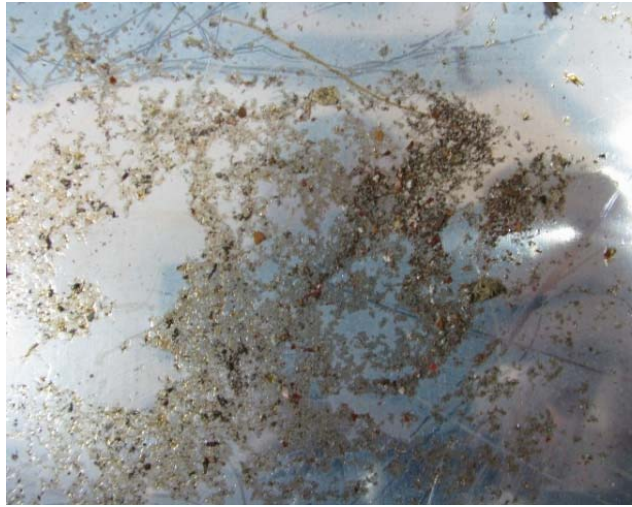
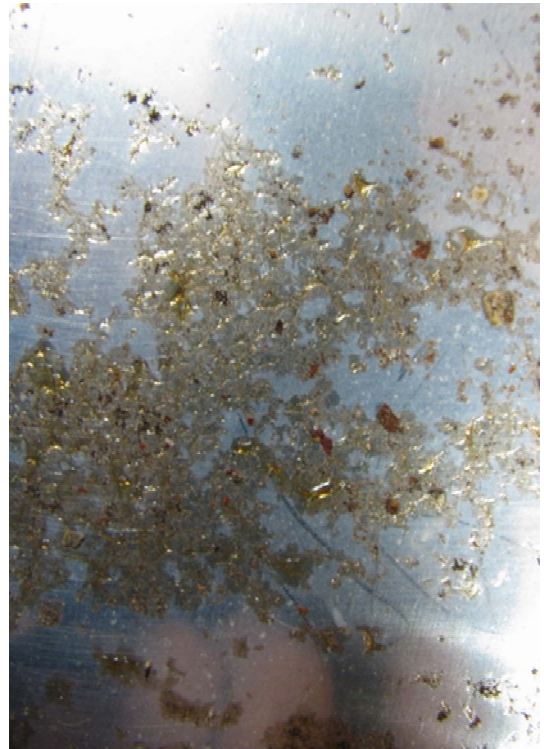
Also, from their further examination it was found that the right tank contained deposits which, after being removed from the wing of the Aircraft and its opening, are shown in Photo 23. These deposits were in the form of a sticky material and a sample was collected for laboratory examination. At the same time, after the removal of the tank, the fuel level sensor of the tank was removed for laboratory examination, while its vent lines were found to have free flow inside them.

**Photo23: Findings of the right tank after its opening.**

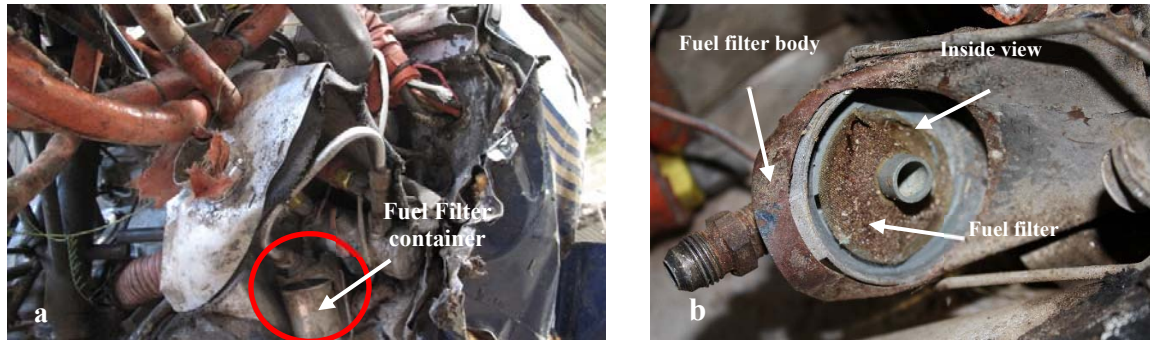
The fuel filter was found as shown in Photo 24(a), with the filter bowl partially open, while after removing the bowl, it was found that on the filter and more specifically on the side of the unfiltered fuel, earthy deposits were found as shown in Photo24(b) and 38, 39 of Appx. 5.5, while its inner side was deformed and torn. Also, at the exit of the fuel from the body of the fuel filter there were deposits as in the filter. The fuel filter and the filter body were subjected to laboratory testing.

Photo 24: The engine fuel filter with the partially open filter tank (Photo a) but also the filter after removing the tank (Photo b).

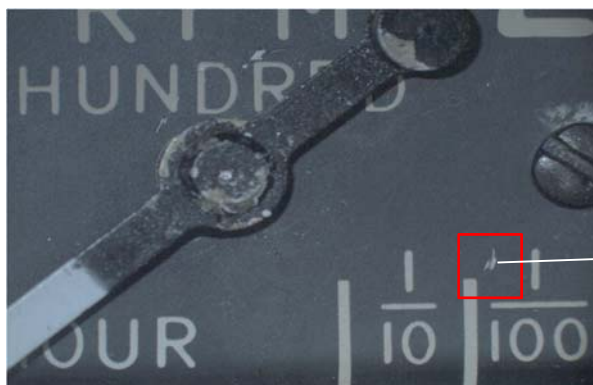
The engine speed pointer showed an imprint on its back on the calibrated plate as shown in the Photos. 25 and 26. Photo 27 shows that the extension of the imprint through the needle shaft corresponds to an indication of 890 rpm.

Photo 25: Imprint on the calibrated plate of the engine RPM indicator

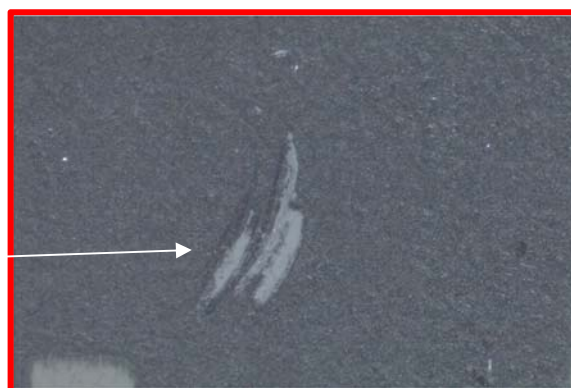
Photo 26: Detail of the footprint on Photo 25.

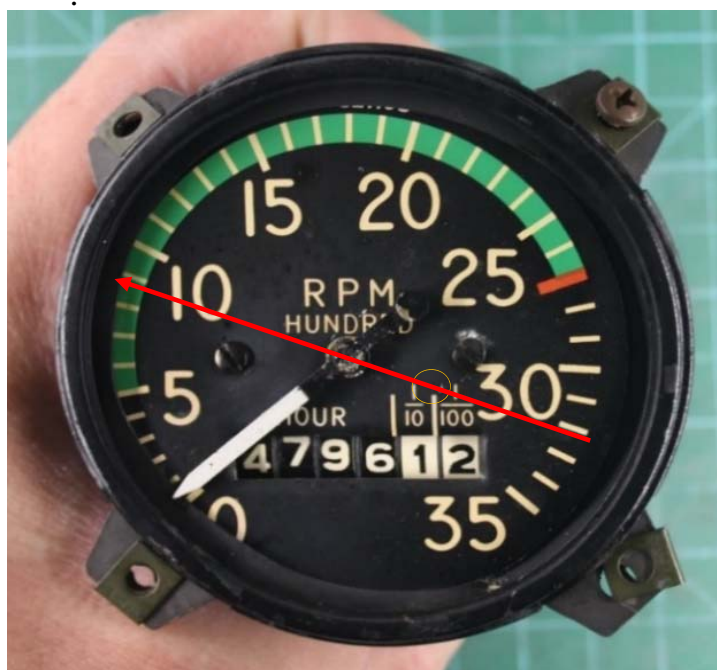
Photo 27: Correspondence of the imprint extension on the calibrated scale

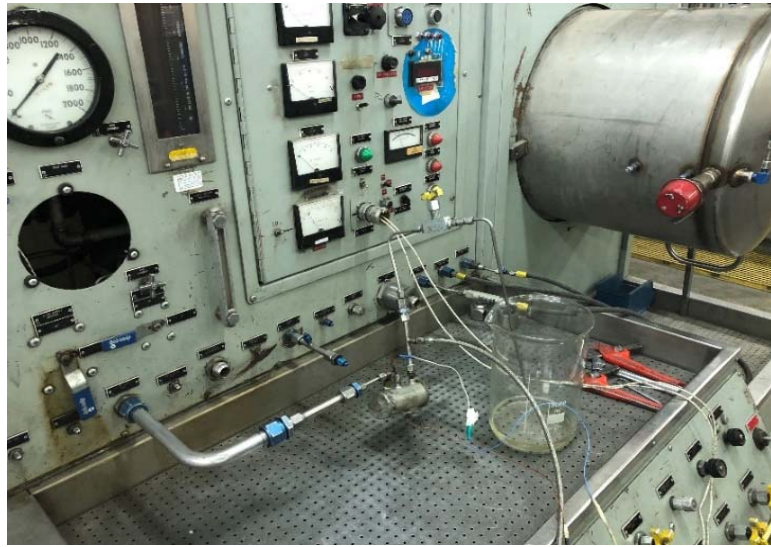
Also, a functional test of the pump was carried out in a suitable laboratory in order to measure its outlet pressure according to the procedure defined in the service manual of the manufacturer (Photo 28). The test revealed that the value of the outlet pressure was 4.84 psi, with manufacturer-defined limits of 4.0 psi - 4.75 psi.

Photo 28: The electric fuel pump during its functional test.

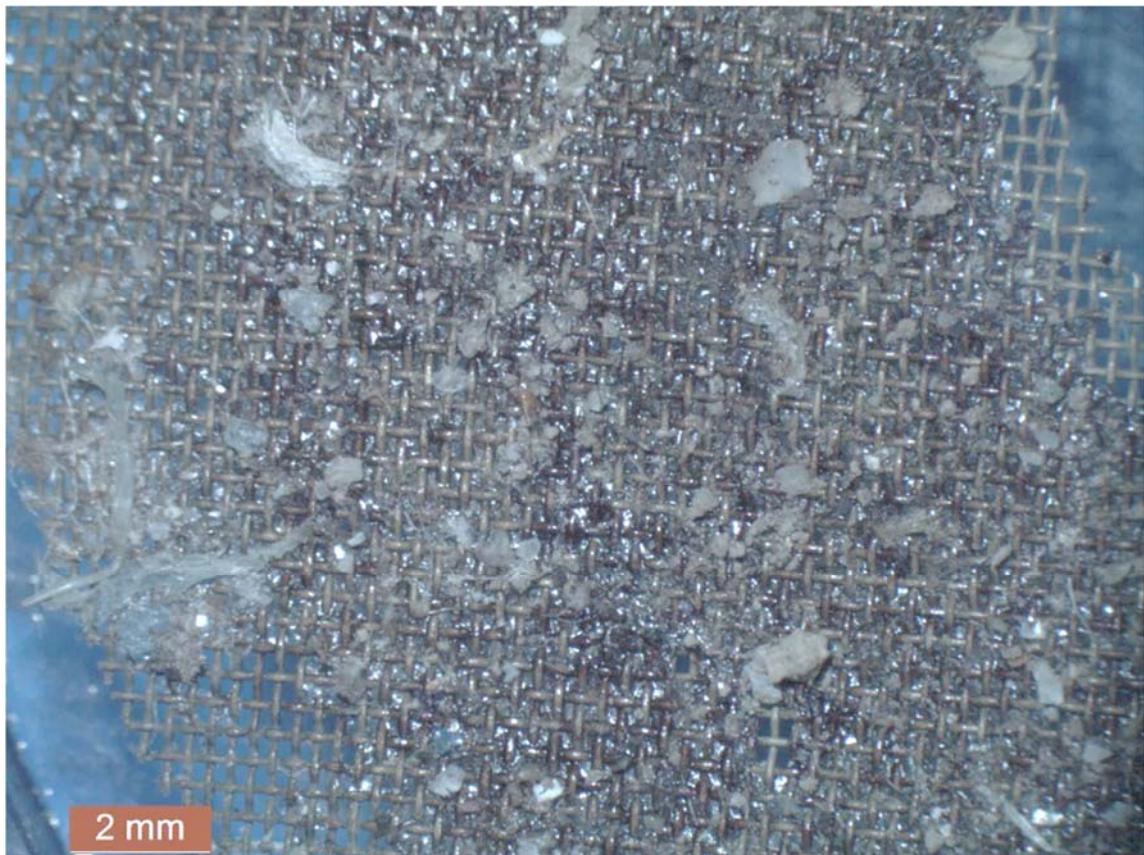
In addition, during the examination of the fuel filter in the stereomicroscope, a glassy material was observed that almost completely covered its cells, as seen in Photos 29, 30, 31 of high magnification.

**Photo 29: Field view of the fuel filter.**

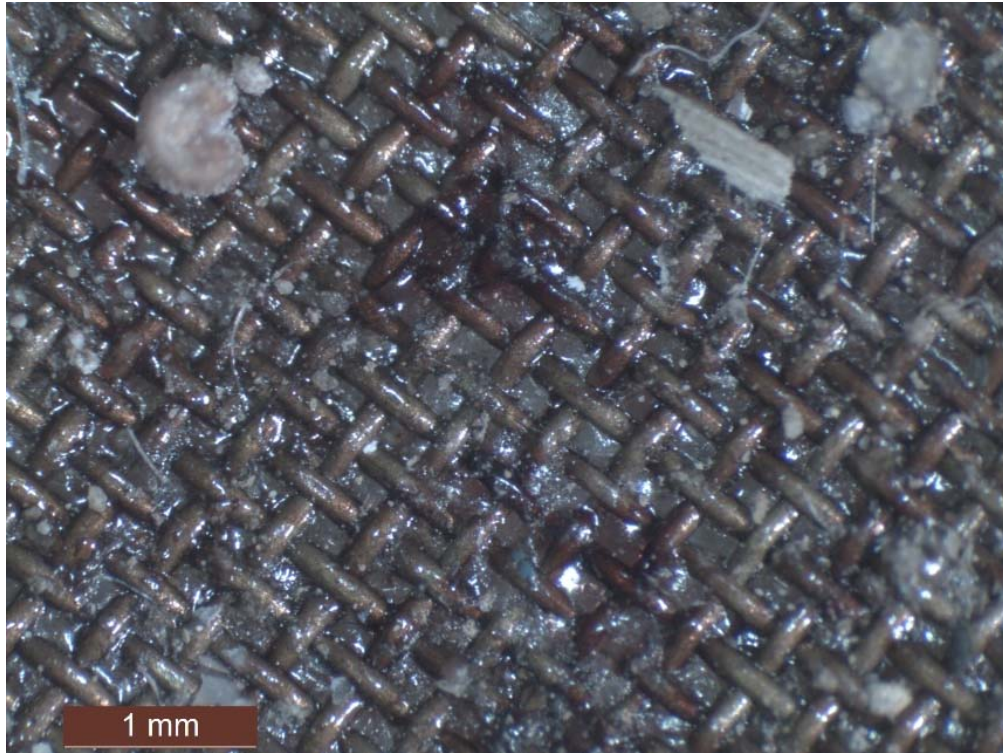
Photo 30: View of fuel filter with glassy material

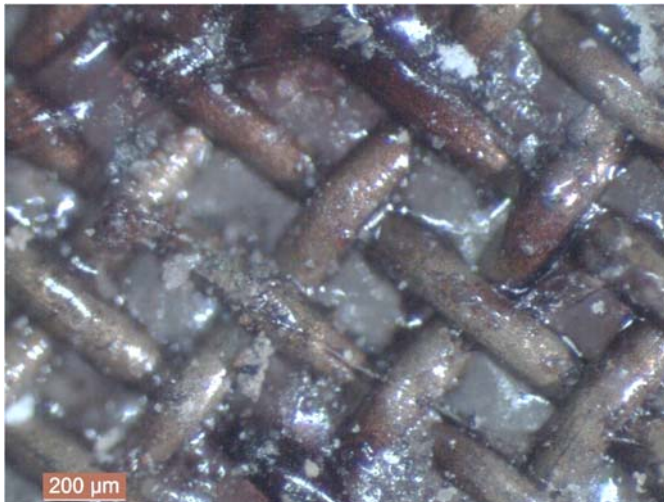
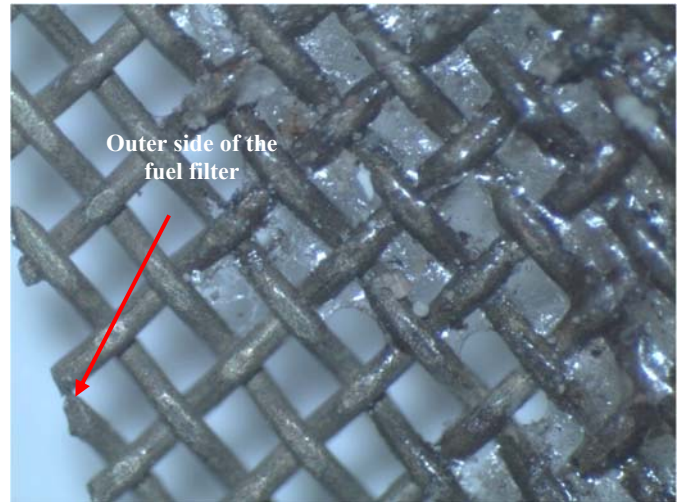
Photo 31: View of the glass material at a larger magnification.

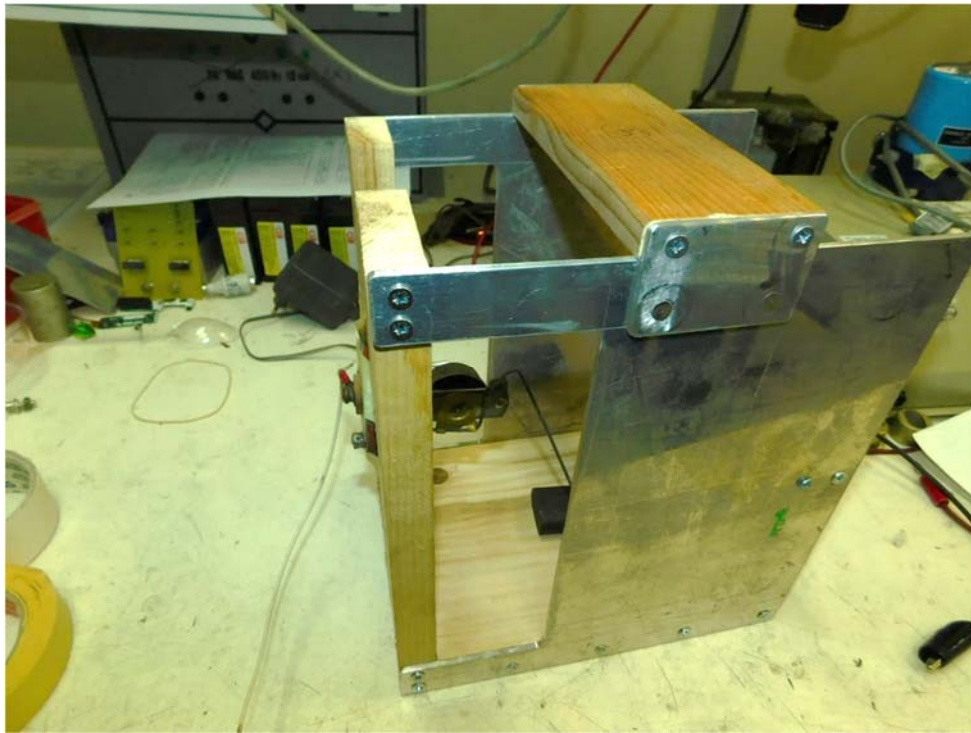
**Photo 32: The proprietary control of the fuel tank level sensor with the sensor mounted.**

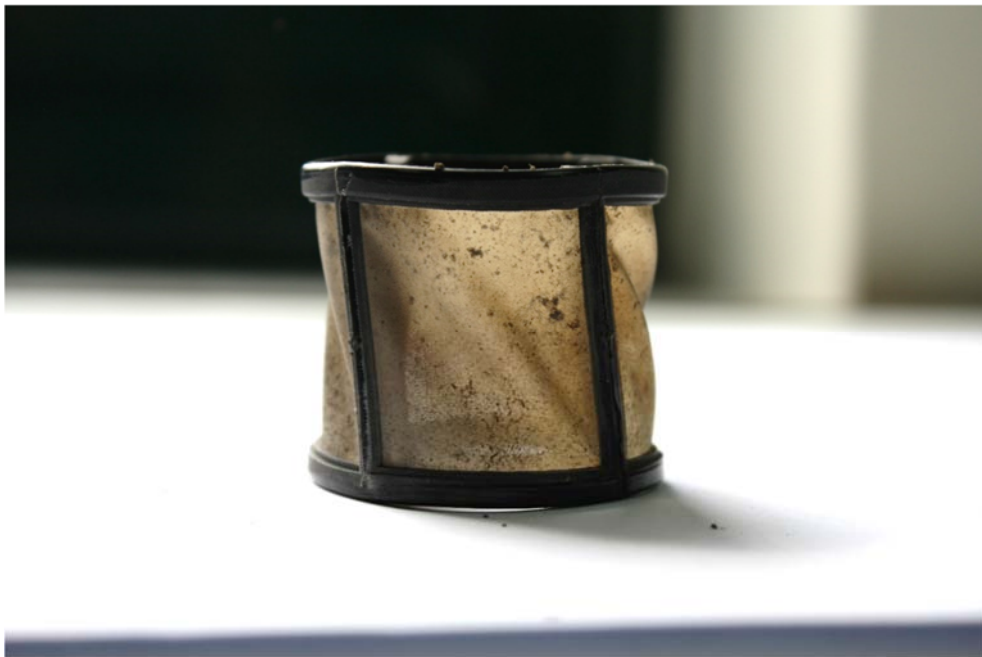
The electric fuel pump was also removed from the engine from which the fuel filter inside it was removed for macroscopic examination. From this, light deposits were found on its surface (Photo 33, Appx. 5.2), while the pump was subjected to laboratory testing.

**Photo 33: The filter of the electric fuel pump in the macroscopic examining it with its slight deposits.**

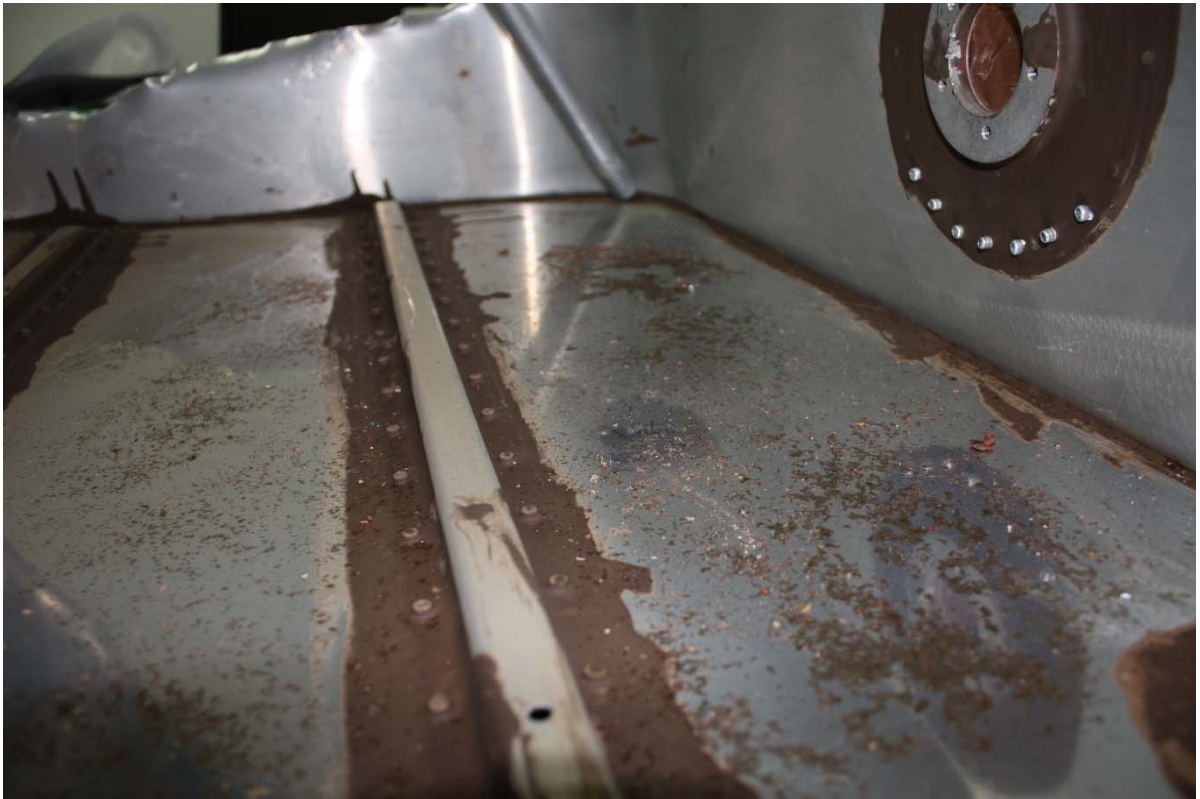
Photo 34: Right hand fuel tank after being opened

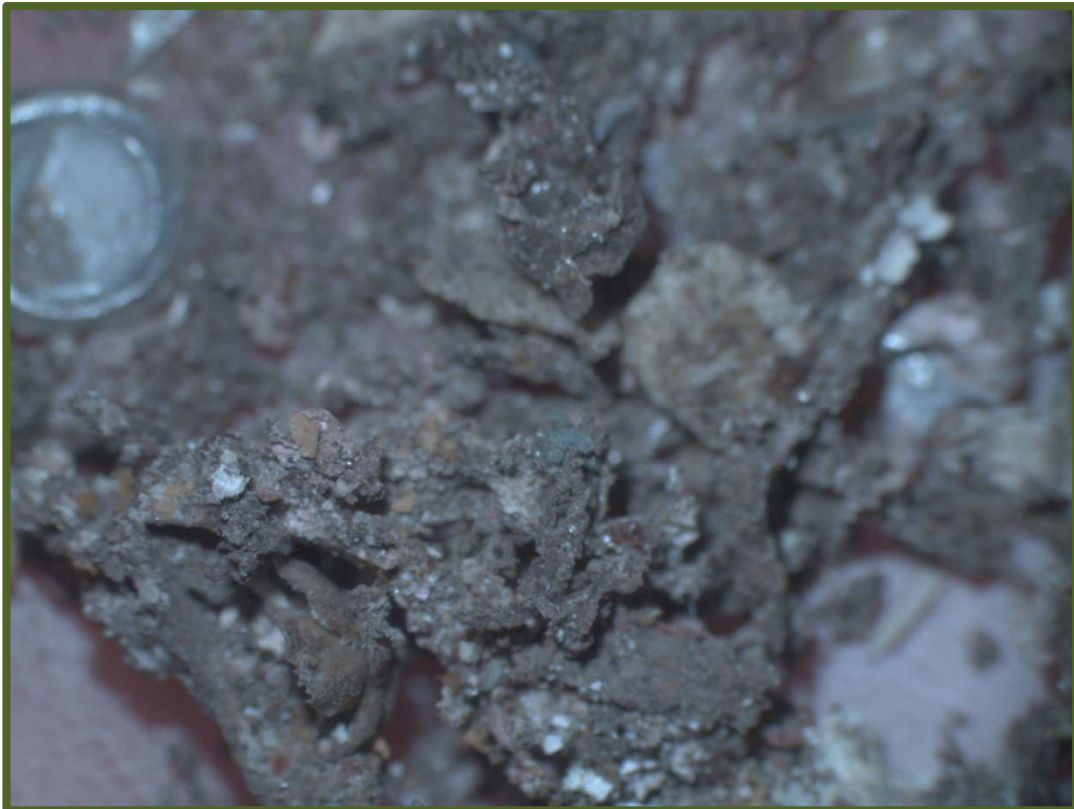
**Photo 36: Detail A, Stereomicroscopy of the deposits in the right fuel tank during the laboratory test.**

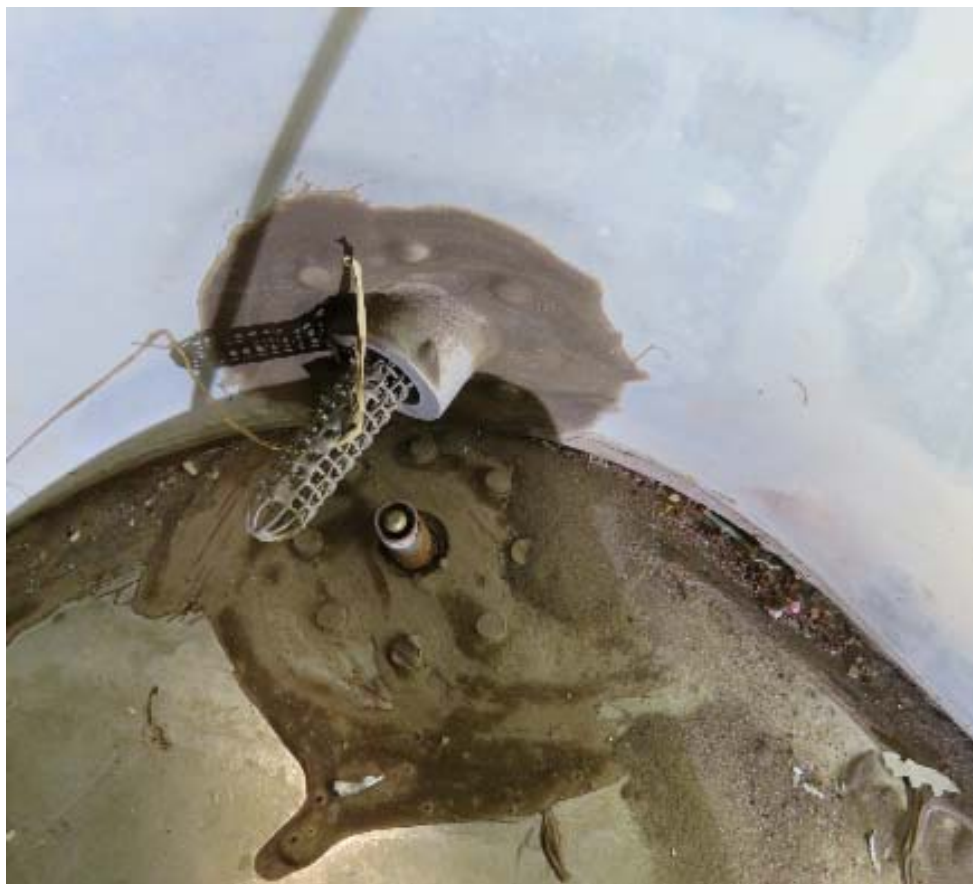
The left tank was opened from its back, without being removed from the wing of the Aircraft. From the macroscopic examination, a piece of rivet and deposits (Appx. 5.4, Photo 37) were observed in the area of the level sensor but also of the fuel outlet, while the existence of the sticky material of the right tank was not found.

**Photo 37: Sample of deposits in the left fuel tank**

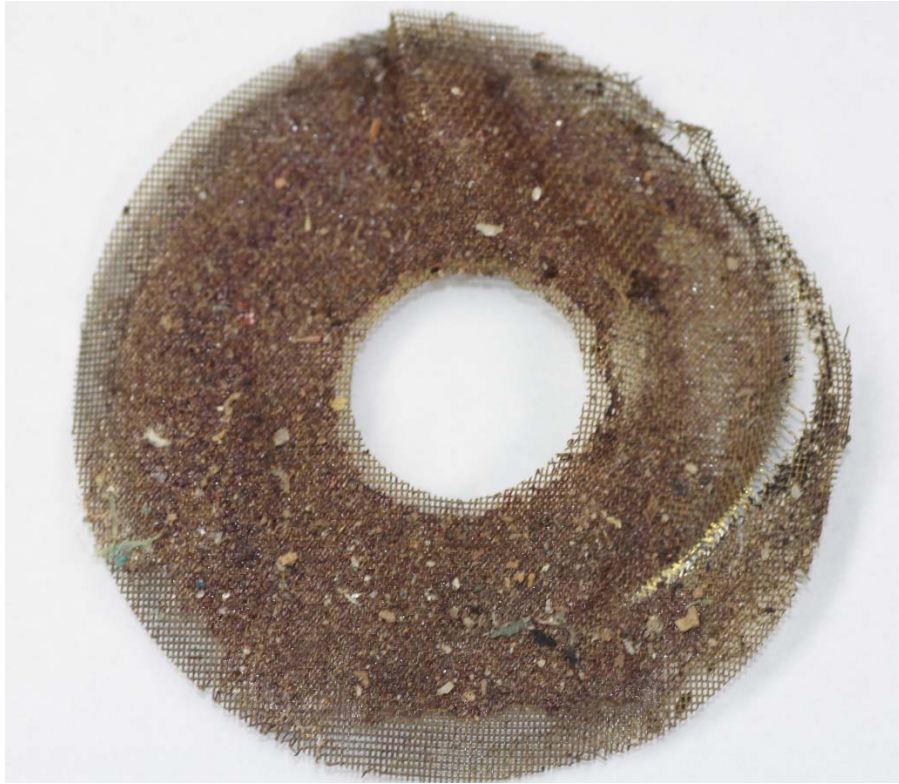
In addition to the above laboratory results, from Photos. 38 and 39 of Appx. 5.5, it is observed that the deposits of the glassy material in the fuel filter have a symmetrical distribution around its inner and outer diameter and cover almost the entire area of the fuel flow through the filter.

Photo 38: The inside view of the fuel filter

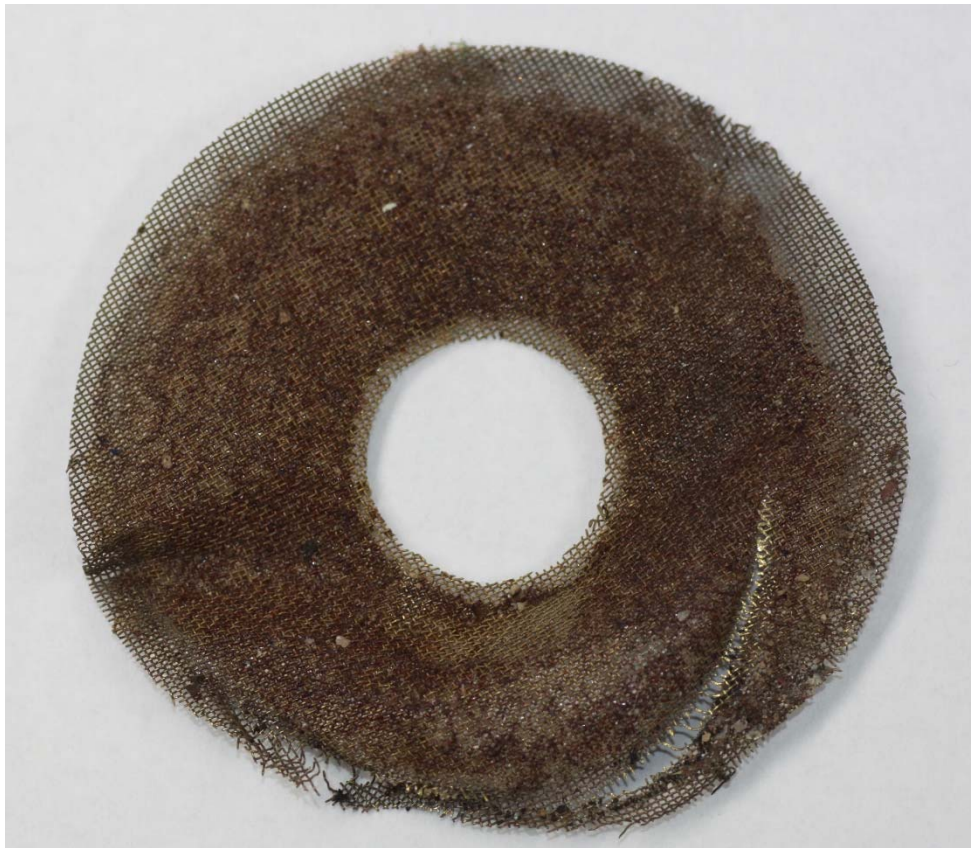
Photo 39: The outside view of the fuel filter .
