**ACCIDENT INVESTIGATION REPORT  
AIRCRAFT I-A468  
AT THE GULF OF PATRAS (POSITION KRYONERI)  
ON JANUARY 16, 2019**

**04 / 2021**

## **I-A468 Aircraft Accident at the Gulf of Patras (Position Kryoneri) on January 16, 2019**

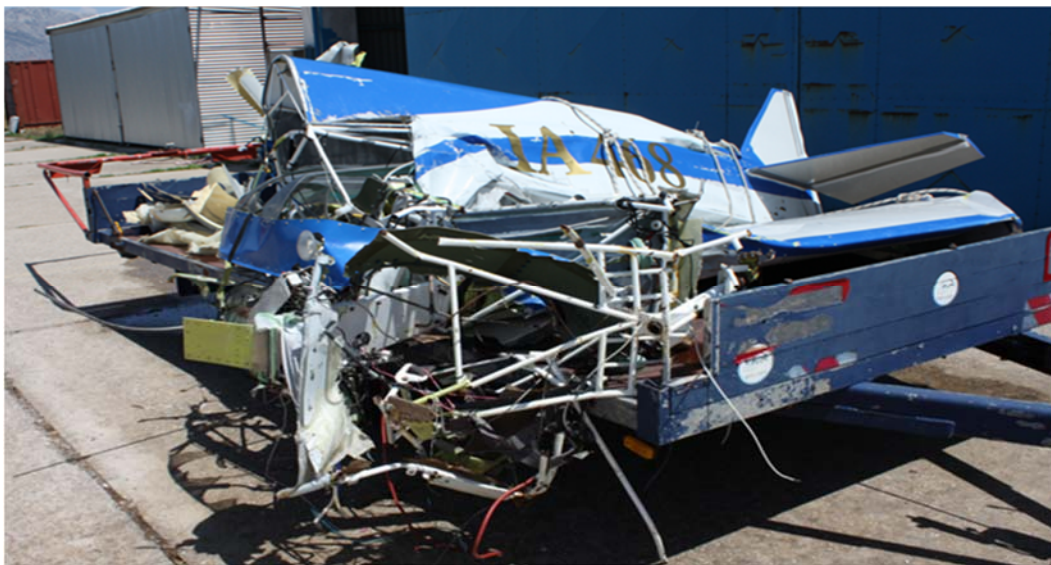
**Photo 2:** Aircraft wreckage.

The aircraft was completely destroyed, its right wing was detached from the fuselage and had a large deformation. The engine could not be found.

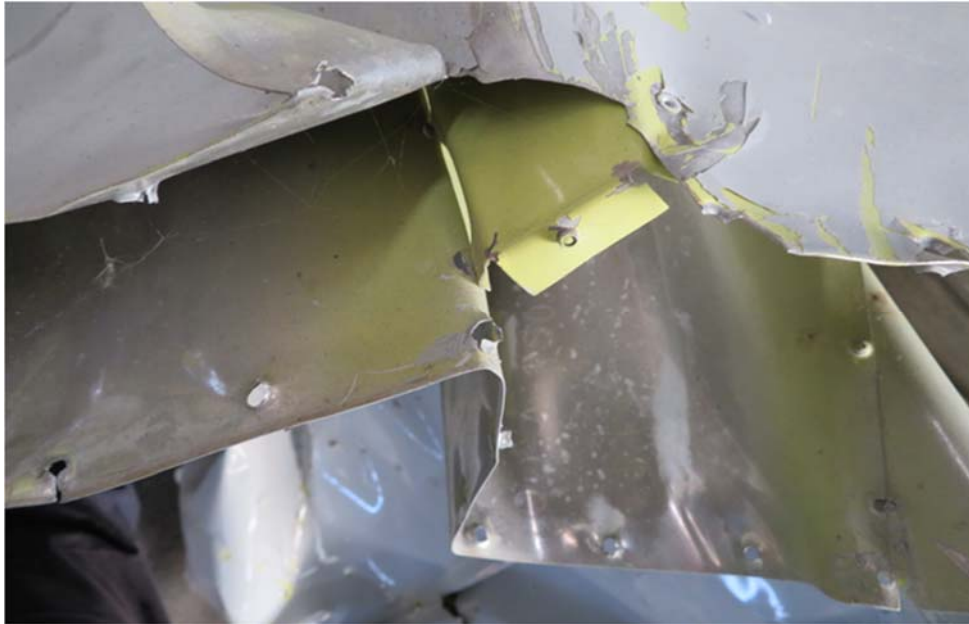
**Photo 5:** Right wing rear spar area.

On the right wing, the aileron was detached together with the rear spar of the wing and was never found.

The rivets that join the skin of the wing to the rear spar, were found with a rearward elongation.

The aileron was detached from the right wing together with the rear spar of the wing, as a result of the violent impact of the wing at sea, which is indicated by the rivets that connect the skin of the wing with the rear spar of the wing which were found with a rearward elongation.

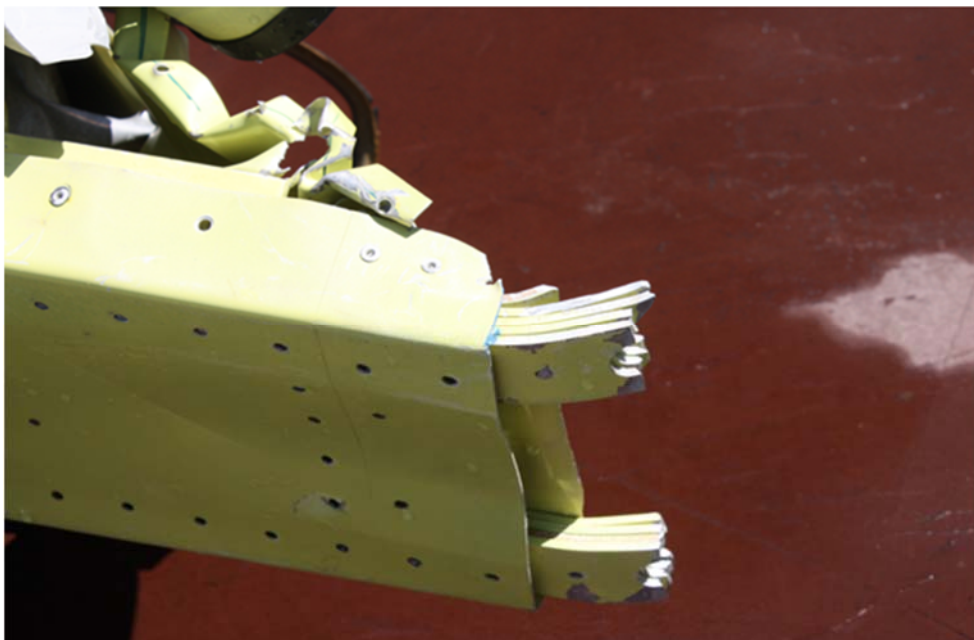
**Photo 6:** Right wing forward spar fracture.

- a) There was no problem in connecting the flight controls to the Rudder. The cables were in good condition, as were the connectors.
- b) There was no problem in the connection of the flight controls with the Elevator, which has deformations due to impact, as well as the body of the push/pull bars (rod body).
- c) The right wing was found detached from the aircraft, it has undergone great deformation (Photo 5) as shown at the point of fracture (Photo 6), with deformations compatible with static fracture, indication of the violent impact on the sea surface.

According to the same testimony, the aircraft crashed into the sea with the right wing, which was detached from the fuselage after its contact with the sea, which is confirmed by the findings of the wreckage, since the point of fracture presents deformations compatible with static fracture, indication of violent impact at sea.
