**SERIOUS INCIDENT INVESTIGATION REPORT  
AIRCRAFT FAIRCHILD SA 227-AC  
SX-BKZ  
AT ATHENS INTERNATIONAL AIRPORT LGAV  
ON DECEMBER 13, 2019**

**E05 / 2021**

**Serious Incident of Fairchild SA 227-AC aircraft with registration SX-BKZ  
on December 13, 2019 at Athens international Airport LGAV**

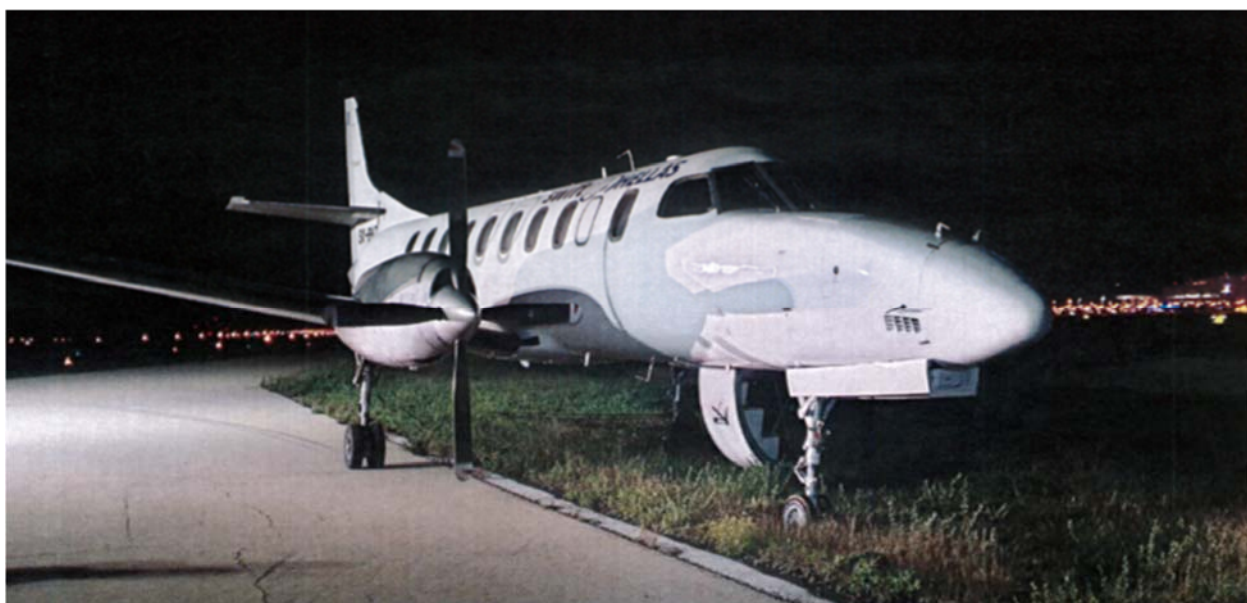
After landing on runway 21R at Athens International Airport, SX-BKZ aircraft type Fairchild SA 227 Metro III and while turning to exit the runway on the A6 high speed exit, the steering of the nose wheel turned sharply to the left. The aircraft was immobilized on the A6 taxi link halfway out of the taxiway. The right main wheel remained on hard surface while the left main and nose wheel on soft ground. No injuries were reported.

**Photo 1:** The aircraft at the incident site.

After landing on runway 21R at the A.I.A., the Commander taxied out of the runway on high speed taxi link A6. During the turn the nose wheel steering sharply turned to the left and the aircraft exited the taxi link with the nose wheel and left main landing gear to rest on soft ground. Both pilots evacuated the aircraft without help and without being injured and the aircraft was towed to the ramp on stand F01.

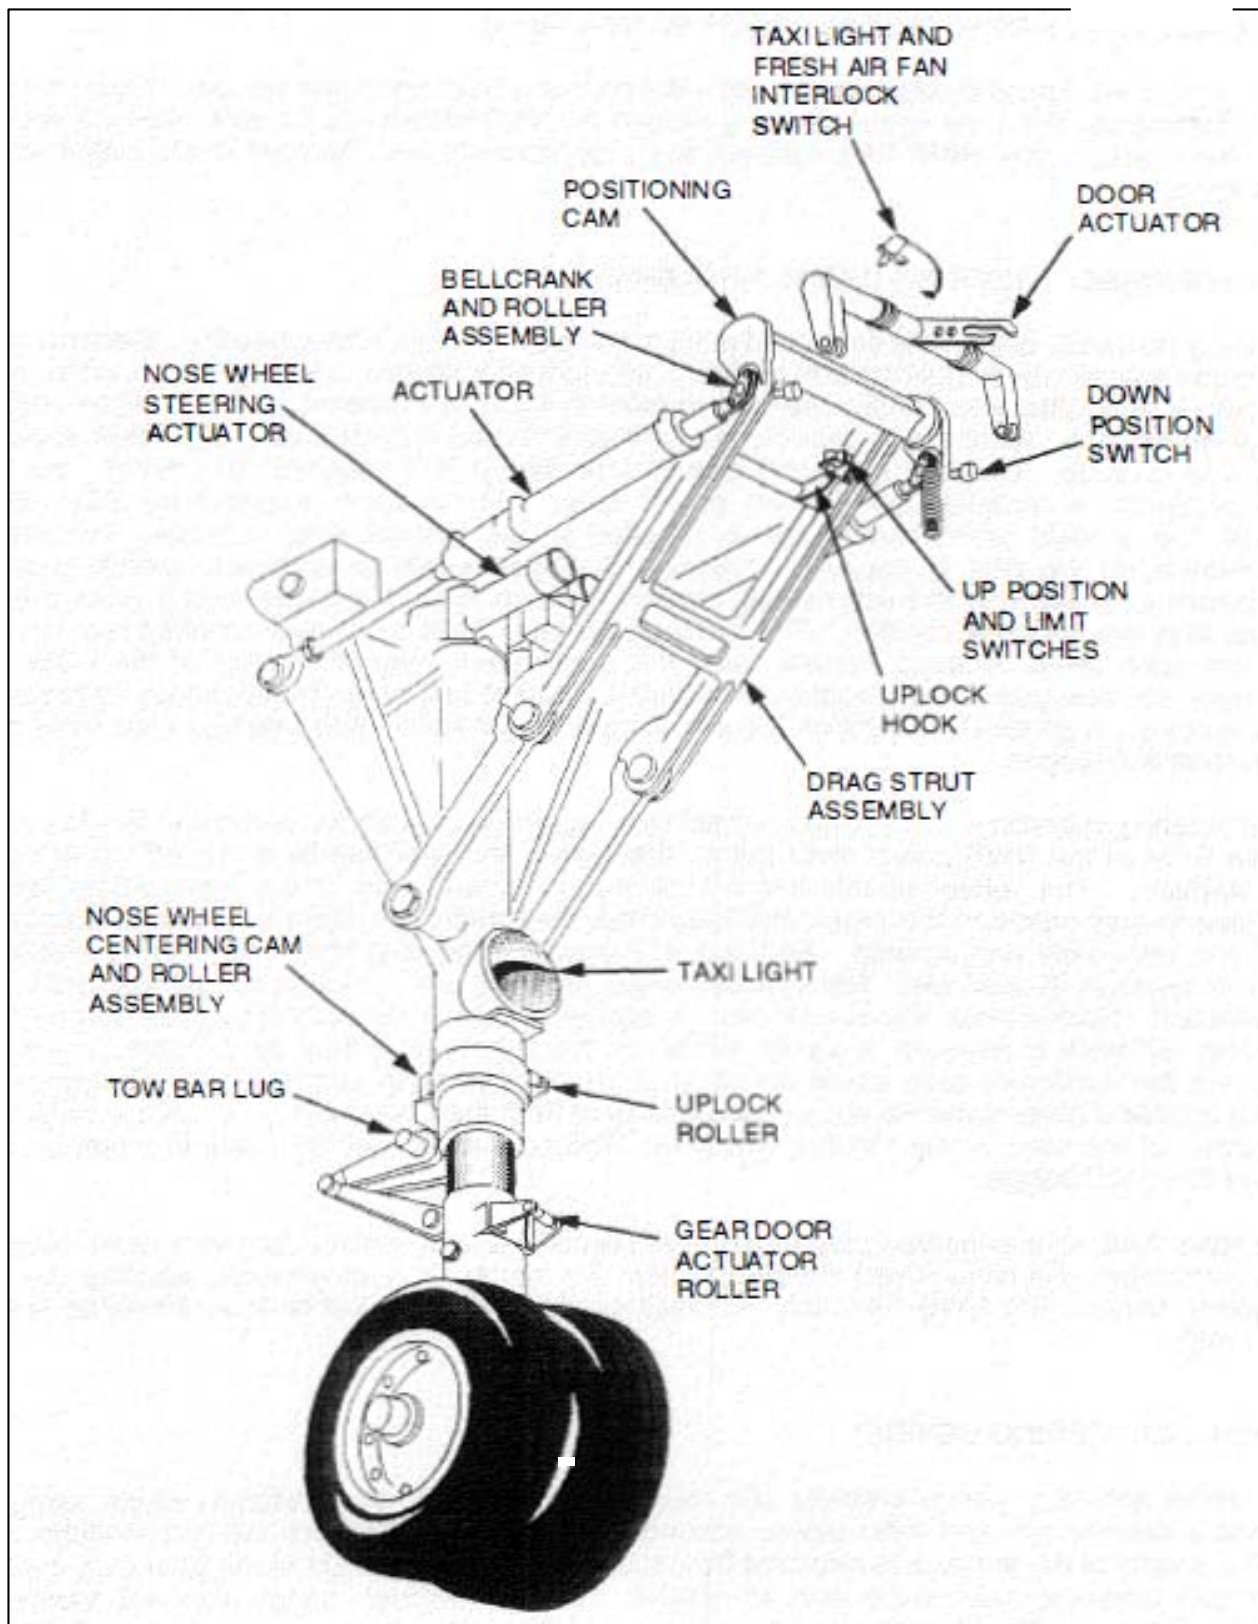
### 5.3 Nose gear assembly

The mechanics of the airline performed the project from the kept file and judging this as satisfactory, they controlled the aircraft and primarily the steering system of the nose wheel. Although they did not find any malfunction, they changed the entire nose wheel assembly.

1. The nose wheel steering was thoroughly inspected without findings.
2. The nose landing gear assembly was precautionary replaced.
3. A hard landing check on the aircraft was performed.
