**AIR ACCIDENT INVESTIGATION  
AND AVIATION SAFETY BOARD  
(AAIASB)**

**ACCIDENT INVESTIGATION REPORT  
HELICOPTER SX-HTO  
AT THE SEA AREA BETWEEN POROS ISLAND - GALATA  
ON AUGUST 20, 2019**

**Accident Investigation Report**  
**04 / 2022**

**Accident of Helicopter Agusta A109C with registration SX-HTO**  
**at the sea area between Poros Island – Galata**  
**on August 20, 2019**

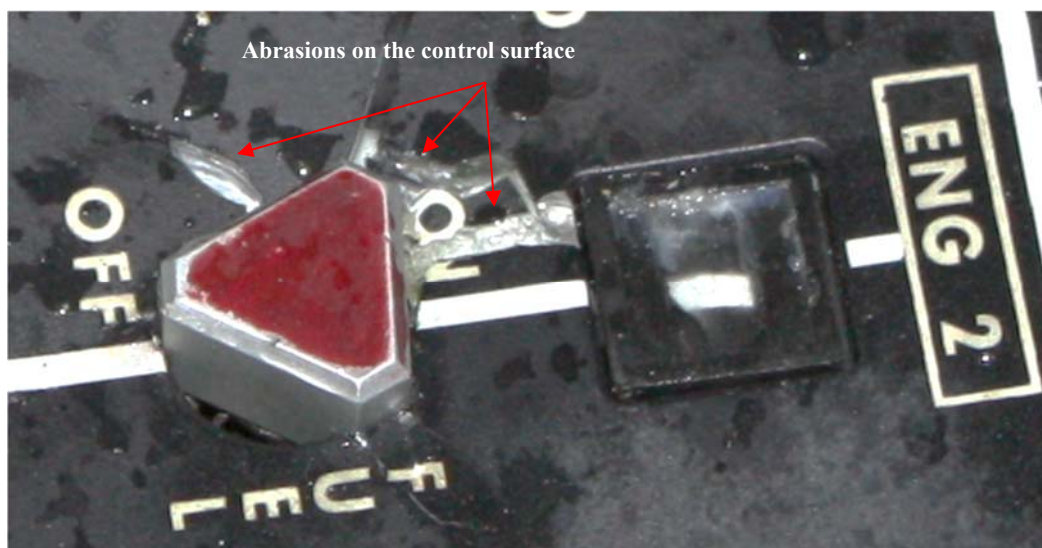
- The right Engine Fuel Shut off Valve Switch was found inside the Switch Socket. From the position indicator of the valve, which was in the open position, to the Socket of the Switch and to the left of the Socket, abrasions and cracks were created on the control surface (Photo 5 and App. 5.6, Photos: 34, 35).
- On the right side of the above control panel, a deformation had been created upwards, while its structural frame had been distorted to the left (App. 5.6, Photo. 36).
- The rear of the mounting thread of the right Engine Fuel Shut off Valve on the control panel, was damaged (App. 5.6, Photos 37 and 38).
- The Collective Control Lever had a perforation measuring 3.0 x 3.5 cm at its bottom (App. 5.6, Photo 40).

**Photo 5: The Right Engine Fuel Valve Switch.**

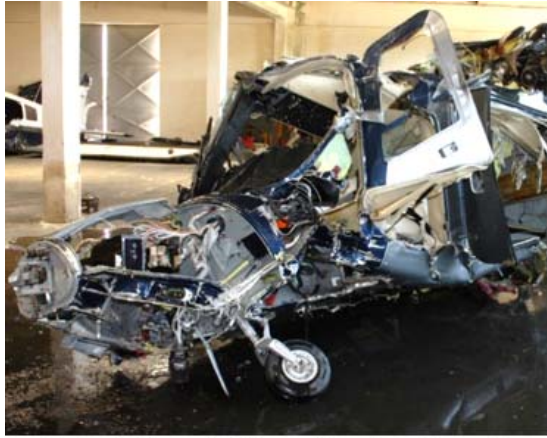
- The forward Fuselage Section was deformed upwards, consistent with the impact angle at sea (Photo 6).
- Traces of contact with the Power Cables were observed on the metal cover of the Right Engine, while at the point where the metal cover surrounds the exhaust of the Right Engine, traces of an electric arcing were observed from the contact of the metal cover with the Power Cables (App. 5.3, Photos 26, 27, 28).

**Photo 6: Upward deformation of the forward fuselage section**

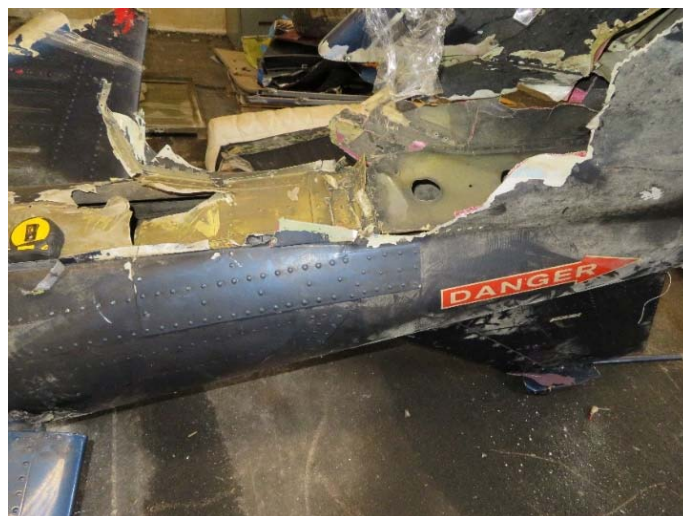
The deformations in the area where the Rotor Shaft was located (Photos 8, 9), in the Vertical Fin (Photo 8 and App. 5.4 Photo 29) but also in the Right Horizontal Stabilizing Fin are consistent with the impact of the Main Rotor Blades.

**Photo 8: The Helicopter Tail Section.**

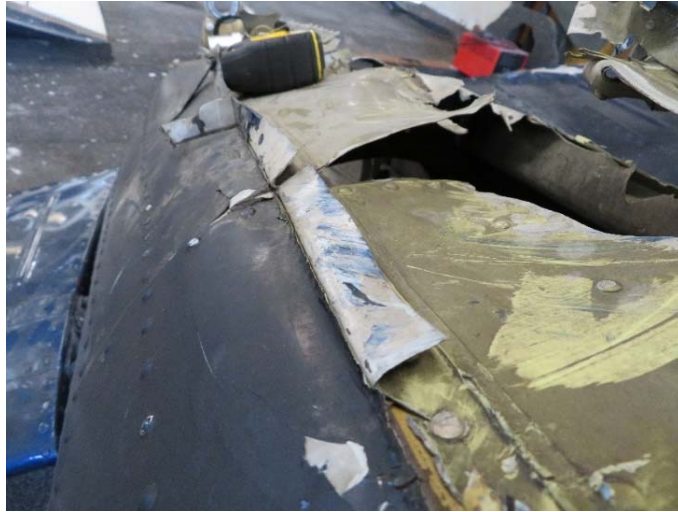
**Photo 9: Deformations in the area of the Shaft of rotation of the Tail Rotor. The photo has a forward direction.**

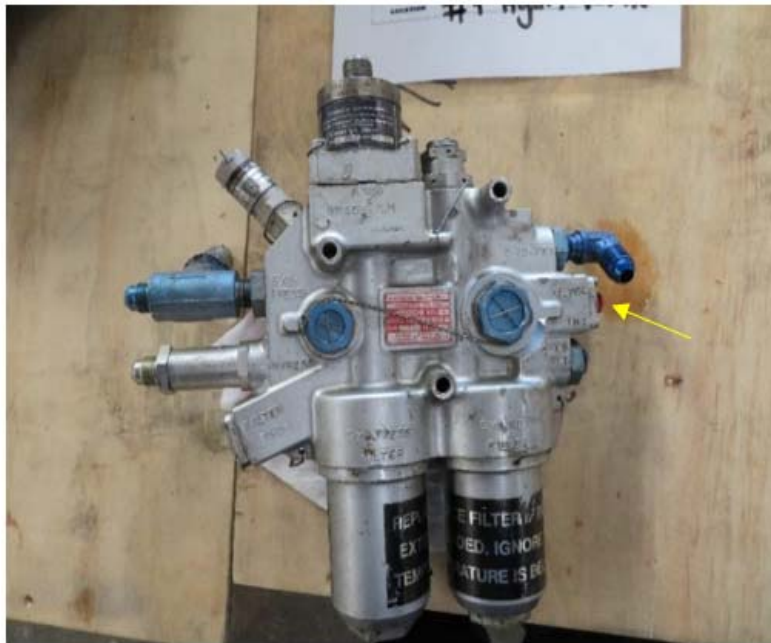
During the examination, the two Hydraulic Filters Modules were removed. After their removal, it was found that in the No. 1 Module, the Differential Pressure Indicator of the Return Filter had been extended (Photo 10). After the Filter removal and macroscopic examination of the Filter and its Bowl, there were no findings which justify the extent of the Indicator and the pre-crash blockage of the Filter (Photo 11).

Φωτ. 10: The No1 hydraulic filter assembly with the indicative extended (yellow arrow) of the return filter.

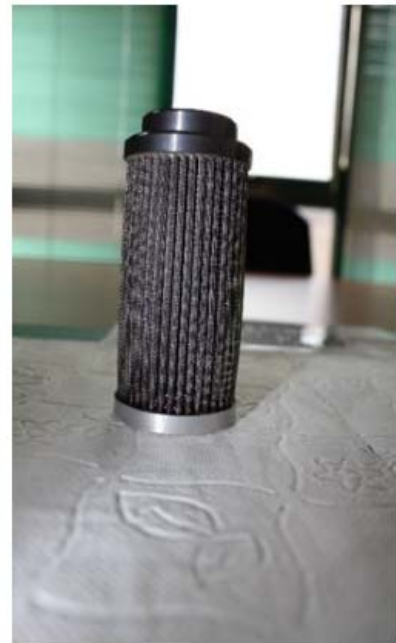
Φωτ. 11: The return filter during its examination.

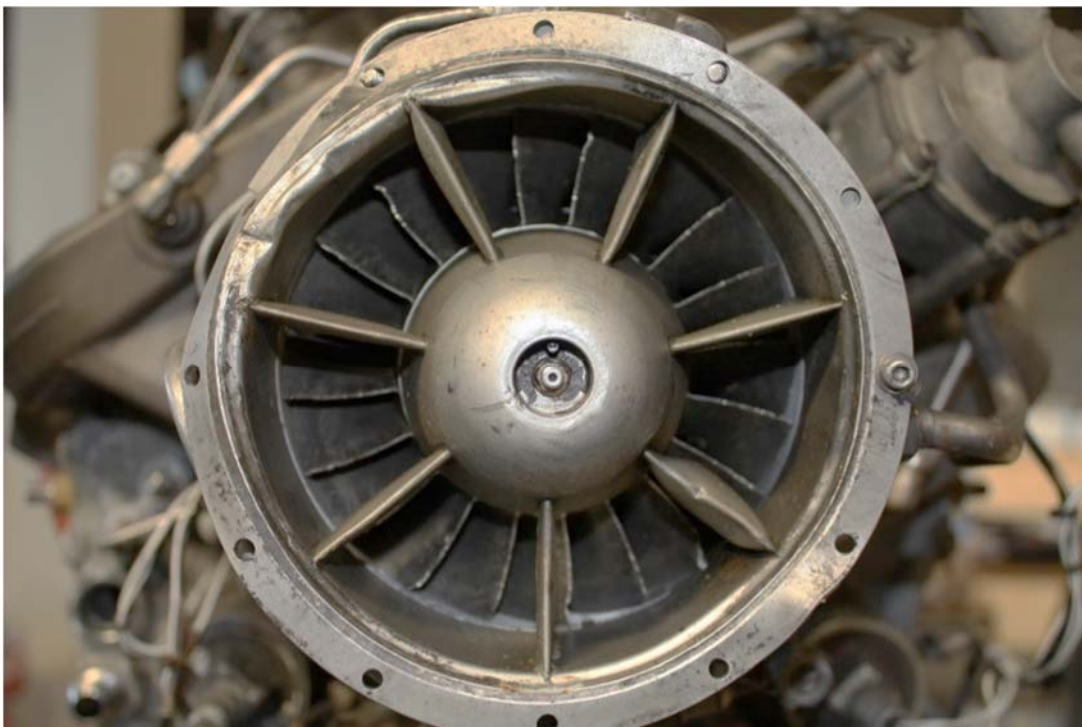
- The Compressor Front Support had been deformed in its Upper Right Quadrant (Photo 12).
- The leading edge of all Compressor First stage Blades had been damaged which was consistent with the suction of foreign objects during engine operation (Photo 12).

**Photo 12: Left Engine Compressor Inlet and its Front Support.**

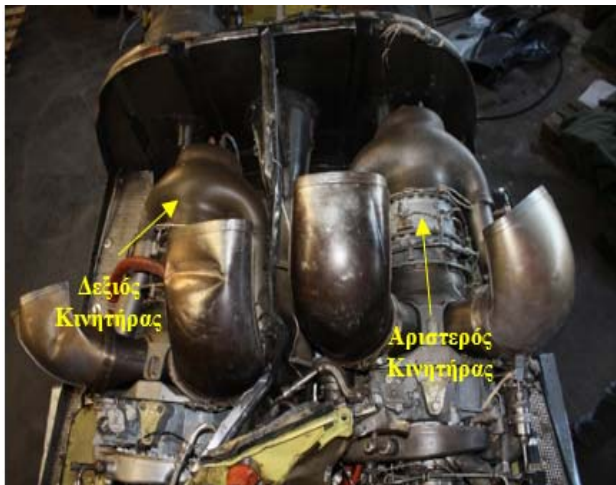
Photo 13: The axial displacement of the right motor  
to the left .

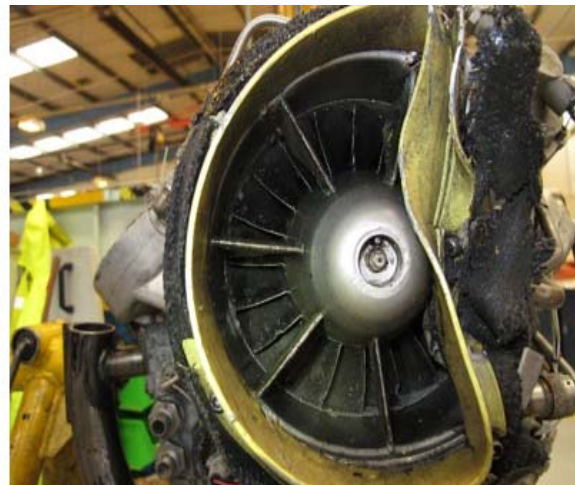
Photo 14: The intake of the right engine compressor with  
the deformation of its front support part.

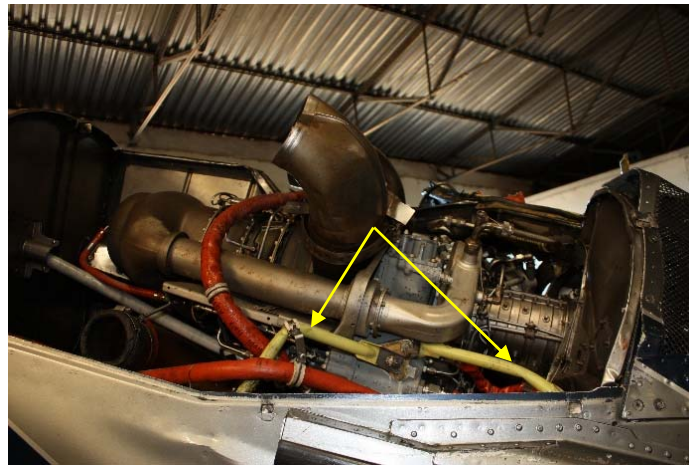
**Photo 15: Deformed engine mounts (yellow arrows).**

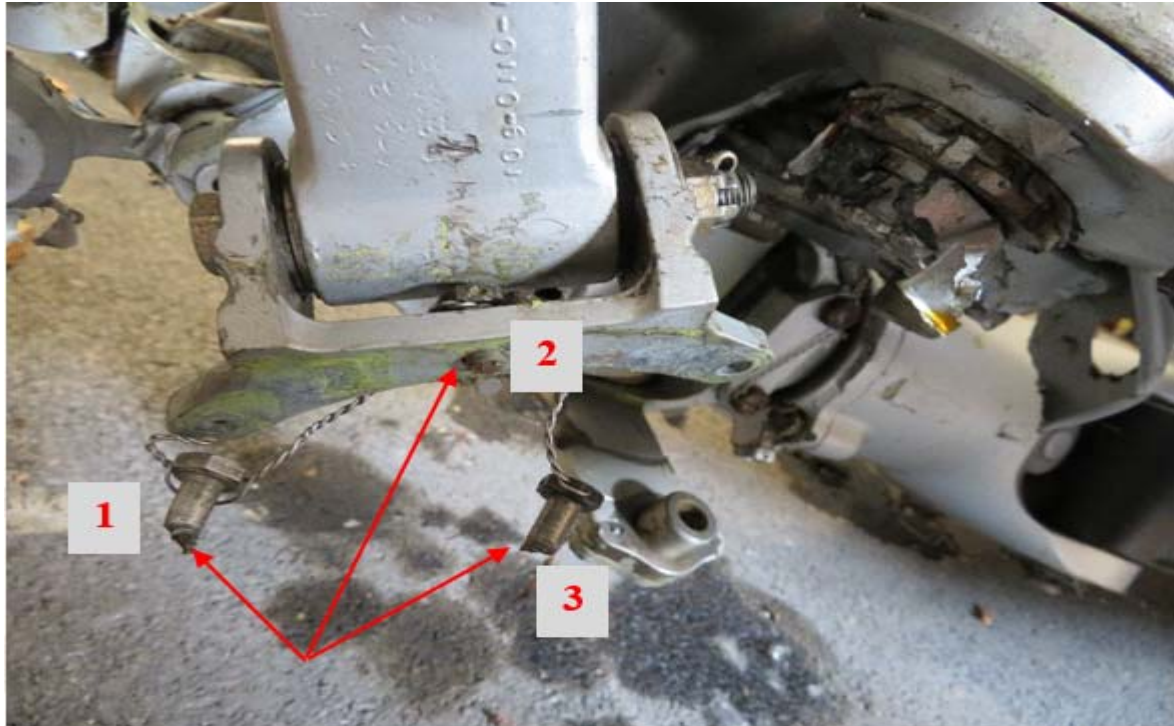
The Rotating Scissor was mounted on the Main Rotor Hub with three Bolts. During the macroscopic examination of the Main Rotor, the three Bolts were found broken as shown in the Photo 16.

**Photo 16: The three connecting Bolts of the Rotating Scissor with the Hub of the Main Rotor.**

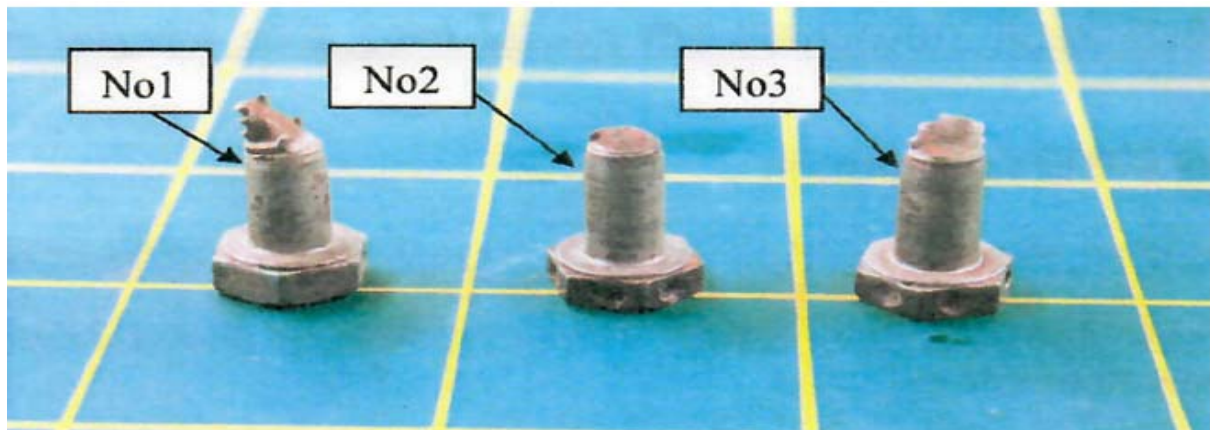
**Photo 17: The examining Bolts 1, 2, 3.**

The three Bolts were examined to a laboratory test where it was found that from the macroscopic examination of Bolts 1 and 3, as well as by the microscopic examination in Scanning Electron Microscope (SEM) submitted Bolt 2, the breakage of all three Bolts was abrupt due to abnormal tensile load.

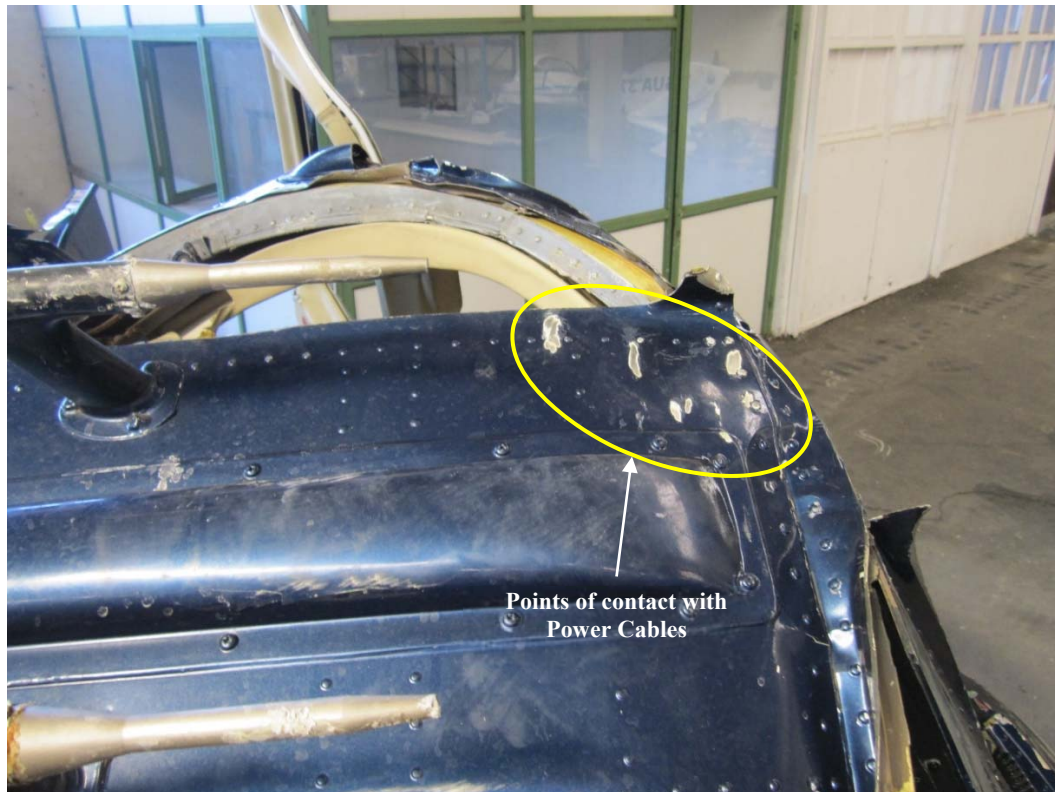
Photo 22: The points of contact of the Helicopter cockpit upper part with the Power Cables.

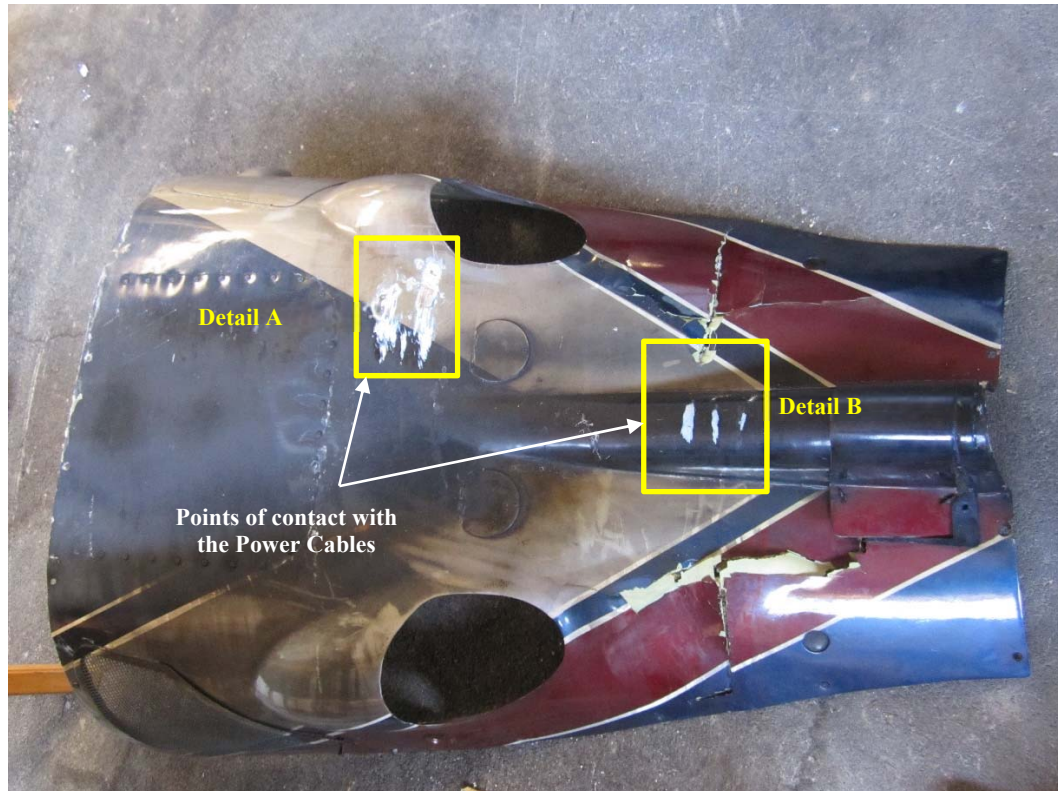
Photo 23: The points of contact and fracture of the outer oil coolers cover.

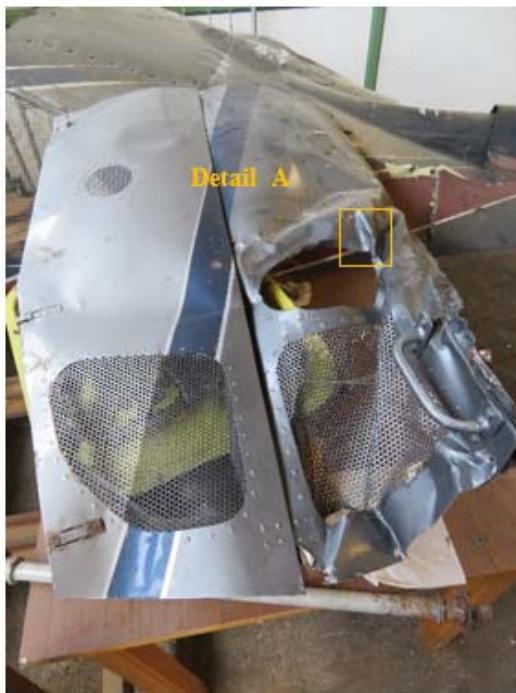
**Phot. 26: Right engine cover.**

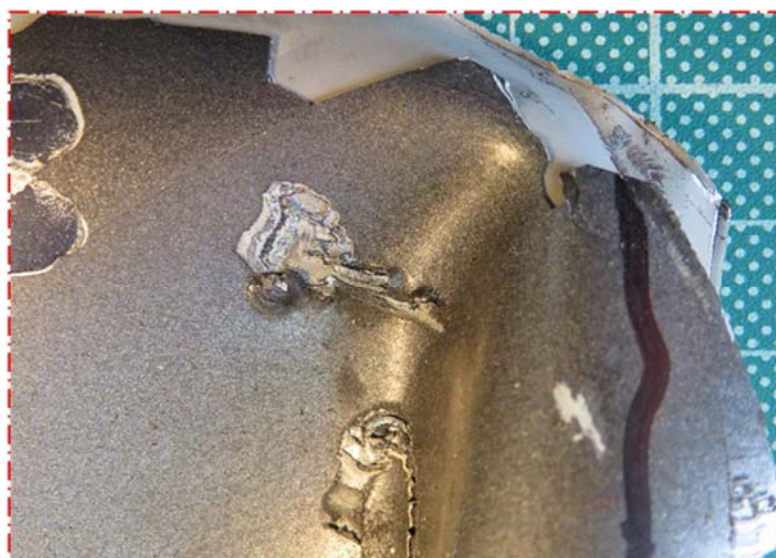
**Photo 28: Detail B, the characteristic traces of the electric arc that was created between the metal cover and the Power Cables.**

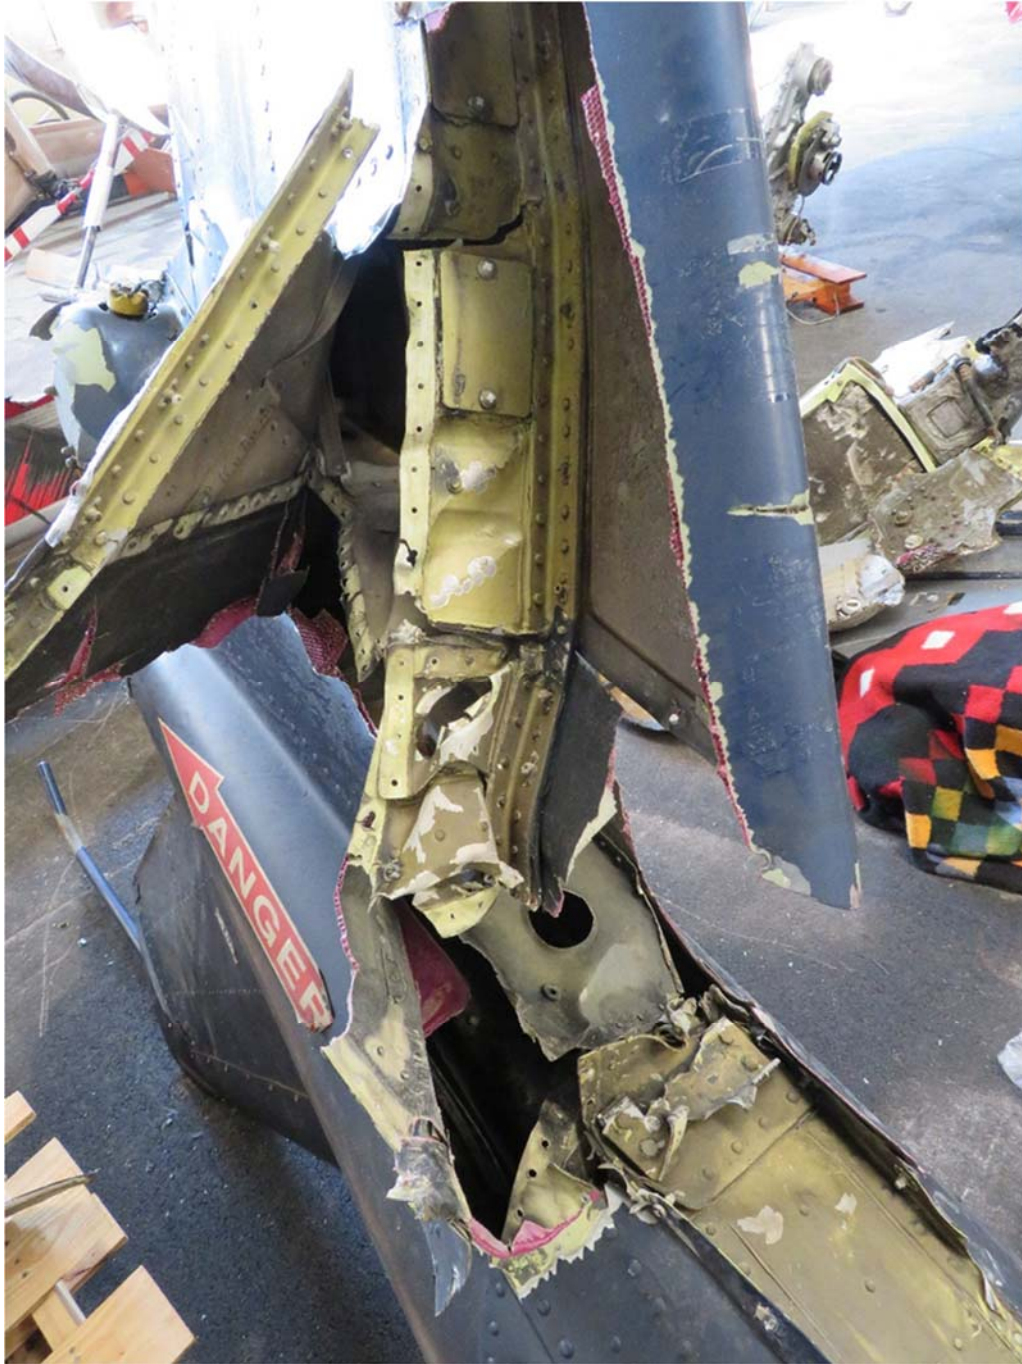
**Photo 29: Deformations of the vertical fixed tail section.**

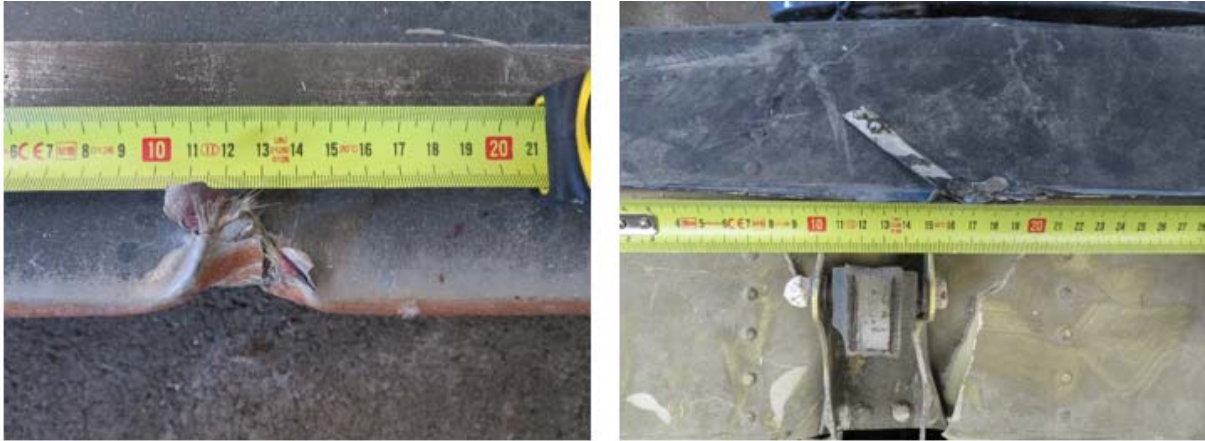
- On the white blade there is a 5 cm long deformation blow on the leading edge at a distance of 48 cm from the Blade Tip. At the Blade Tip there are imprints of the same color as that of the Helicopter, while there are also deformations in length 24.5 cm along the tip of the blade.
- In all four blades of the Main Rotor, abrasion and detachment of material from their upper and lower surface was observed.
- In the Main Rotor Link Assy, the blue and yellow blade Connecting Rods were deformed and statically fractured, while the white and red vane Connecting Rods were not fractured. In all four Connecting Rods, their Rod Ends were connected and secured.
- The Rotating Scissor was not fractured and was secured. The three Connecting Screws to the Main Rotor Hub were broken and a laboratory examination was performed on them, the results of which are reported in Par. 1.12.7.

**Photo 30: The 5 cm length impact on the edge of the white blade and of the same dimension at the base of the bearing support of tail rotor shaft.**

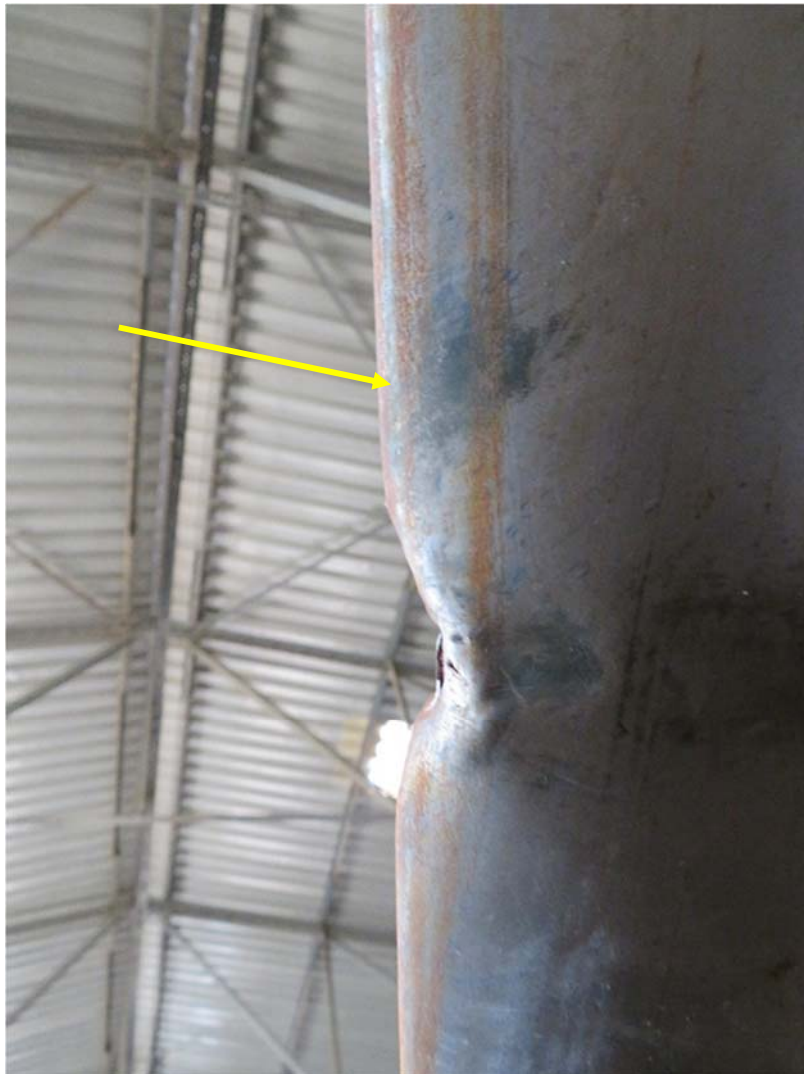
**Photo 31: Imprint on the blade from the Helicopter color with the tail section (yellow arrow).**

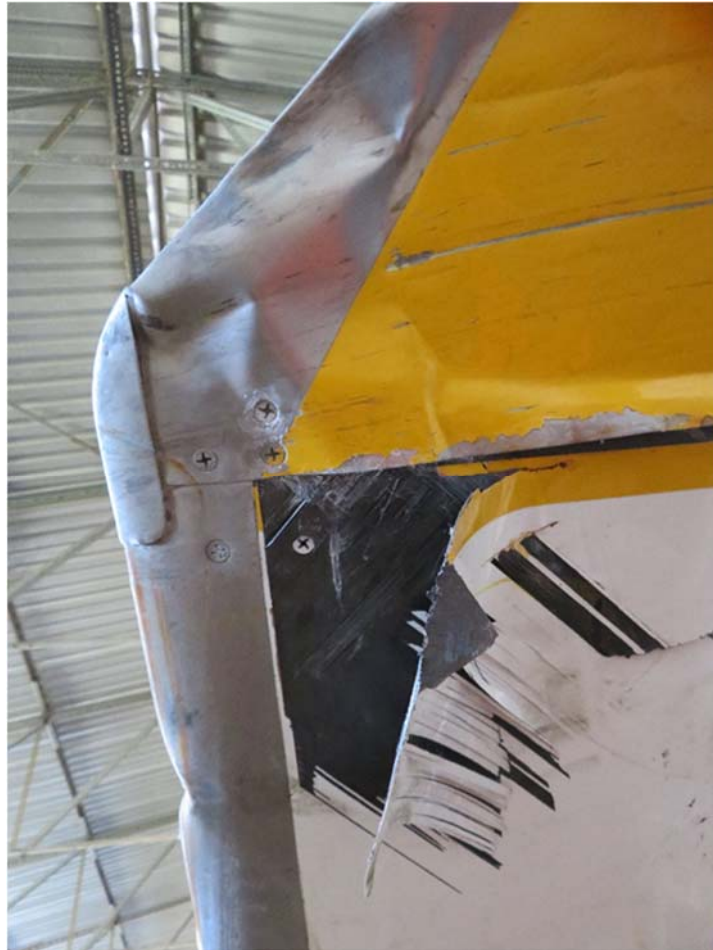
**Photo 32: The tip of the white blade with the existing deformations.**

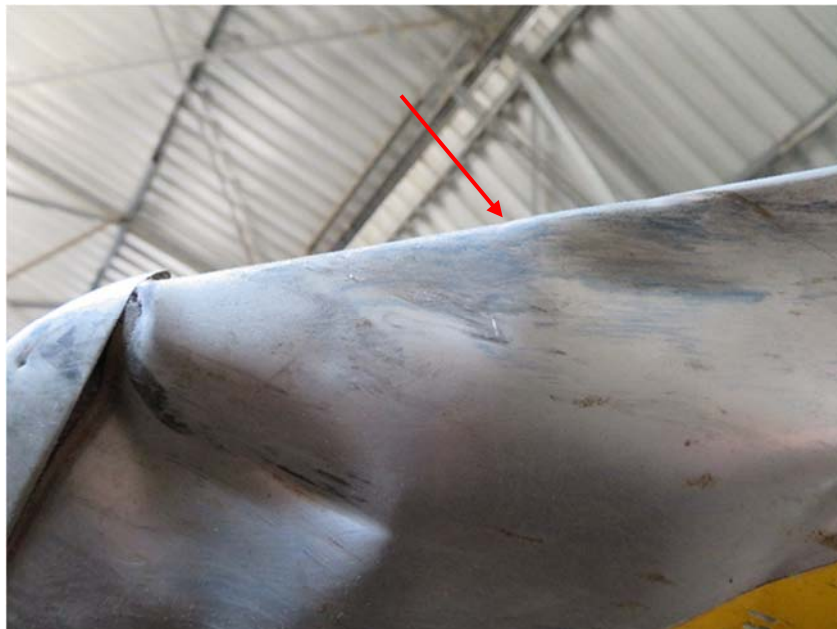
**Photo 33: The tip of the white blade with color imprints from the impact on the tail section (red arrow).**

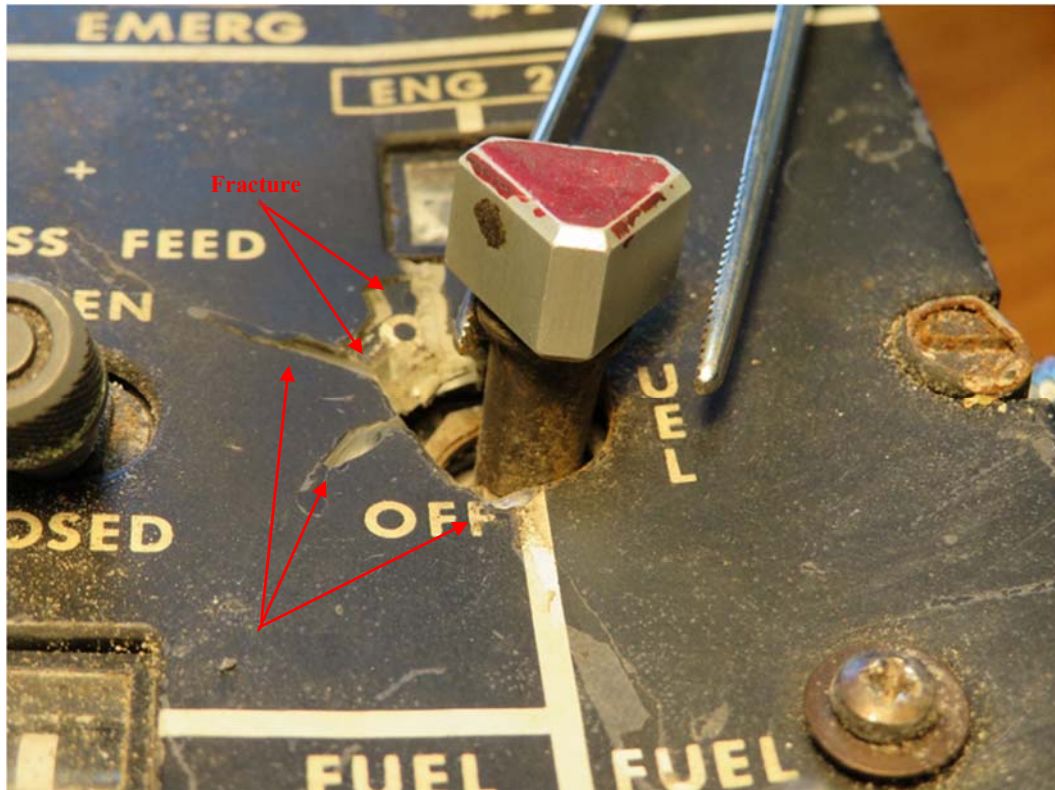
Photo 34: Abrasions and breaks on the switch control surface.

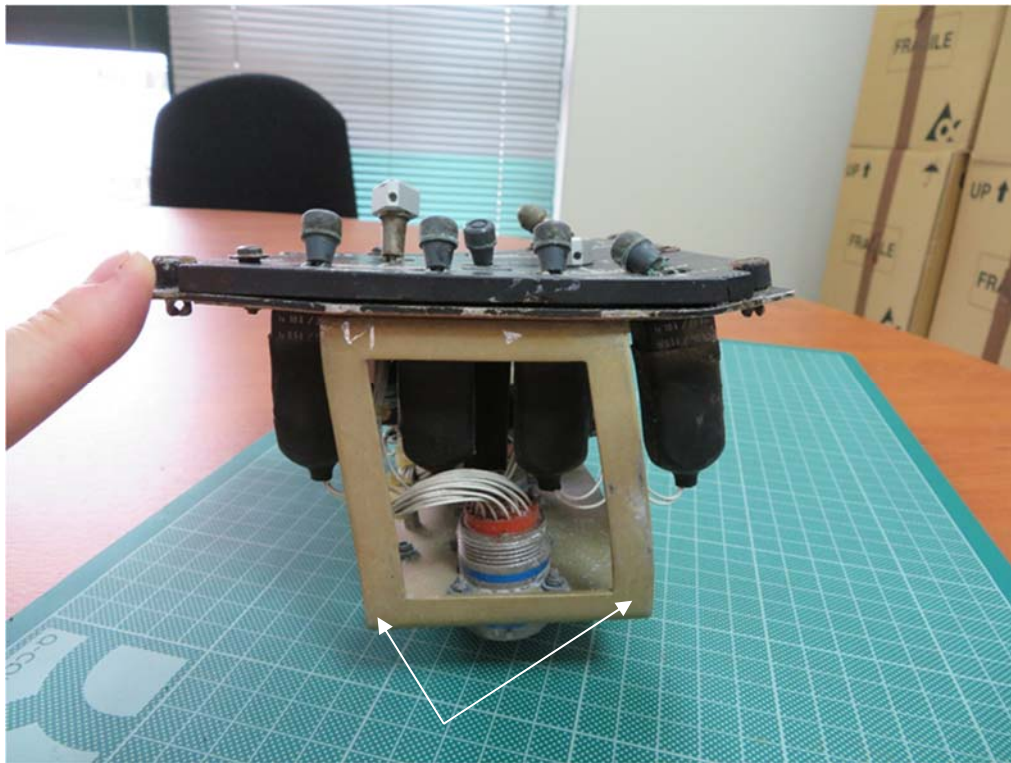
**Photo 36: The distortion of the control panel frame.**

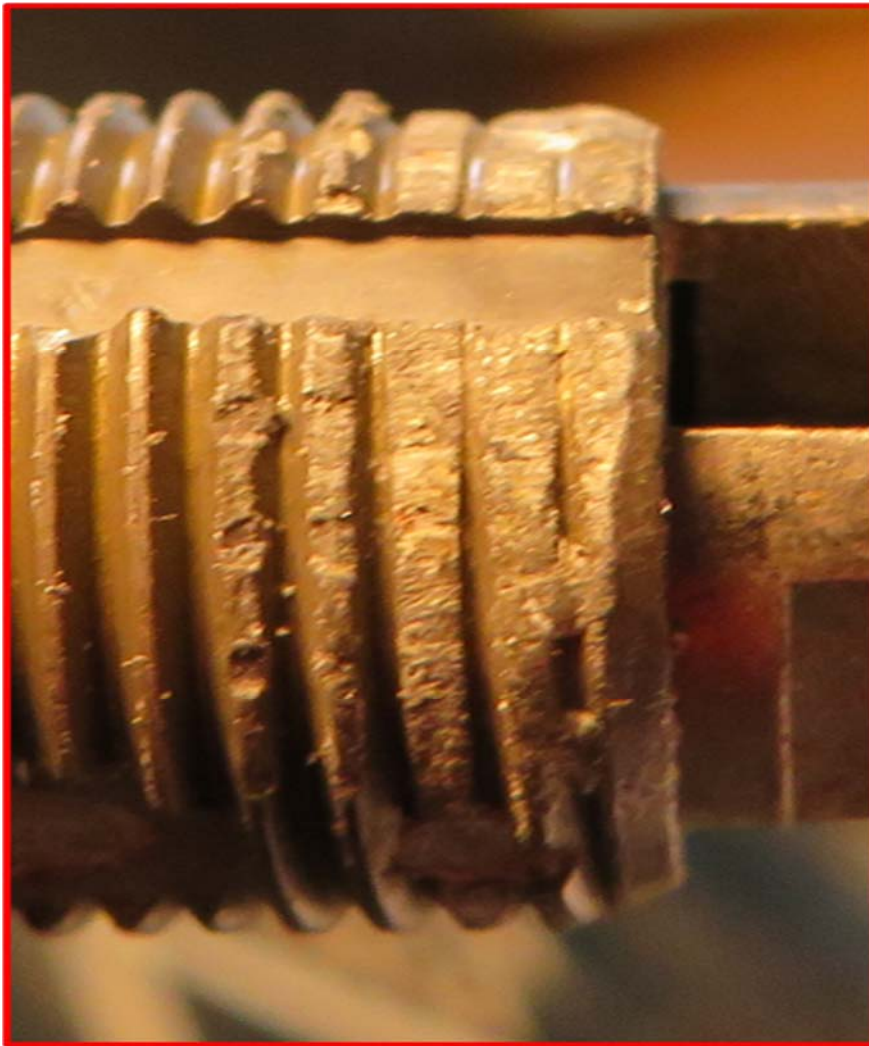
**Photo 38: Detail A showing the wear of the rear side of the thread.**

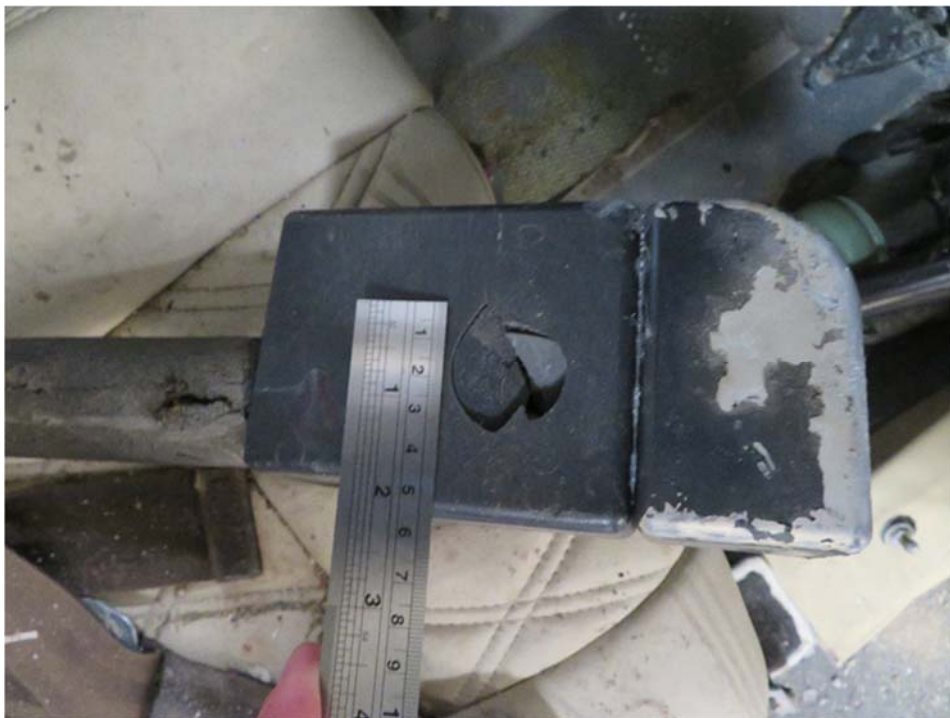
**Photo 40: Collective control lever perforation.**

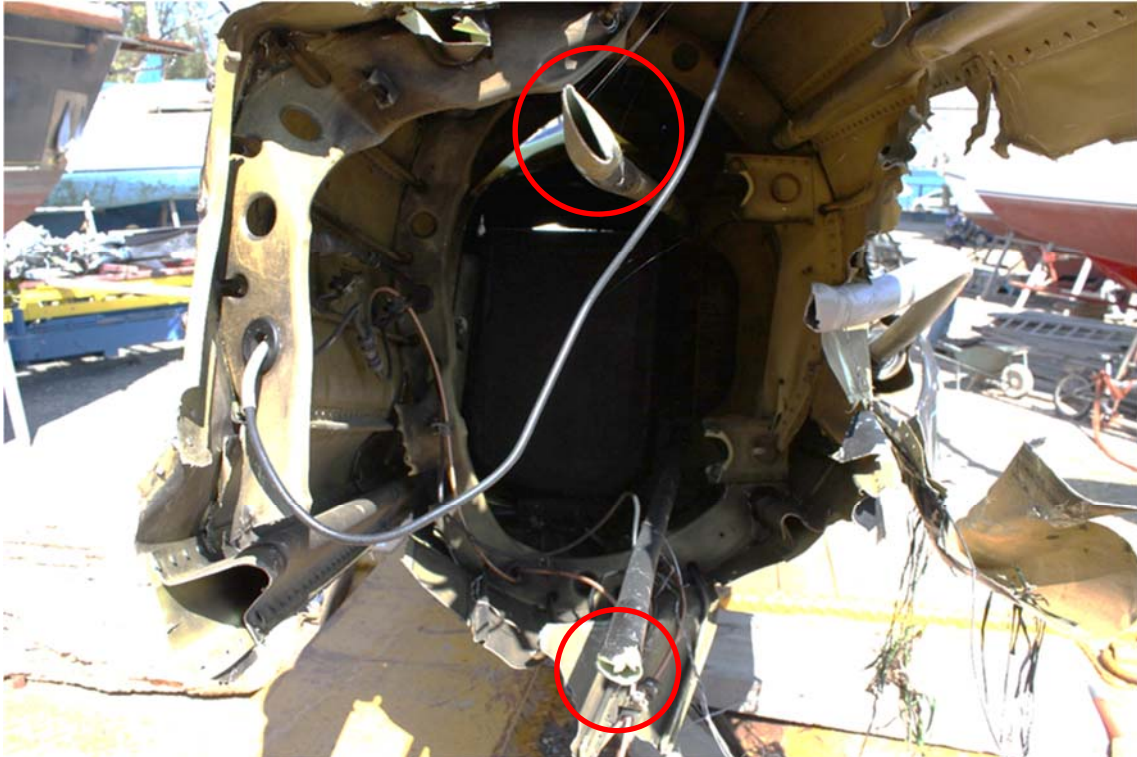
The connections on the Tail Rotor Gearbox for changing the pitch of the rotor, no discontinuities were found, while the two Push - Pull Rods, for the change of pitch of the Rotor and the movement of the two Balancing Surfaces of the Tail, were connected and secured while their deformation was consistent with static fracture.

Photo 43: The fractured points of the two Push-Pull Rods

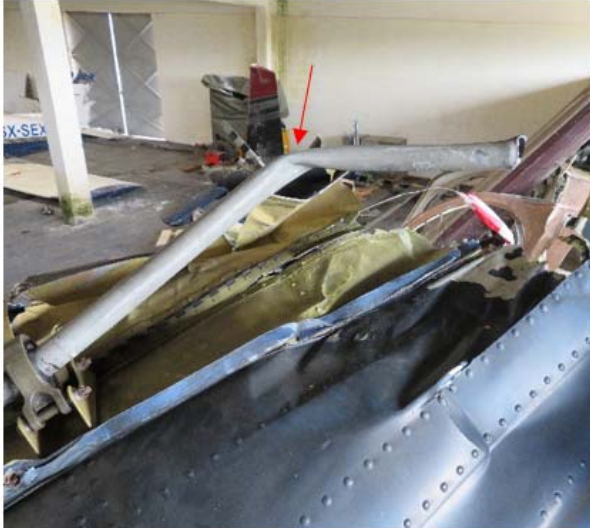
- Fracture of the Tail Rotor Shaft at the point of detachment of the Tail Section, with obvious twisting of the Shaft (App. 5.20, Photo 44). The fracture point showed characteristics of static fracture (App. 5.20, Photo 45).

Photo 44: The twist of the rotation axis of the tail rotor (red arrow).

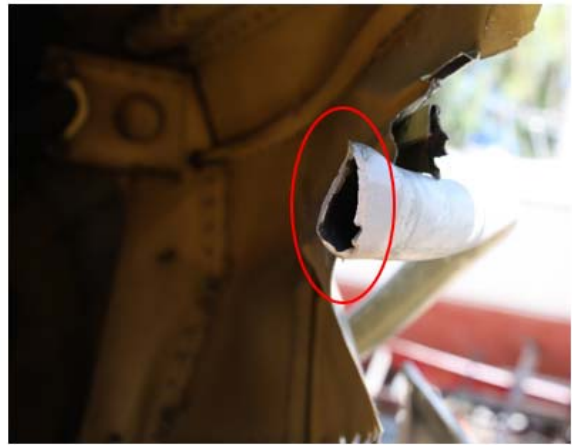
Photo 45: The breaking point of the tail rotor shaft.

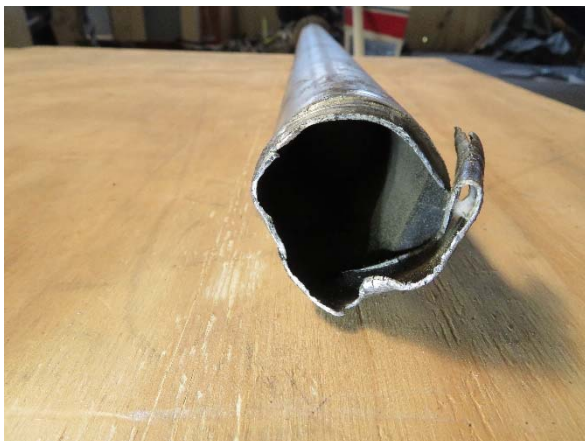
- The fracture point of the front part of the Tail Rotor Shaft near the point of its connection with the main Gearbox, showed characteristics of static fracture during its rotation while surface abrasions were observed (App.5.20, Photos 46, 47).

Φωτ. 1: The tail shaft's forward section fracture point

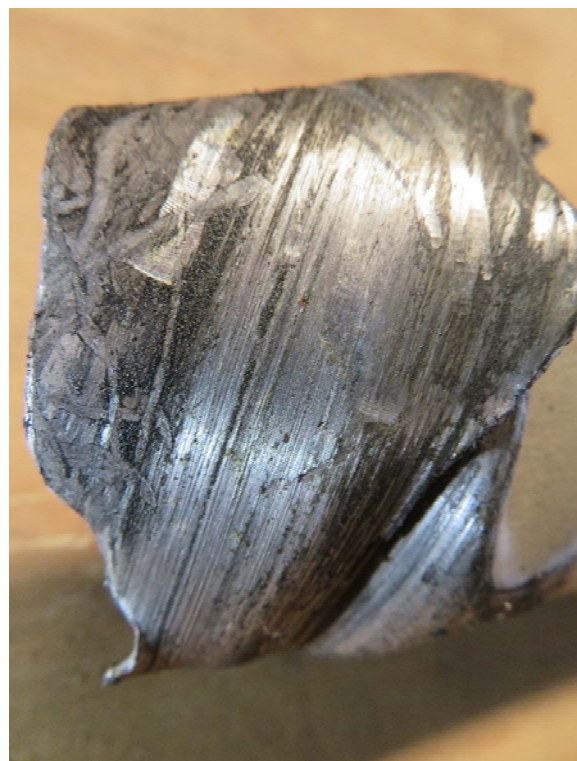
Φωτ. 2: Abrasions on the tail rotor shaft surface at the point of fracture.
