**ACCIDENT INVESTIGATION REPORT  
AIRCRAFT FLIGHT DESIGN CTSL SUPRA LIGHT  
REGISTRATION UR-STAS  
AT KERASIA AREA OF RODOPI  
ON SEPTEMBER 22, 2017**

**ACCIDENT INVESTIGATION REPORT**  
**06 / 2022**

**Aircraft Flight Design CTSL Supra Light**  
**Registration UR-STAS**  
**At Kerasia area of Rodopi**  
**On September 22, 2017**

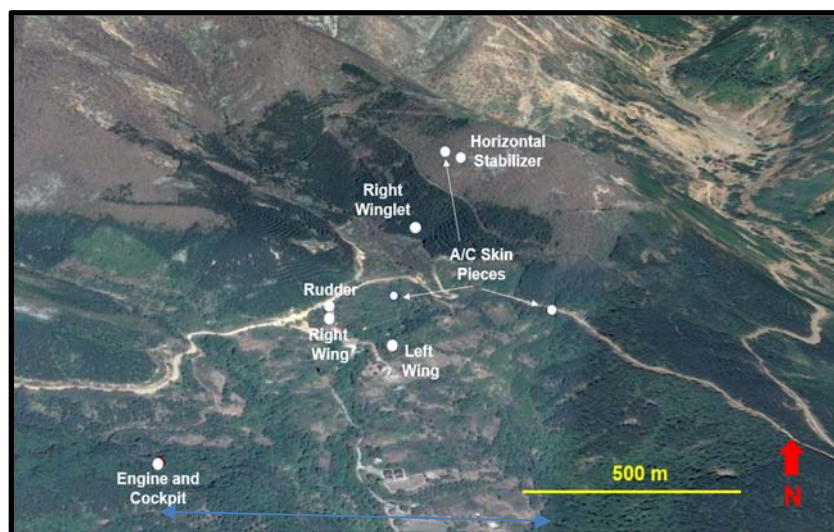
**Figure 1:** Scattering of debris  $\cong 500,000 \text{ m}^2$

The trail of large scattering of debris indicates the course of the aircraft from North to South with the disintegration of the aircraft in flight. The heaviest parts of the aircraft, engine, cabin and steering system were found in the Southern part. The left wing was found in the Eastern Section and part of the right wing in the West. The dismantling of the aircraft began from the tail section. The traces that exist in the right part of the steering wheel, testify strong vibrations. The steering wheel was found complete with its connection to the fuselage. Many parts of the aircraft were missing. The propeller blades indicate that the engine was not running when it hit the ground. This is considered a reasonable reason due to the inflight detachment of the fuel tank.

11. The entire dispersal of the aircraft parts, at the scene of the accident, testifies that the aircraft disintegrated in the air.
12. There was no significant weather phenomenon during the flight.
