**AIR ACCIDENT INVESTIGATION AND  
AVIATION SAFETY BOARD  
(AAIASB)**

**ACCIDENT INVESTIGATION REPORT  
ULTRA-LIGHT AIRCRAFT P2008 JC SX-IRN  
AT PROTI SERRON ON AUGUST 03, 2020**

**Ultra-Light Aircraft P2008 JC SX-IRN**

**At Proti Serron on August 03, 2020**

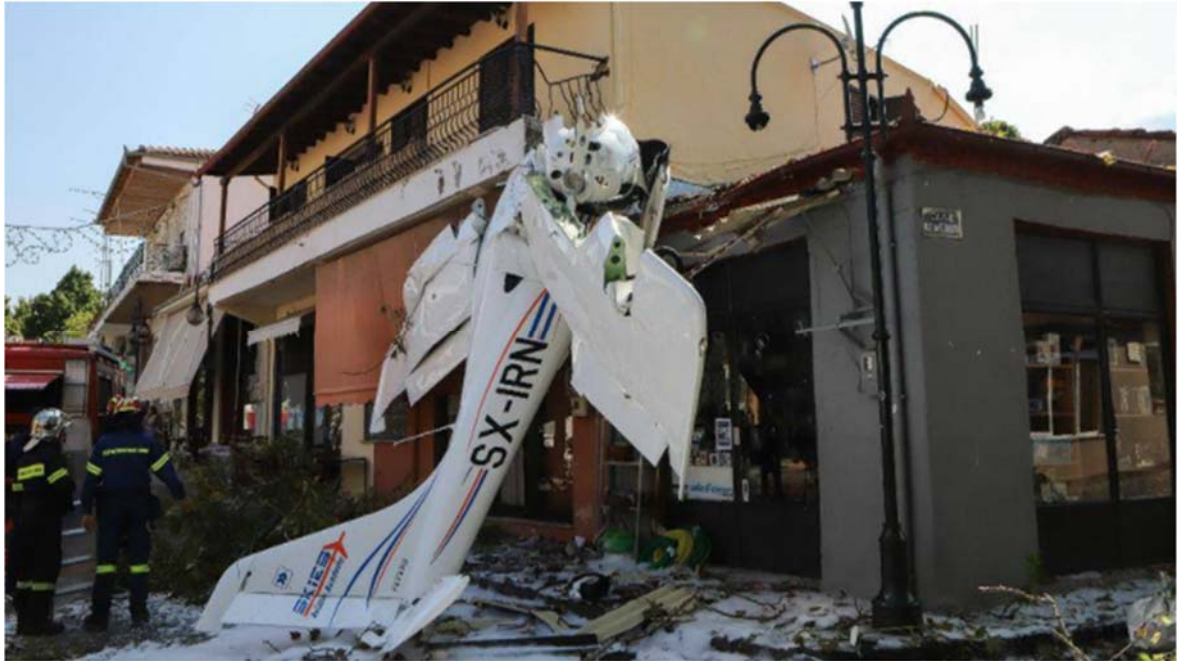
The Aircraft after colliding with the platanus tree ended up vertically on façade of a building with the lower part of the fuselage touching the ground. The propeller disintegrated at distances indicating that the engine was running at high speeds.

The tail part of the fuselage is resting on the ground as seen on Photo 2.

**Photo 2:** The Aircraft at the accident site.

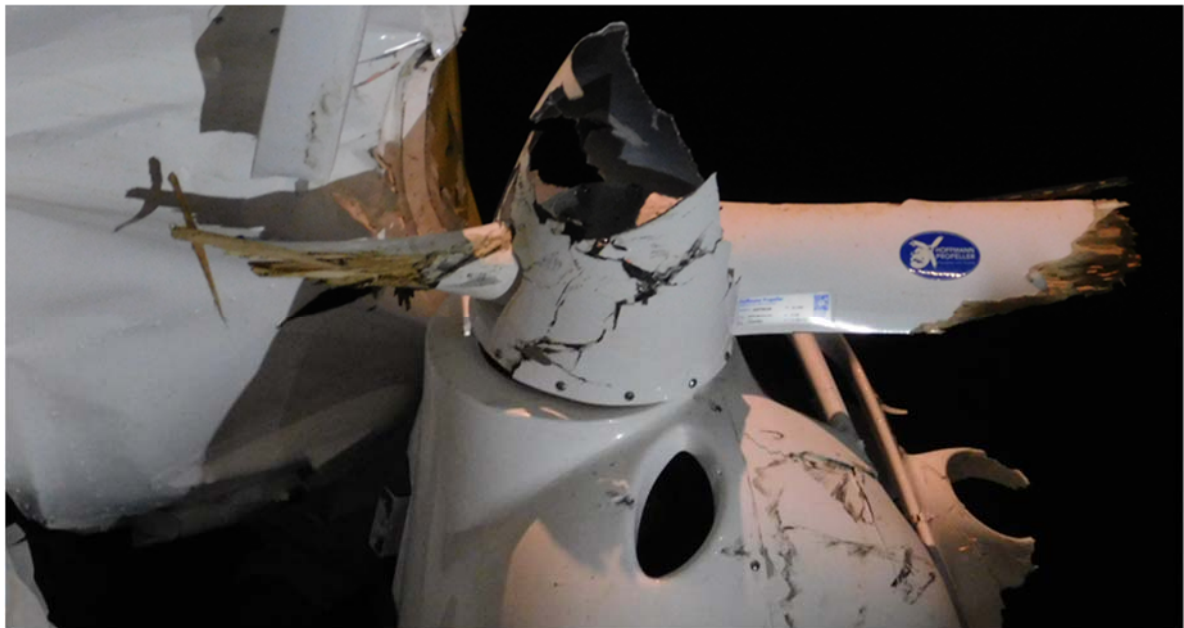
The propeller was destroyed indicating that the engine was running at full power in high rpm (Photo 3).

**Photo 3:** The Aircraft Propeller.

1. Nothing abnormal was found in the Engine and its accessories.
2. A Borescope Inspection was performed on the internal parts of the Engine and specifically on the Crankshaft, the Cylinders and the Gear Box and no malfunction or problematic rotation of its moving parts was found.
3. The Propeller had obvious signs of impact with obstacles and operating at a high number of rpm.

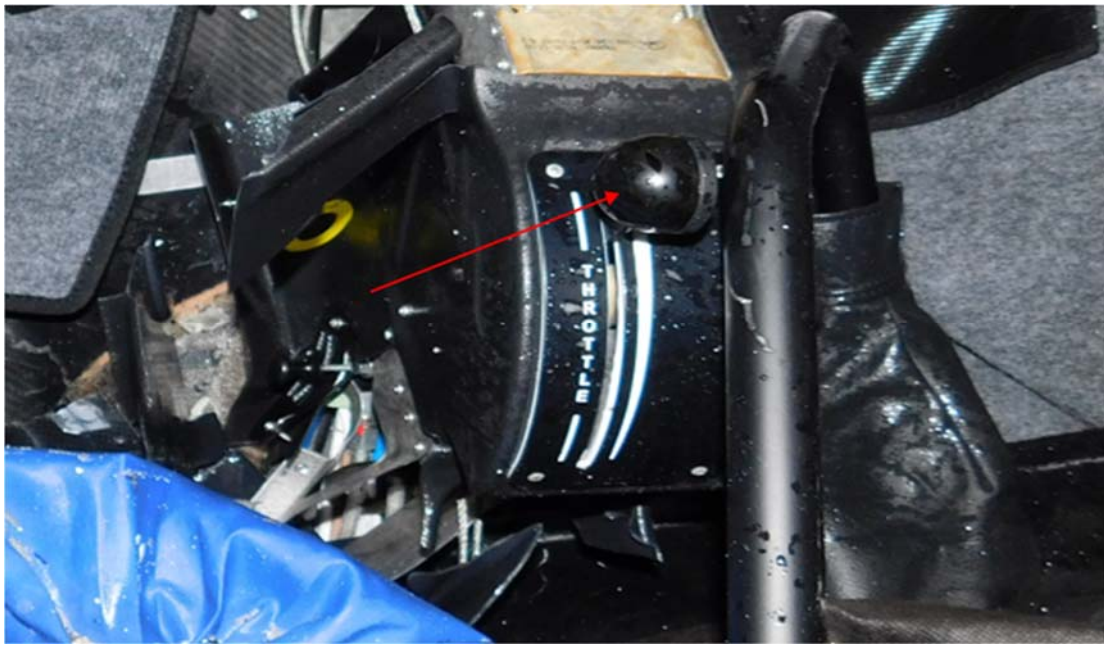
The Aircraft Engine Power Throttle lever was pictured after the Accident as being in Full Power (Photo 4).

**Photo 4:** Engine Throttle in full power.

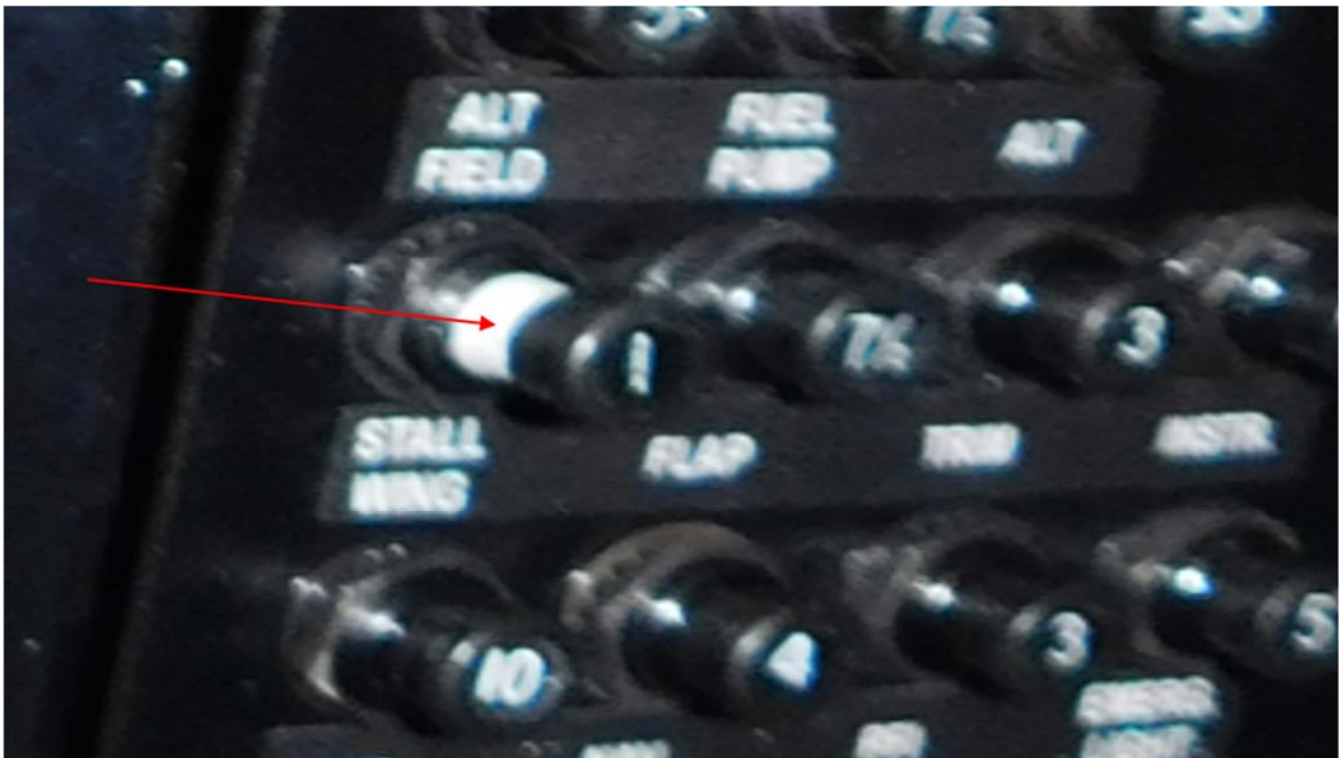
The Stall Warning Circuit Breaker was found in the disconnect position (Photo 5).

**Photo 5:** Stall Warning Circuit Breaker in disconnect position.

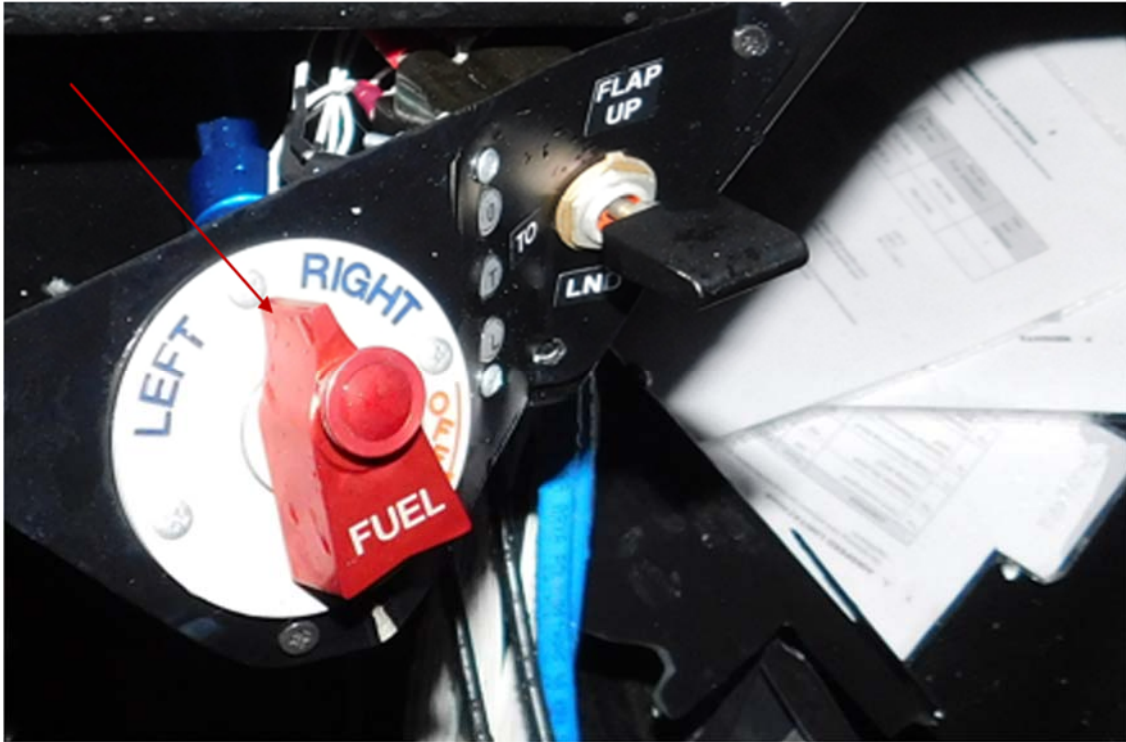
The Fuel Tank Selector Switch was in Mid Position (Photo 6).

**Photo 6:** Fuel Tank Selector Switch.

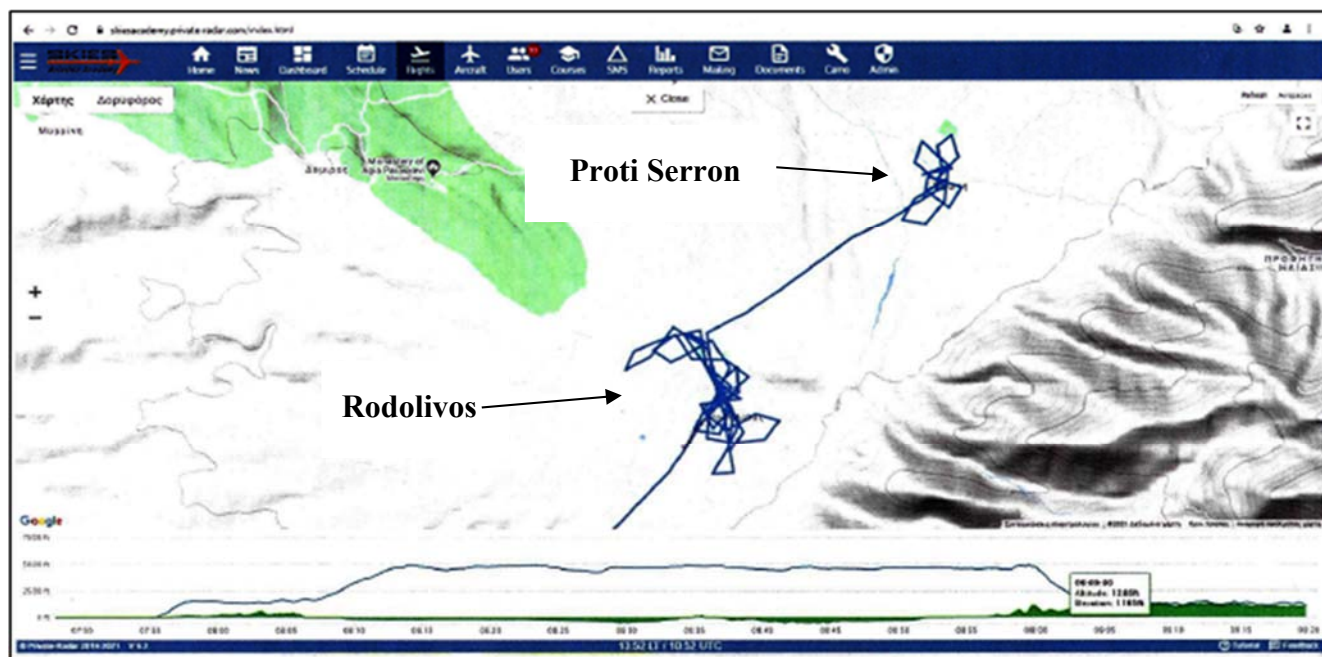
## 5.2 Radar capture over Rodolivos and Proti Serron

According to Radar capture, the Pilot deviated from his Flight Plan towards the villages of Rodolivos and Proti Serron, remained in the area for about 35 min executing low altitude manoeuvres over Rodolivos and Proti Serron. The Radar capture recorded low level flights between 36 to 236 feet and speeds between 46 to 120 kts. On his last low passage over a square in Proti Serron, at 06:35 UTC SKIES 05 collided with a Platanus tree and then ended up on the facade of a building almost in a vertical position.

- The Pilot had an adequate Rest Period before the Flight.
- The Pilot had undergone a satisfactory detail briefing before the SOLO Flight.
- The Pilot deviated from the Flight Plan track and altitude, executing low level manoeuvres over populated areas of the villages Rodolivos and Proti Serron as depicted from the captured Radar Track (Appendix 5.2).
