# **AIR ACCIDENT INVESTIGATION & AVIATION SAFETY BOARD**

Accident Investigation Report  
a/c PH-AHQ of TUI Airlines  
at Chania International Airport  
on 12/ 12 /2007

Report No 10/2008

**Accident of the a/c PH-AHQ of TUI Airlines**  
**at the apron of Chania Airport on 12<sup>th</sup> December 2008**

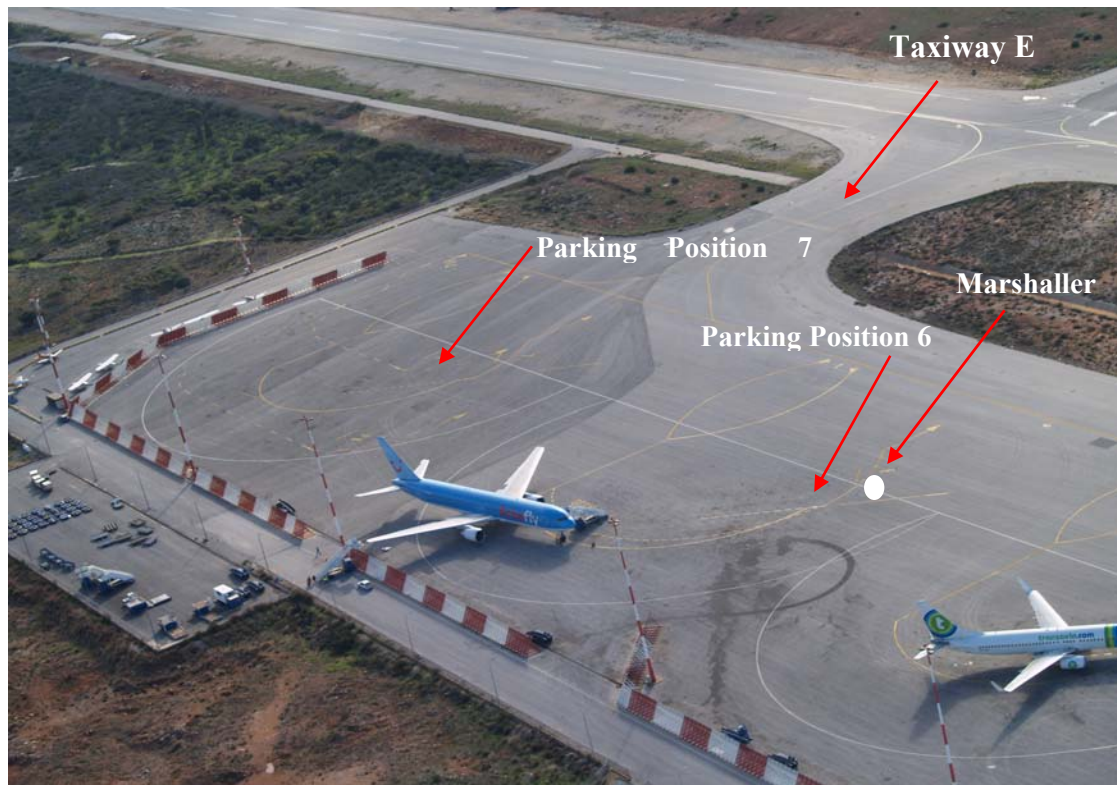
Photo 1. Apron at CHQ.

At the time, there were no other a/c on the apron and the ground handling agent's marshaller waited for the a/c at parking position no. 6. The a/c crew gained visual contact with the marshaller and taxied towards the parking position in front of which stood the marshaller. Based on the landing gear tracks on the apron surface, after entering the apron the a/c proceeded straight towards the blast fences on the N-NE side of the apron without following the markings either for parking position no. 6 which was on the left of the apron entrance or for position no. 7 which was on the right of the apron entrance (photo 1).

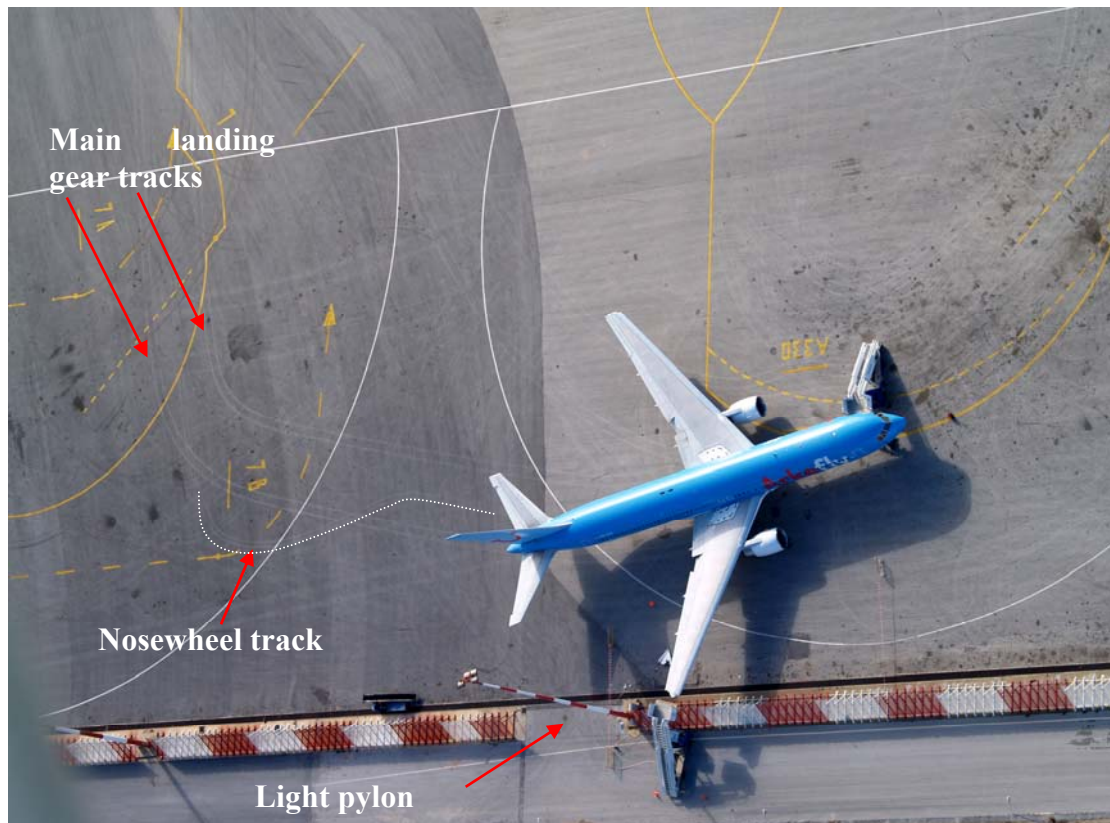
Photo 2. Landing gear tracks.

The track of the nose wheel (photo 2) shows that when it reached a distance of 31 m from the blast fences it turned to the left, bringing the a/c parallel to the blast fences, but that after about 50 m it started turning to the right (photo 3), reaching a distance of 18 m from the blast fences before starting again to turn to the left. By then the right main landing gear had reached a distance of 13.5 m from the blast fences and the right wing was already above them. During initiation of this second left turn of the a/c the wing collided with a light pylon that was in line with the blast fences, causing a section of the wing to break off. The captain brought the a/c to a complete stop. The ground handling agent apron supervisor notified his agency, who informed the Hellenic Civil Aviation Authority (HCAA) who, in turn, informed the airport fire-fighting service. The passengers disembarked with safety.

(The nose wheel track is indicated by the white line parallel to the inscribed track and directly below it.)

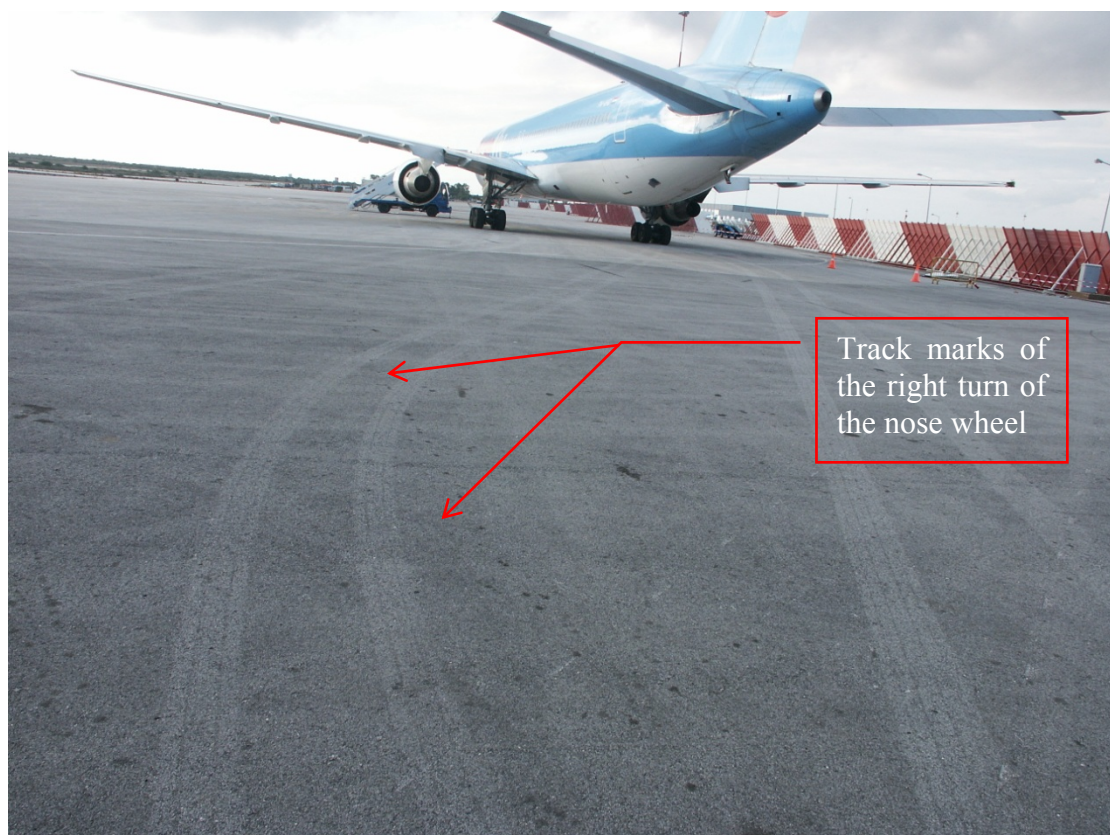
Photo 3. Track marks of the right turn of the nose wheel.

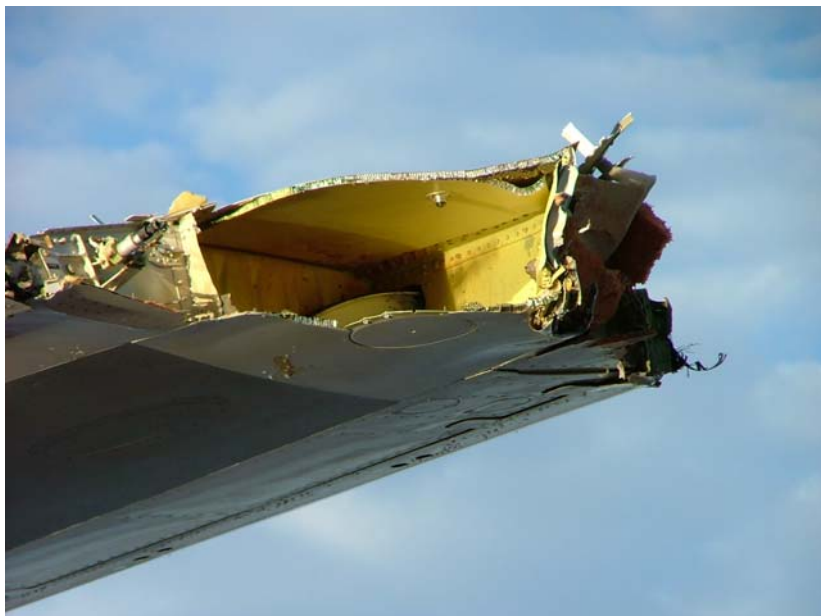
The collision caused a 1.5 m in length section of the right wing to break off.

A section of the right wing of the a/c measuring 1.5 m in length broke off after the collision and fell on the ground (photo 4).

Photo 4. Right wing of the aircraft.
