# AIR ACCIDENT INVESTIGATION & AVIATION SAFETY BOARD

**Accident Report a/c HA-SUD  
Tympaki Airport, Crete  
29<sup>th</sup> June 2008**

**Report No 06 / 2009**

## **Accident of the a/c HA-SUD near Tympaki Airport, Crete on 29<sup>th</sup> June 2008**

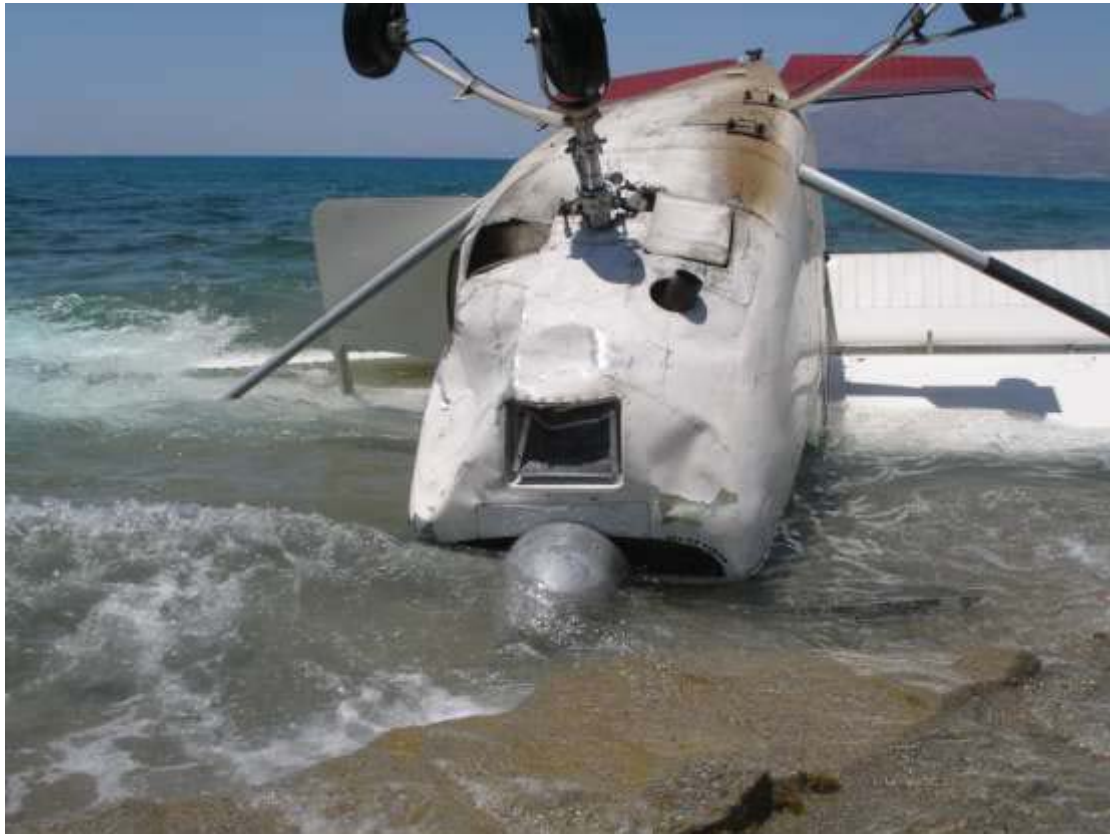
**Photo 1**

Because of low altitude and the large distance to the runway, K1 saw that it was impossible to reach the airport, and so he chose to ditch the plane near the coast. As there were people on one part of the coast, he manoeuvred in the form of an S to reduce altitude and to ditch it on a clear space along the coastline. During the last phase before ditching the aircraft and whilst flying parallel to the coast he unsecured the left door of the aircraft, reduced the descent speed to minimum (40 – 45 kt) and then extended the flaps to their full position, with a ground speed of 22 – 25 kt, and selected to touch the water with the aft of the aircraft first and to reach as near as possible to the coast. As soon as the main parts of the landing system touched the water, the aircraft turned around its transverse axis and overturned. After it overturned the left wing and the engine sank into the sea and the right wing stayed almost out of the water because it was touching land. The pilot and passengers department were half sunk into the sea. (photo 1).

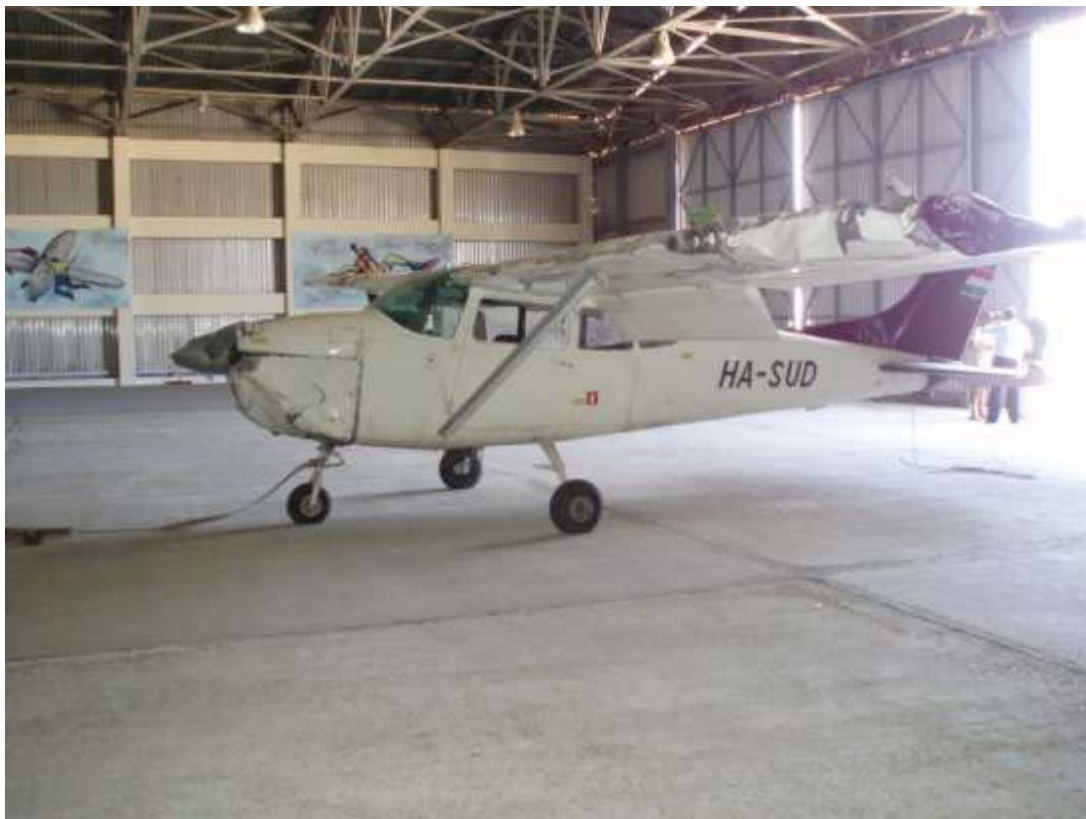
**Photo 2**

The external optical check reveals that the aircraft suffered serious damage, as described below (photo 2):

- Extended damage to the leading edge and the wing tips of both wings are damaged and deformed.
- Distortion of the propeller.
- Deformation of the propeller's cone and the engine covers.
- Snapping of the antennae of the communication and navigation system.
- Breaking of the windscreen.

The distortion of the propeller, the sinking of the engine and the instrument panel in sea water caused a series of inner damage to the engine, the instruments and other equipment of the aircraft which are not possible to be defined.

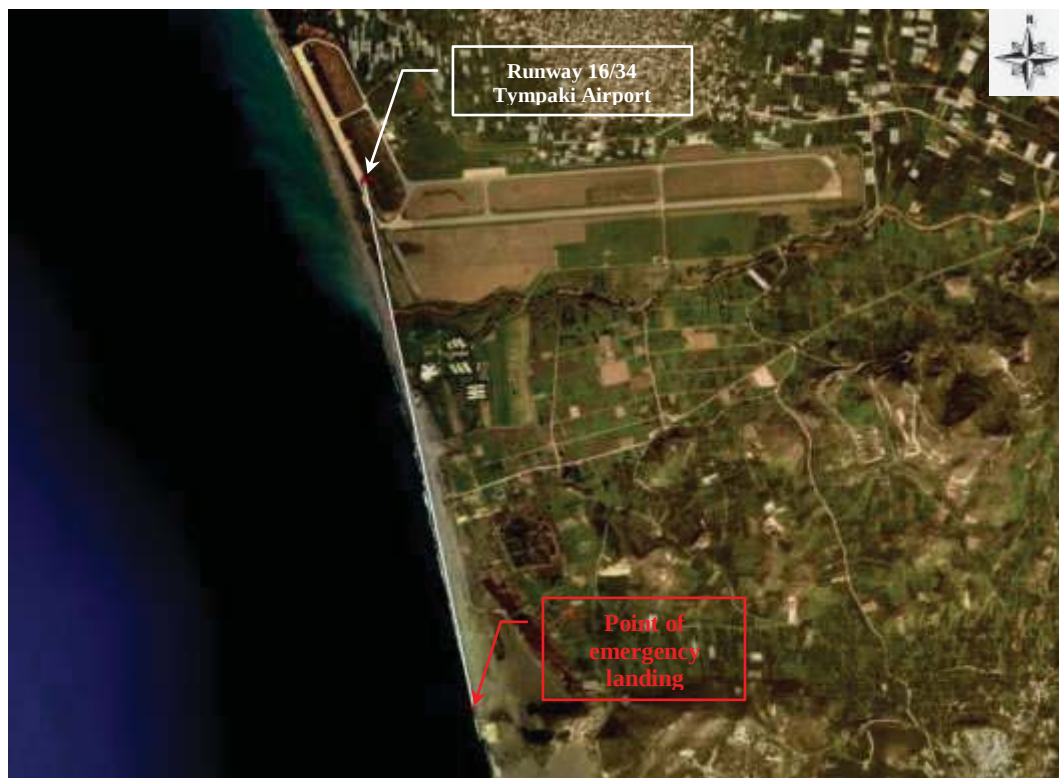
Photo 3

The aircraft was immobilized at location 35°02'14'' N, 024°45'23'' E and at a distance of 2 miles from the threshold of runway 34 (photograph 3).

During the ditching of the aircraft it overturned by turning around its transverse axis, its propeller suffered distortion and both its wings suffered serious damage. The aircraft remained immobilized inside sea water, which covered its engines, the instrument panel and the passenger compartment, without any further debris.
