# AIR ACCIDENT INVESTIGATION & AVIATION SAFETY BOARD

**Incident Report of the a/c HB-JIC  
at Rhodes Airport “Diagoras”  
on 12<sup>th</sup> October 2008**

**Report No 08/2009**

Incident of the a/c HB-JIC of Hello AG  
at the apron of Rhodes Airport “Diagoras” on 12<sup>th</sup> October 2008

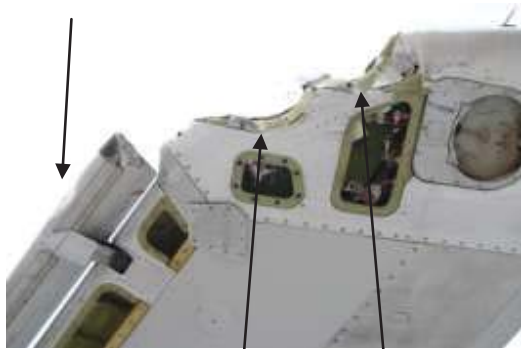
**Picture 1**

### **A: Left Hand wing # 05 Leading Edge Slat:**

The Left Hand (LH) wing # 05 Leading Edge Slat was found with a dent near its outboard end at the front curved area. In accordance with the records in the Airplane Technical Log Book (ATL) no other damage was observed. (Picture 1)

# 05 L/E Slat Dent

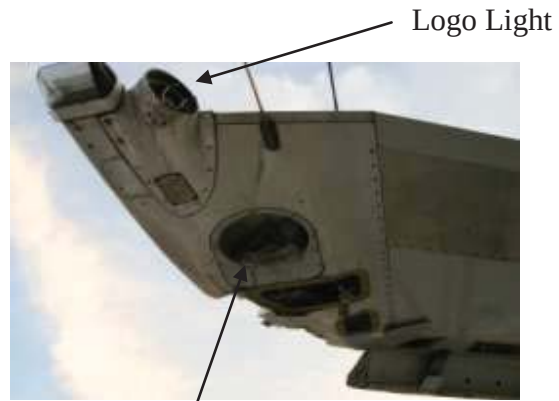
**Picture 2**

Retractable Landing Light

### **B. LH Wing tip:**

The LH Wing tip was found to have damage mainly in the front/ side areas, where the LH wing tip Navigation and Strobe Lights are located, both of which were destroyed. Also the LH wing tip retractable landing light, was destroyed, but without significant damage to its case.

Signs of scratches, dents and wear were observed on the lower surface of the wing tip, between the retractable landing light and near up to the trailing edge. The same scratches, dents and wear were observed on the base of the aerodynamic fairing of the logo light. This light was observed to be missing although its base was still attached. (Picture 2).

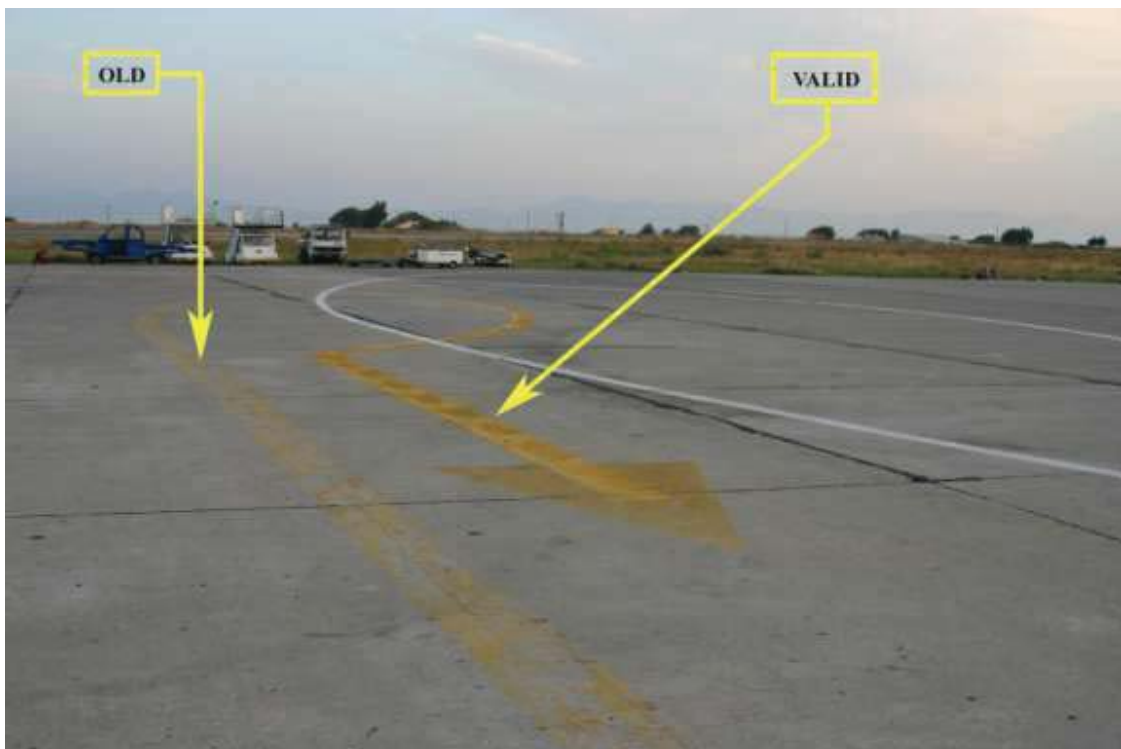
**Picture 3 - Apron Lines – Position 9**

The Apron floor markings consist of yellow and white lines. The white lines are the boundary lines of the airplane parking area and the yellow lines are for the airplane taxi guidance. It was observed that on the Apron floor, there are old yellow lines as well. These are almost faded out, but still visible, that under certain conditions, may be confusing, with the valid ones, by the crews. (Picture 3)

- 3.1.5.** In the Apron there are lines, those which are valid and are painted in bright yellow color and the old semi-faded which are not valid, that may confuse the Flight Crews.

- 4.2.1. 2009-09** Must remove immediately all the old lines and signals that are not in effect, not only in the Apron area but in all the areas of "Diagoras" Rhodes Airport.
- 4.2.2. 2009-10** Must take care in order for the aircraft service vehicles being parked in the areas assigned for this purpose, by the Airport Authorities.
- 4.2.3. 2009-11** Must implement the regulation HCAA/D3/B/28021/6495/19.07.07 “Checks in persons involved in the maintenance, preparation and flight of civil airplanes, for the ascertainment of alcohol and toxic substances or medicines in their organism” (Gov. Gaz. B/1380/03.09.07)

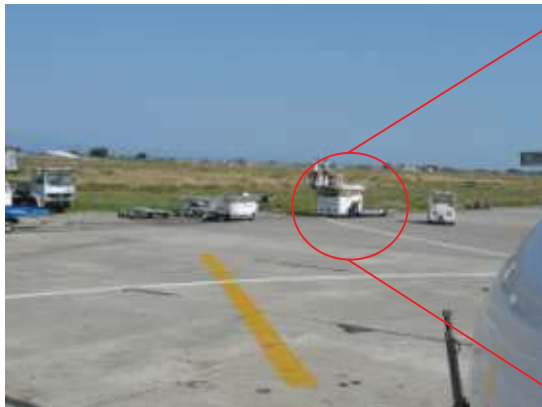
**Picture 4**

### **1.18.1. The probable position of the machine at the time of the incident.**

At the time when the investigator arrived in Rhodes "Diagoras" Airport on 13 October 2008, the machine had already been moved away from the incident area. Therefore it was not possible to determine the distances and the position of the machine at the moment of the collision, in an exact manner. From the photographs taken on 13 October 2008 by the Airport Authorities personnel and from other sources, the machine occupies a space inside of the white line and its imaginary extension, draws the white circle periphery of the boundary of the aircraft parking position No 8. (Pictures 4 & 5). The area indicated, from the sources mentioned above, that the Containers Loader Machine, with registration plates No 70898, was found at the moment of the incident, is not related to the area that has been given to Goldair Handling, by "Diagoras" Airport, Rhodes, Airport Authorities, for parking their equipment.

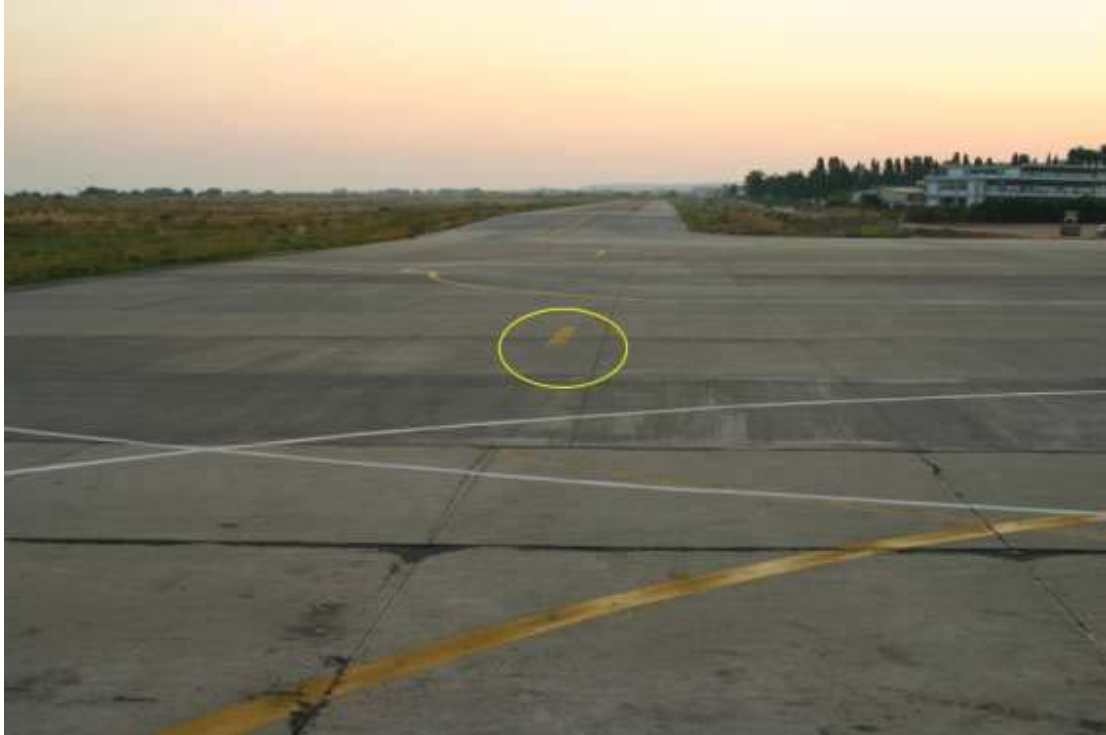
**Picture 6**

The Captain should always have full awareness of the area surrounding the aircraft. Also they must not enter or exit from a parking position without the Marshaller's instructions. In this particular case the Captain states that after the initial right turn lost visual contact with the Marshaller, who states that being on the left side of the airplane and seeing the wrong course being followed, tried, initially with signals, then running in parallel with the airplane to prevent the said course. Thus if the Captain was in doubt about the route he had to follow, he could have looked for the Marshaller, who was to his side and was easy to locate him, or to stop the airplane.

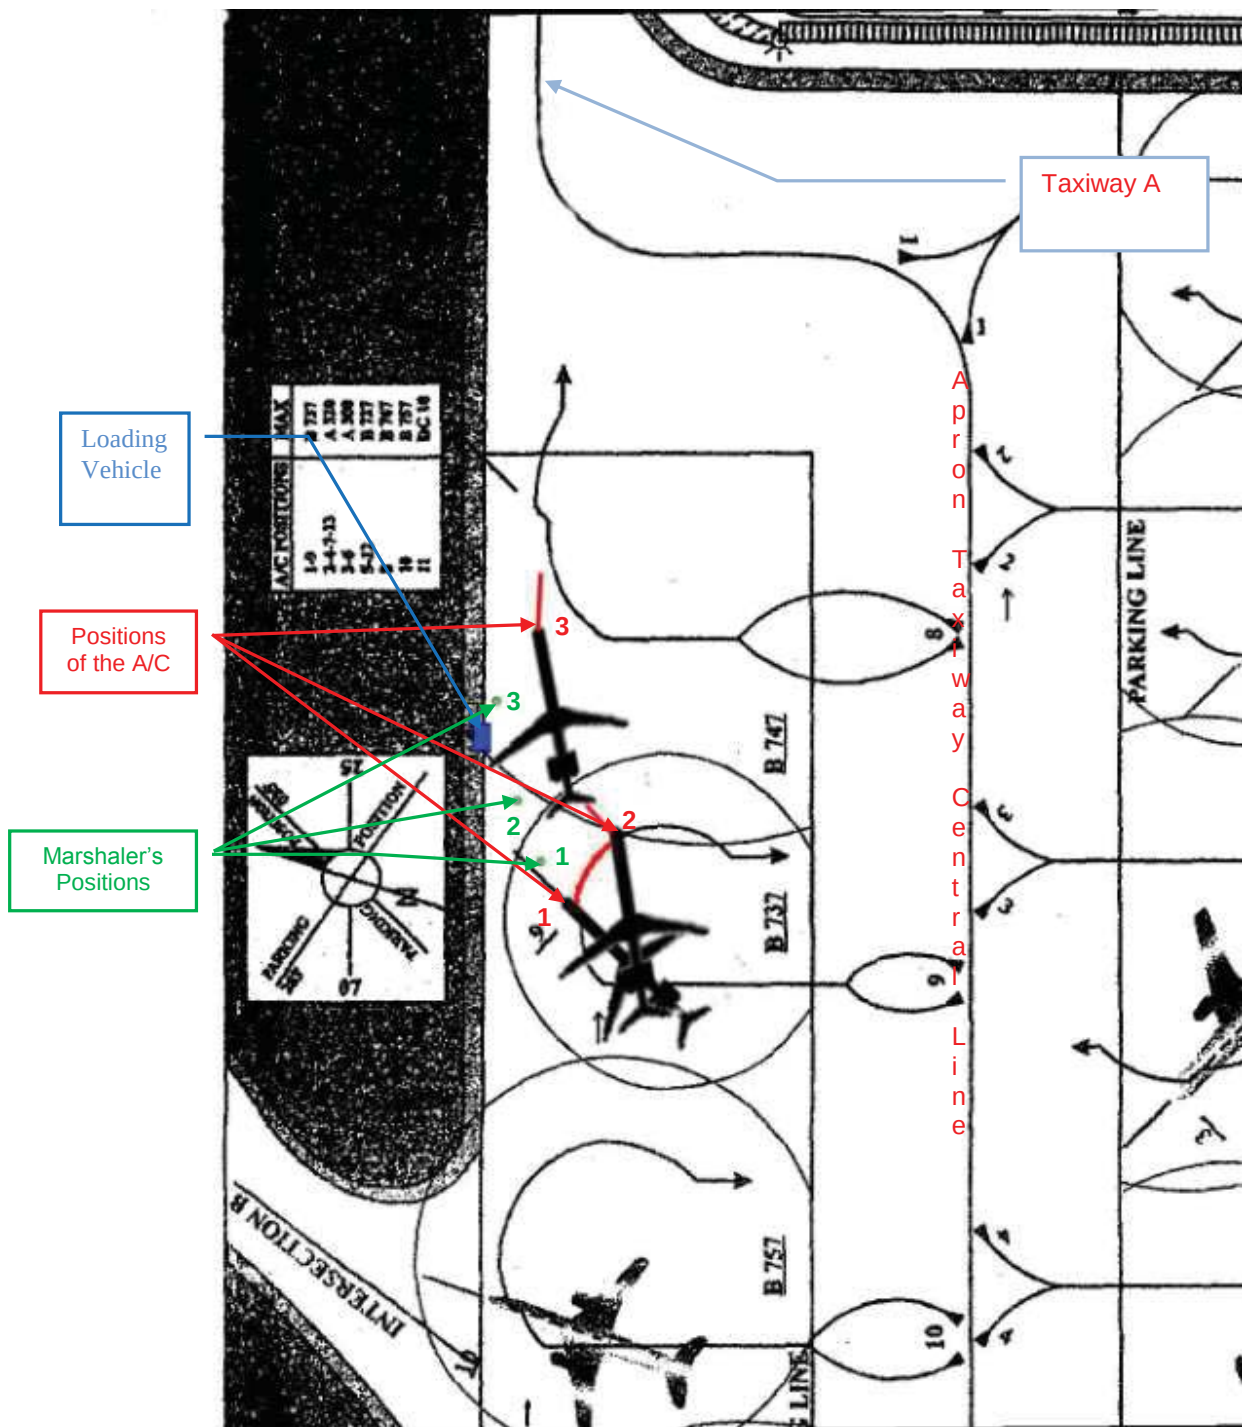
## Appendix B

The Marshaller after engines start-up, moved into position in front and to the right side of the aircraft (Appendix B, Position 1), having in sight the Copilot and with the foreseen signals, indicated the right turn direction which the airplane had to follow in order to vacate the parking position and to taxi into the Apron Taxiway. In order to reach the Taxiway A, from the parking position 9 where the airplane was parked, it should execute a right direction turn of about 130° relative to its orientation, to meet the Apron Taxiway Central Line (CL), then with 90° left turn to align with the Apron Taxiway CL and while rolling on it, to execute again 90° left turn and then 90° right turn to enter the Taxiway A.

Instead of this the airplane executed a right direction turn about 30° - 40° relative to its orientation and after that deviated from the normal expected direction, turning to the left inside the Apron area crossing the parking position 8, in order to align with the imaginary extension, of the Taxiway A center line. The Marshaller, who after the right turn of the aircraft found himself at the left side of the aircraft, and watching the wrong direction of the aircraft, tried to show the correct direction using signals. The aircraft continued towards Taxiway A through the parking position 8 and the Marshaller realizing the upcoming danger of the collision of the aircraft's wing tip with the Containers Loader Machine which was parked at the edge of the Apron and within the safety area of the

parking position 8, moved in parallel with the airplane's track trying with signals to warn the crew, without success. The aircraft continued rolling towards Taxiway A and the left hand wing tip collided on the Containers Loader Machine. (See Appendix B)
