AIR ACCIDENT INVESTIGATION AND AVIATION SAFETY BOARD  
(AAIASB)

ACCIDENT INVESTIGATION REPORT  
INVOLVING THE AIRCRAFT HA-TAH  
AT AXIOS RIVER, 2NM SOUTHWEST OF POLYKASTRO,  
ON 22<sup>nd</sup> MARCH 2015

involving the Aircraft HA-TAH

on 22<sup>nd</sup> March 2015

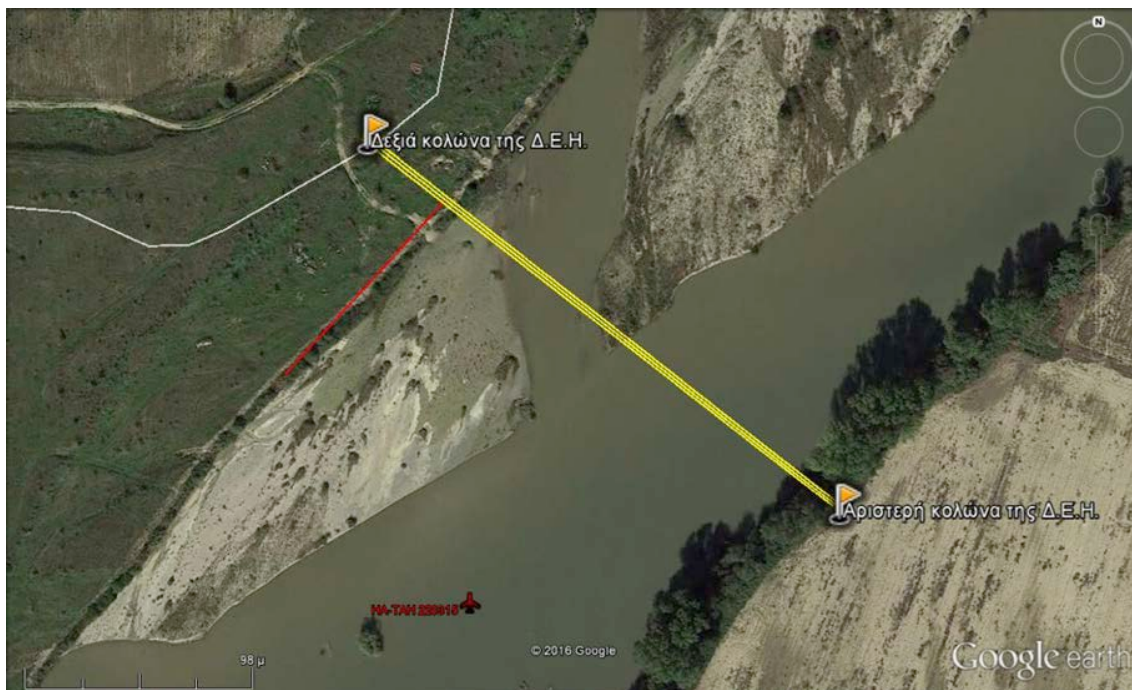
Picture 2. The aircraft crash site

The distance travelled from the point of impact with the overhead power lines up until the final point where the aircraft stopped was about 100 m (Picture 2); this fact, in conjunction with the fact that one power cable was severed and the other two sustained damage, shows that the aircraft had high kinetic energy as a result of its high speed at the time of impact and is not characteristic of an aircraft flying at a little more than stalling speed without flaps, i.e. 44 kt.

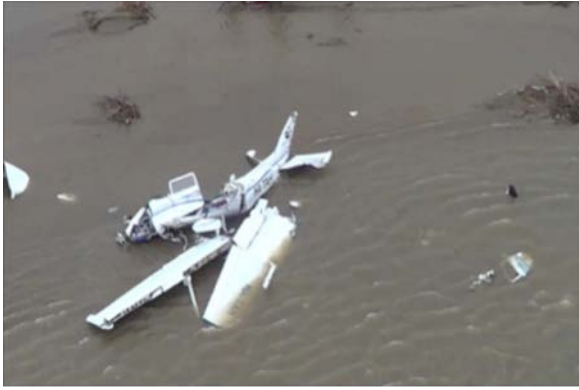
The impact of the aircraft on the power lines was so strong that the metallic surfaces on the upper part of the cockpit were torn almost horizontally from front to back, the wings had almost detached and folded rearward hitting hard and causing deformation on the right and left to the horizontal stabilizer elevators.

- The wings had detached and had folded near the fuselage;

Photo 1. Aircraft wreckage

pieces (Photos 1, 2) are consistent with a small airplane falling at a relatively small angle of impact. The extensive damage caused to the front right part of the cockpit leads to the conclusion that the aircraft had a rather large angle of roll to the right relative to its longitudinal axis at the time of impact on the ground.

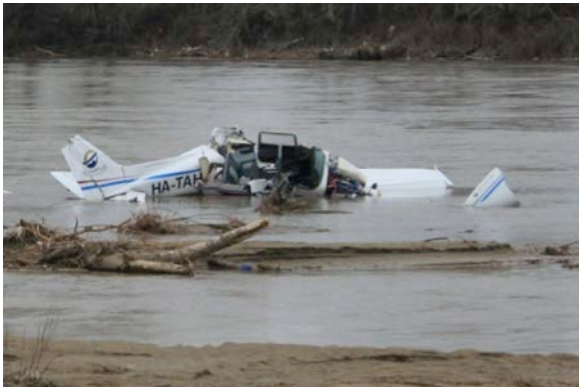
- The horizontal stabilizer elevators, located to the left and right of the vertical stabilizer, were crushed, distorted and torn from their leading edges almost all through to their trailing edges;

Photo 2. Aircraft wreckage

- The vertical stabilizer and the rudder had an almost horizontal tear at their upper surface, from the former's leading edge to the latter's trailing edge, resulting in the whole upper extremity of the empennage being missing;
- The empennage together with part of the fuselage had almost detached aft of the cabin, they were twisted and bent relative to the aircraft's longitudinal axis;
- The fuselage section making up the roof of the cockpit was totally severed almost horizontally, all windows and the windshield were destroyed, the cabin's right-hand door, the main landing gears were completely detached from the fuselage and the front right seat was detached from its rails.

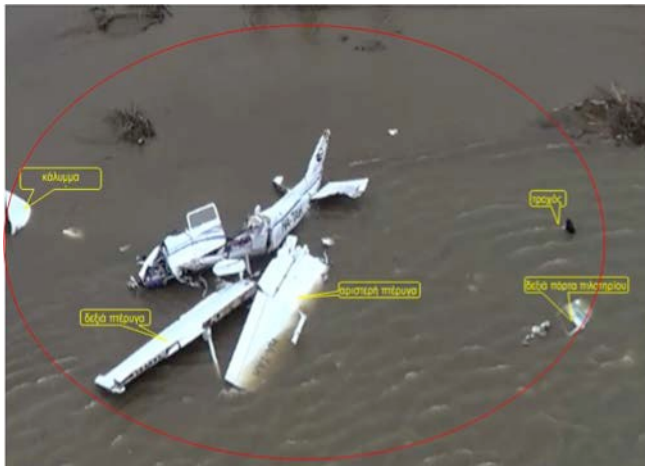
scattering of the wreckage in the stream bed of the river, as viewed from the Air Force helicopter and from the river bank on the day of the accident.

Photo 4 From the rescue helicopter

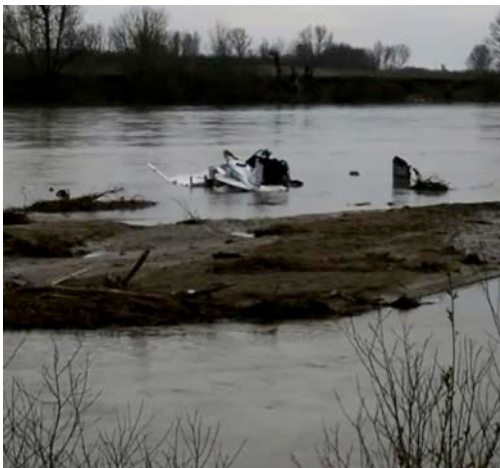
Photo 5 – From the west bank

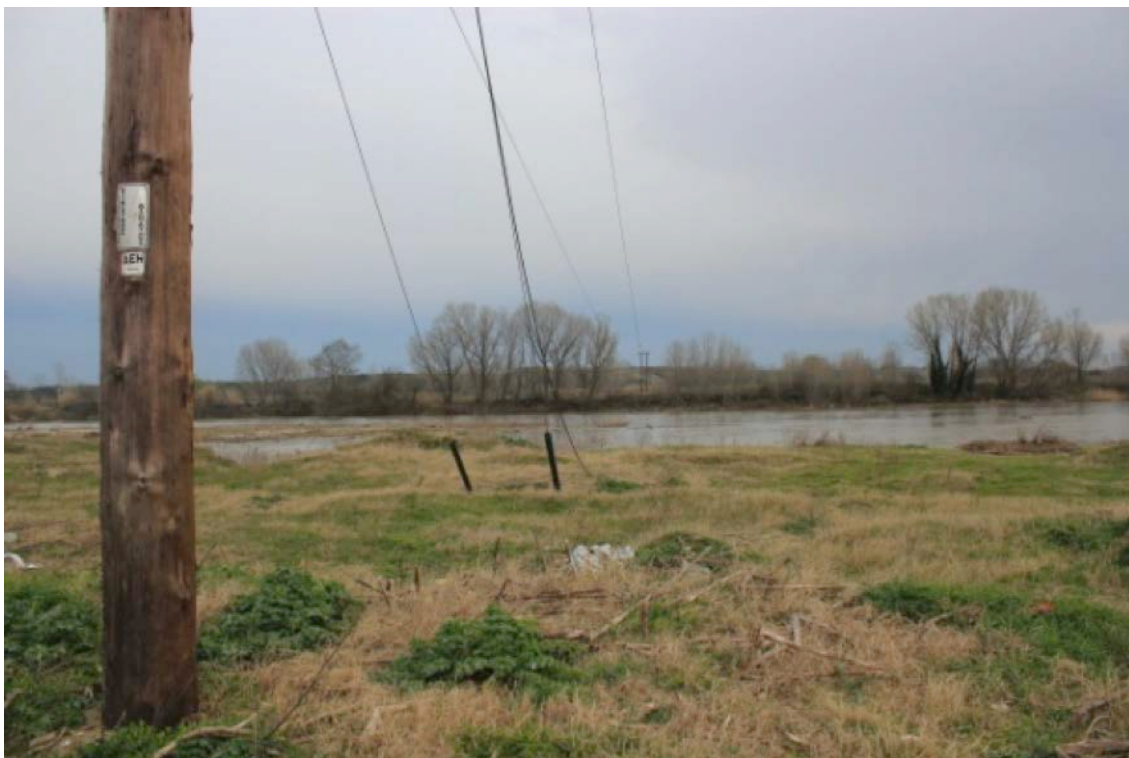
The three overhead power transmission lines, which were in a horizontal configuration, were destroyed. One of the three, the middle one, was completely severed (Annex 2, Photos 1, 2) while the other two sustained serious damage (Annex 2, Photo 3).

Photo 6. Public Power Corporation pylons, the damaged cables and the severed cable

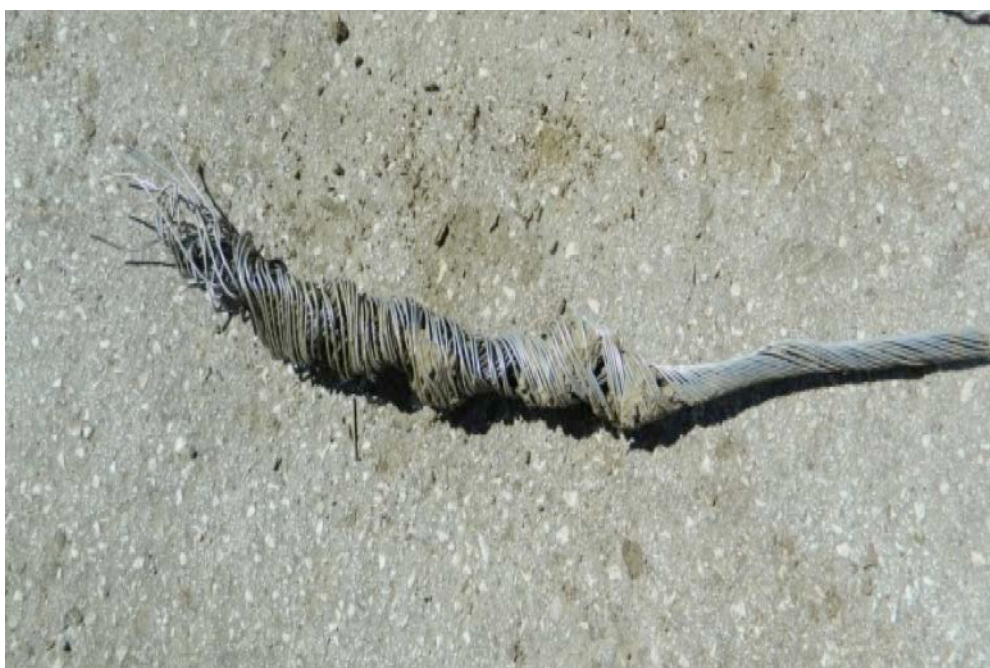
Photo 7. Severed cable end

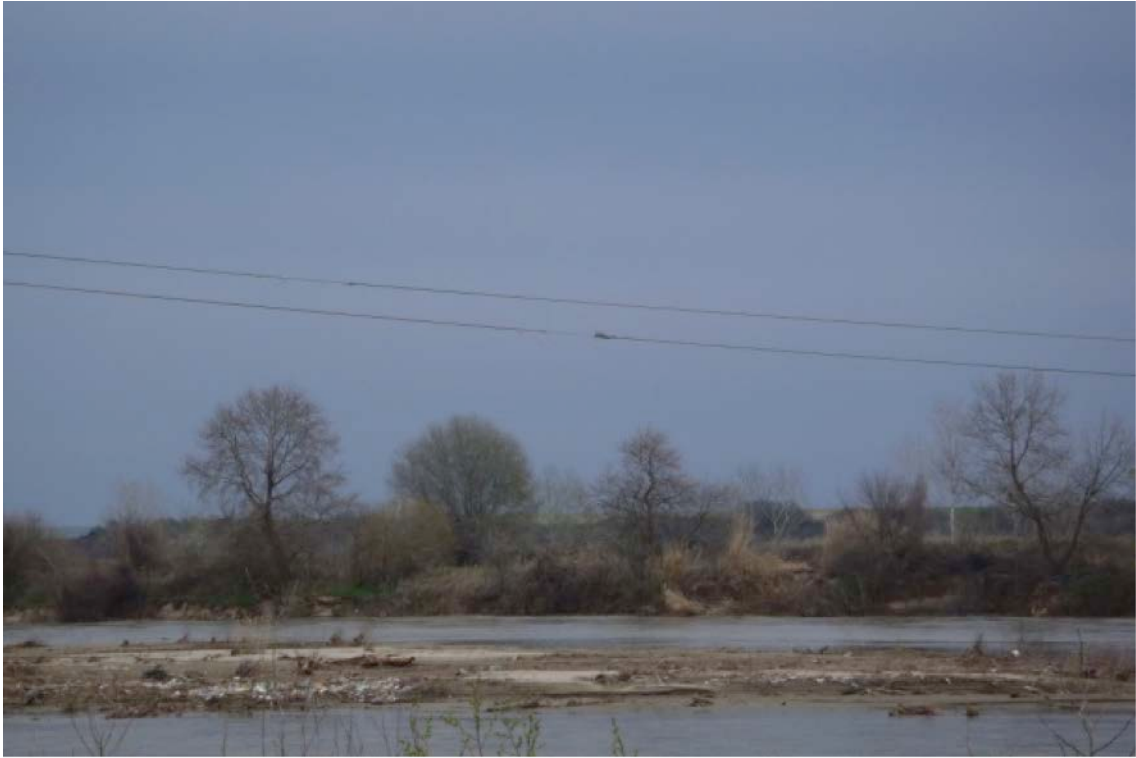
Photo 8. The two damaged cables
