**AIR ACCIDENT INVESTIGATION  
AND  
AVIATION SAFETY BOARD  
(AAIASB)**

**ACCIDENT INVESTIGATION REPORT  
AIRCRAFT BEECHCRAFT HAWKER 850XP  
TC-MAN  
AT MYKONOS STATE AIRPORT  
ON JULY 26, 2017**

**ACCIDENT INVESTIGATION REPORT**  
**02 / 2021**

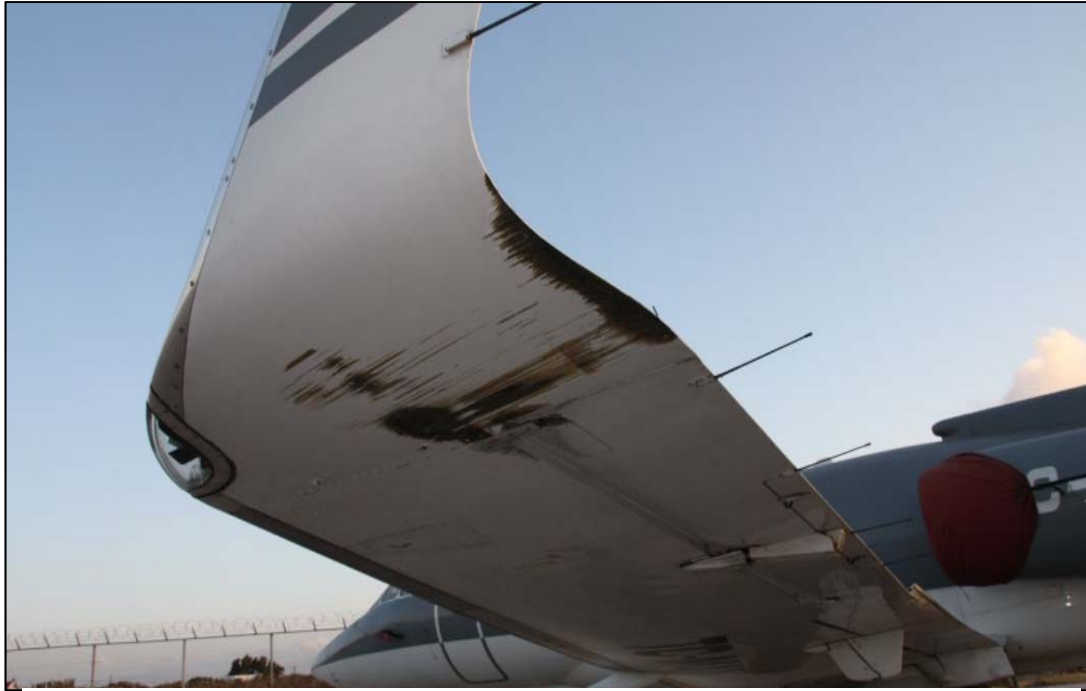
The left wing tip and parts of the left wing of the aircraft during their contact with the runway, showed extensive damage (Appendix: Photos 1 to 3), also wear was observed on the left outer tire of the left main Landing Gear System (Appendix: Photo 4).

**Photo 1:** Damage of the left-wing tip (winglet) of the left wing.

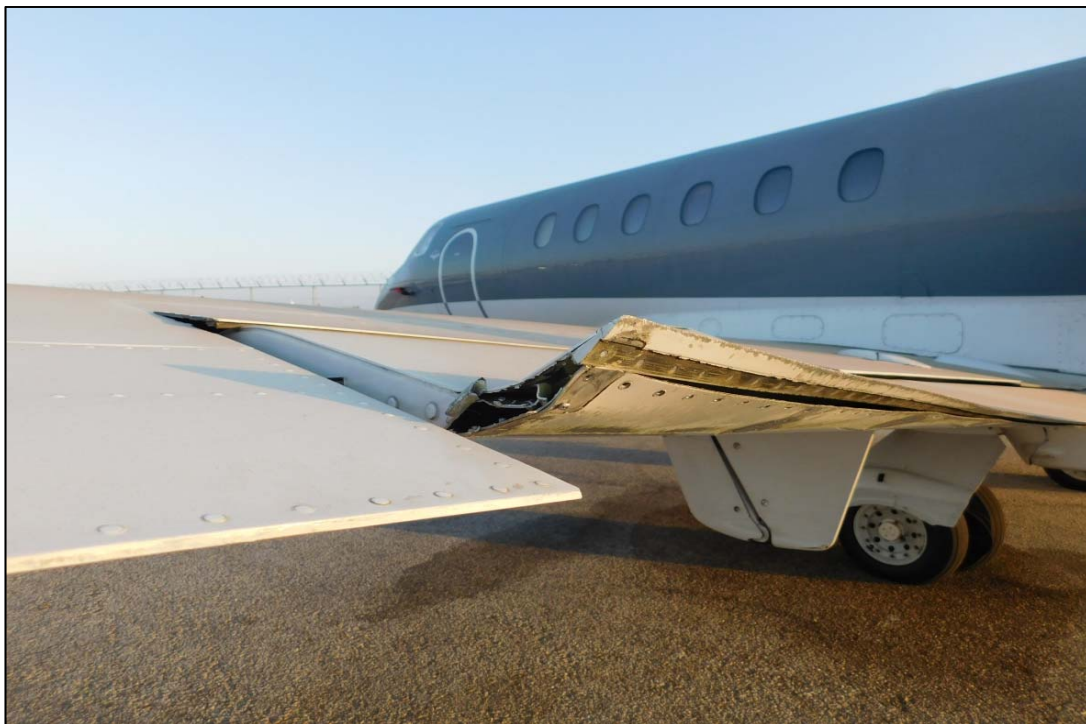
**Photo 2:** Damage of the trailing edge flaps on the left wing.

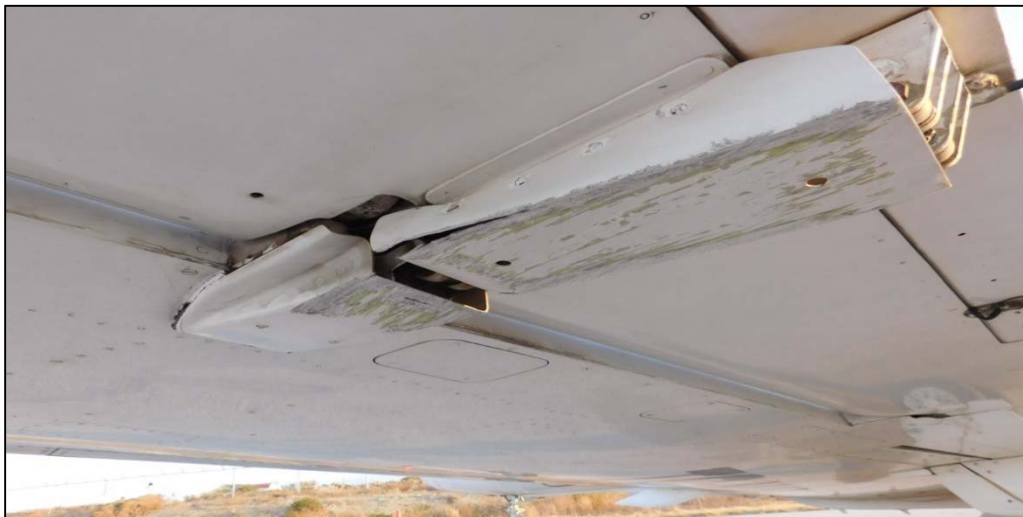
**Photo 3:** Damage of the left aileron drive cover on the lower part of the left wing.

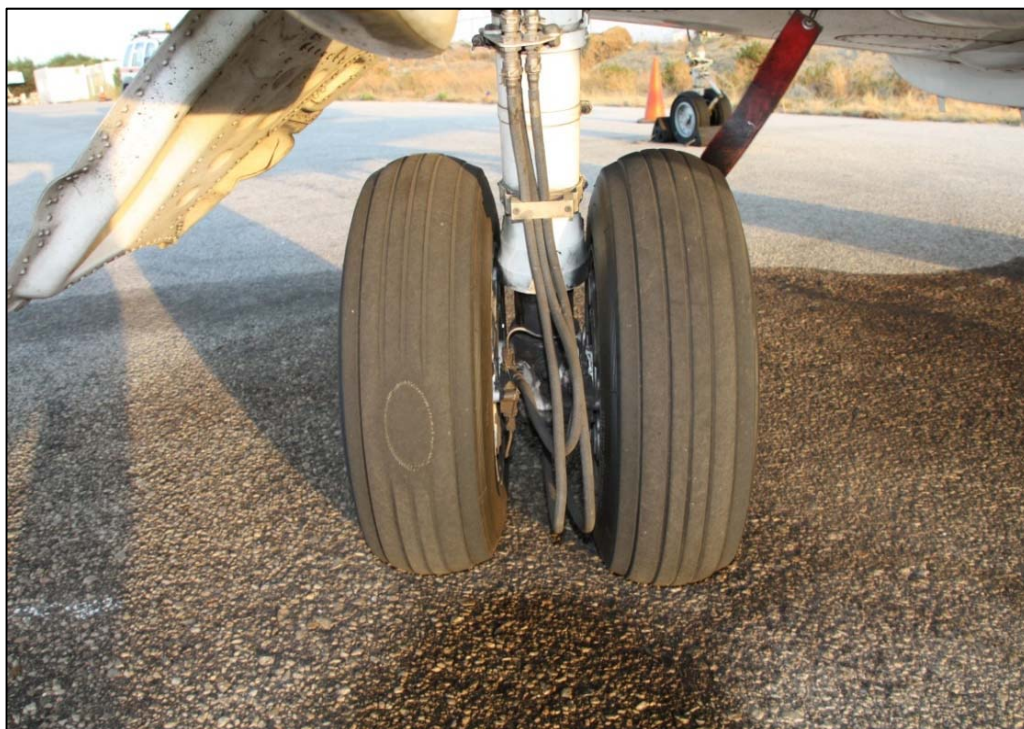
**Photo 4:** Wear to the outer tire of the left main landing gear.
