**AIR ACCIDENT INVESTIGATION  
AND AVIATION SAFETY BOARD  
(AAIASB)**

**ACCIDENT INVESTIGATION REPORT  
AIRCRAFT PIPER CHEYENNE PA 31T  
SX-AVC  
AT THESSALONIKI INTERNATIONAL AIRPORT “MACEDONIA”  
ON AUGUST 14, 2013**

**ACCIDENT INVESTIGATION REPORT**  
**03 / 2021**

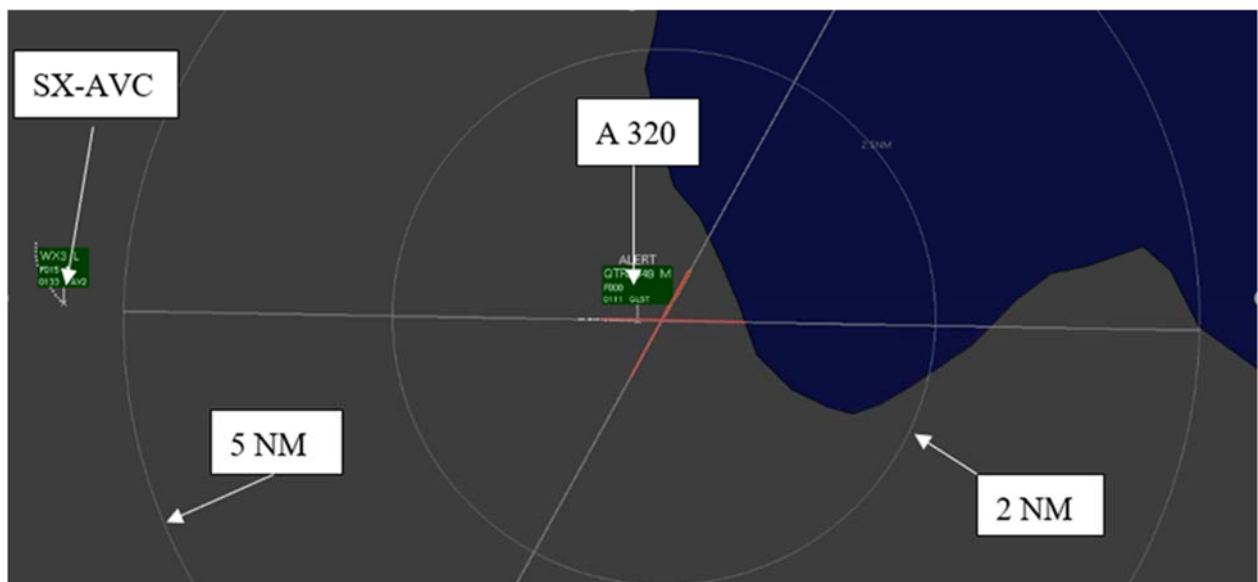
**Radar Capture 1:** Landing A320 and distance from SX-AVC.

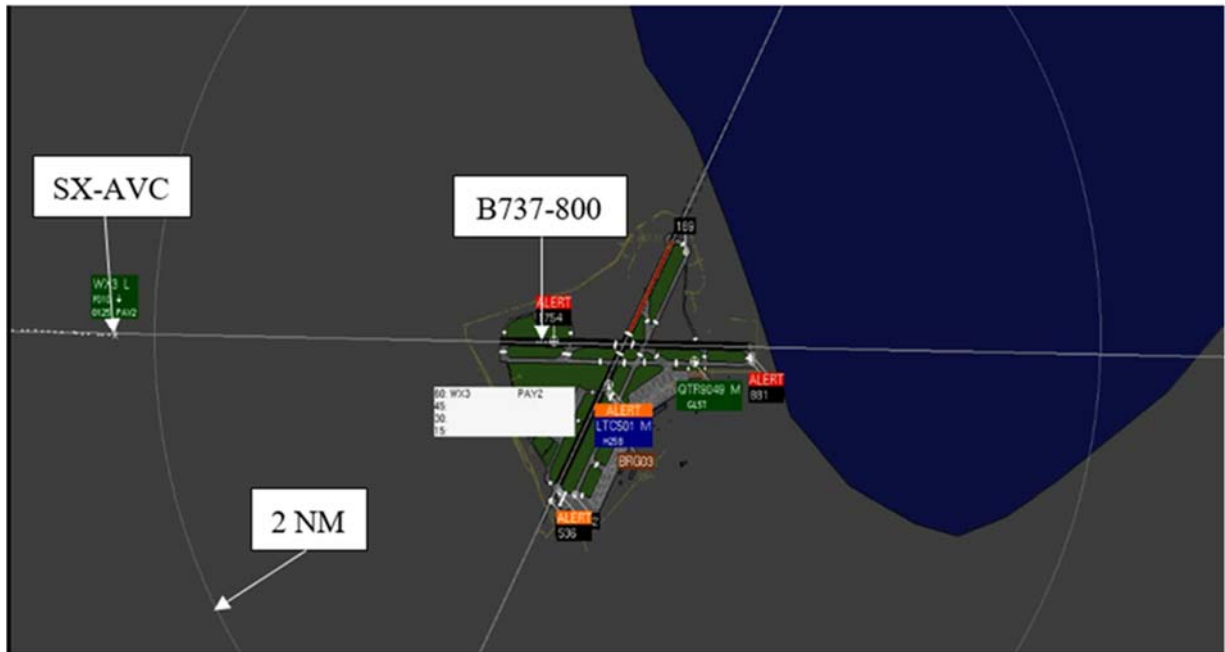
After the A320 had evacuated the runway, a B737-800 was cleared for take-off from runway 34. At that time, the SX-AVC was at 2.5 NM and 1 minute and 12 seconds from the runway threshold (Time separation was calculated with approach speed: Stalling speed of 88 kts x 1.3 = Vref 114.4 kts + 10 kts = **V approach speed = 125 NM / hr**).

**Radar Capture 2:** Take off B737-800 and distance from SX-AVC.

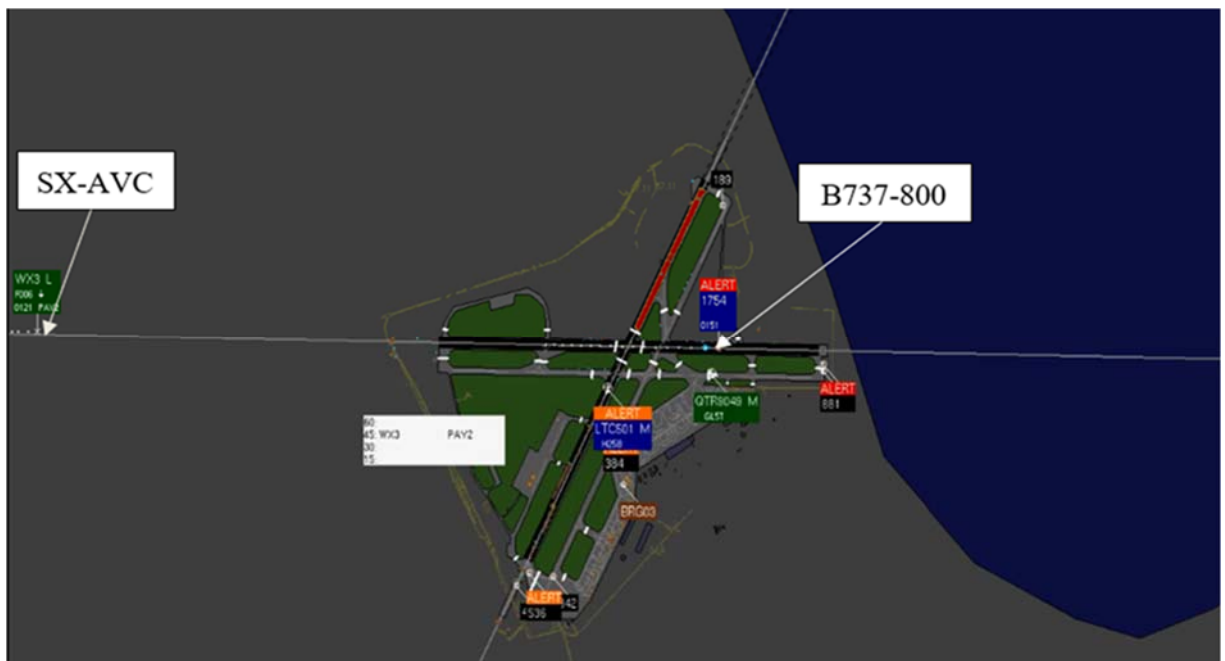
At lift off of B737-800, the SX-AVC was 1.5 NM and 43 seconds from the runway 34 threshold and was cleared for touch and go at 08h17'49" UTC without any warning to the flight crew of the light aircraft about wake turbulence from the departing transport category airplane.

**Radar Capture 3:** B737-800 lift off and distance from SX-AVC.

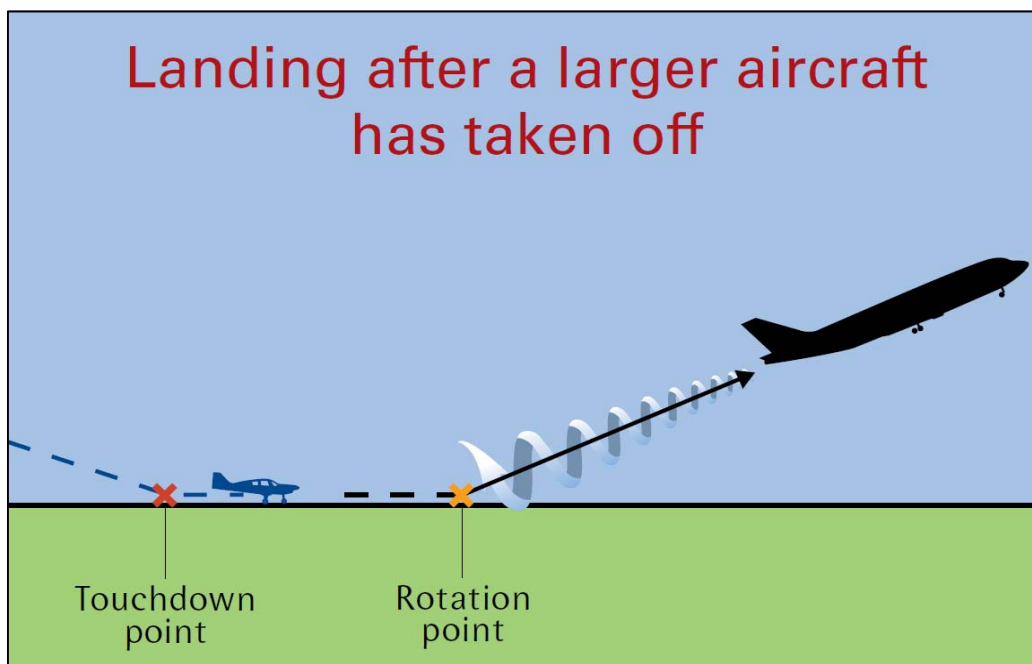
In contrary, no consideration, from ATC, was given for the light aircraft performing a touch and go after the departure of a medium-sized to assure at least 2 minutes separation between small aircraft taking off after a medium-sized.

**Figure 3:** Touchdown point of small aircraft after the take-off of a larger aircraft.

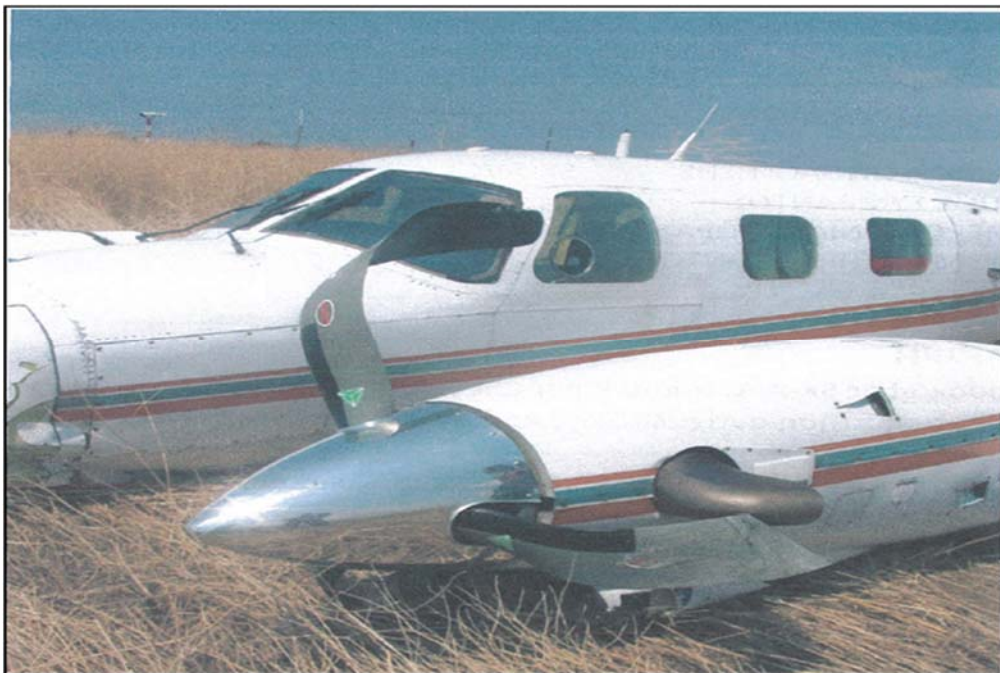
The aircraft suffered extensive damage and was declared as a total loss.

SX-AVC aircraft sustained total loss (Photos in Appendix 5.2).

**Photo 2:** The fuselage and left engine of SX-AVC.

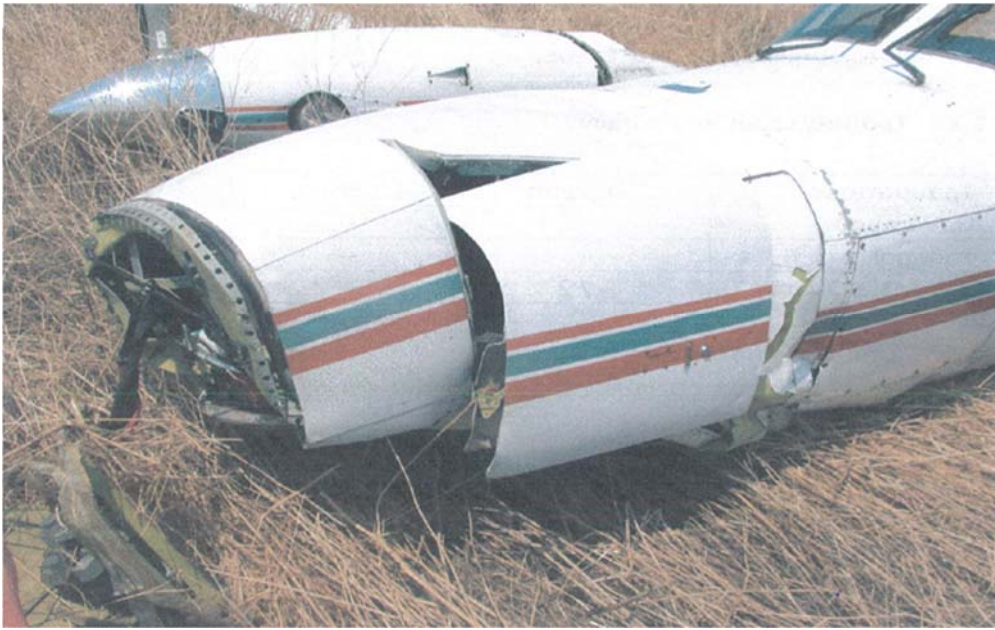
**Photo 3:** The forward fuselage and right engine.
