**SERIOUS INCIDENT INVESTIGATION REPORT  
AIRCRAFT DIAMOND DV 20 KATANA  
SX-KVA  
AT KOZANI STATE AIRPORT LGKZ  
ON FEBRUARY 14, 2020**

**SERIOUS INCIDENT INVESTIGATION REPORT**  
**E04 / 2021**

**Serious Incident of Diamond DV 20 Katana Aircraft with registration SX-KVA  
at Kozani State Airport LGKZ on February 14, 2020**

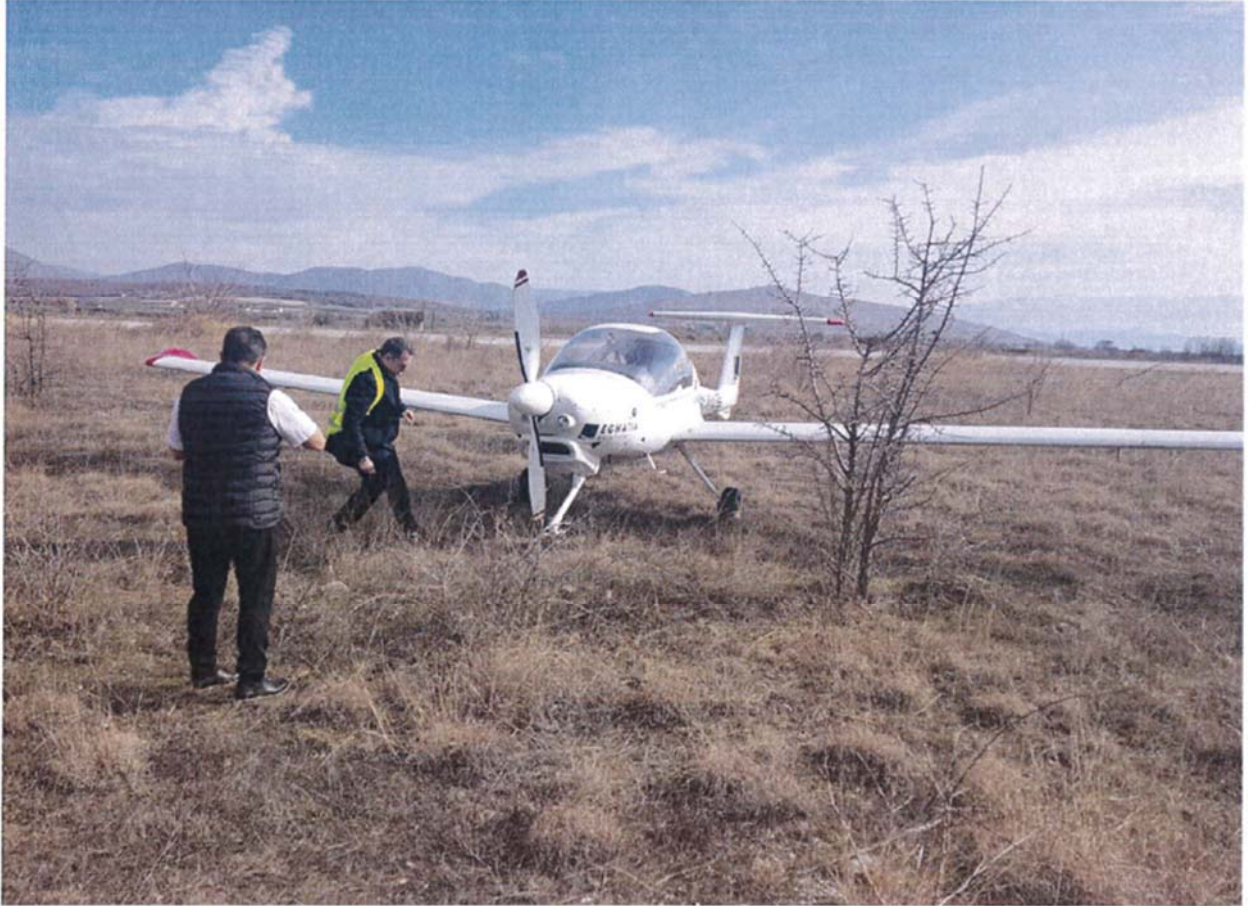
During landing, on a SOLO training flight, on Runway 32 at Kozani State Airport, the student Pilot lost control of the aircraft and exited to the right of the runway on soft ground. The aircraft sustained minor damages. The student Pilot exited the aircraft without injuries.

**Photo 1:** The aircraft on soft ground.

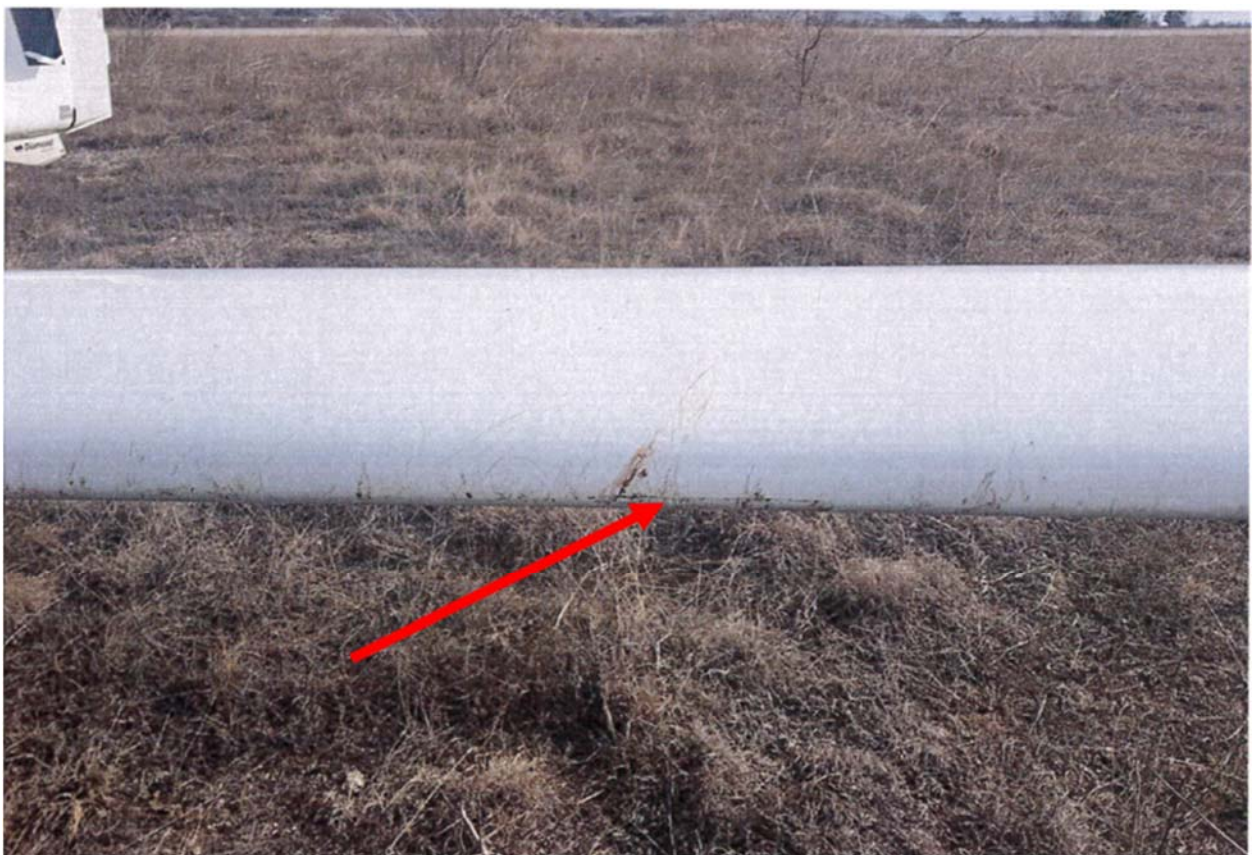
During the landing phase the aircraft exited to the right of the asphalt runway on soft ground. The left wing tip came in contact with the ground and a 22 mm (22mm) long crack was observed on the left wing leading edge. No other damages observed.

**Photo 2:** Left wing leading edge with the 22 mm crack.

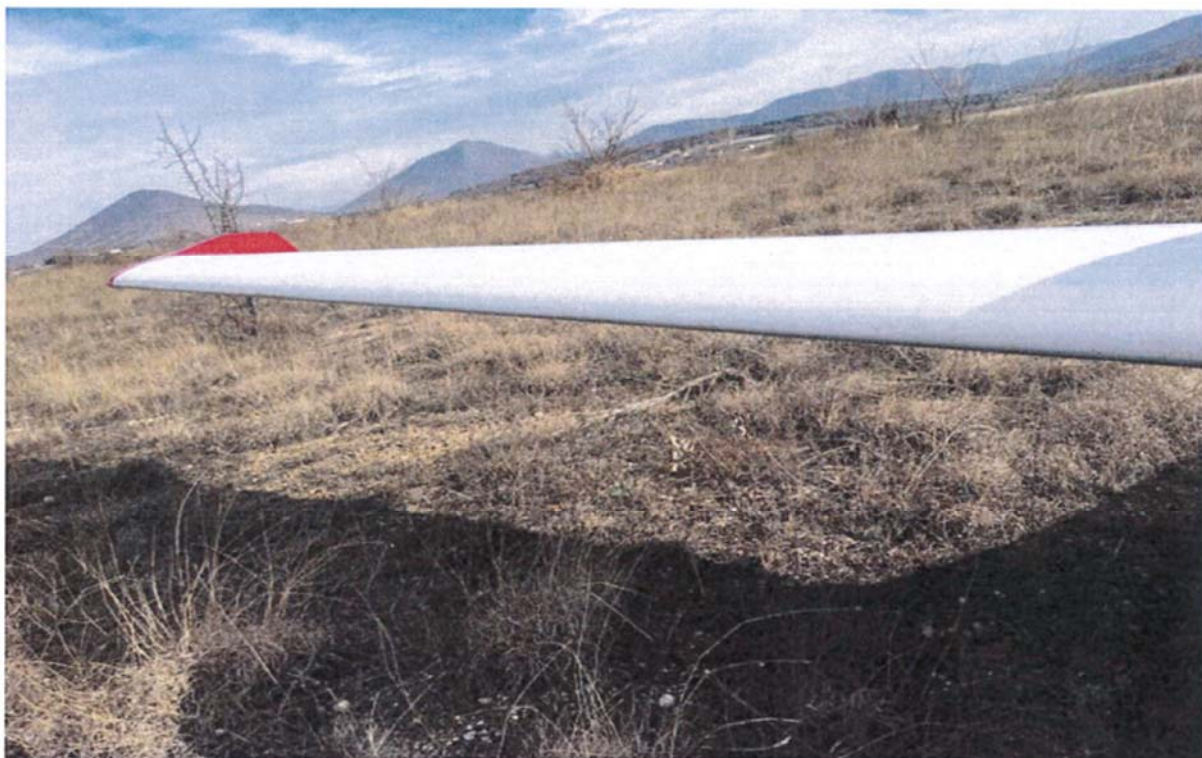
**Photo 3:** Right wing intact.

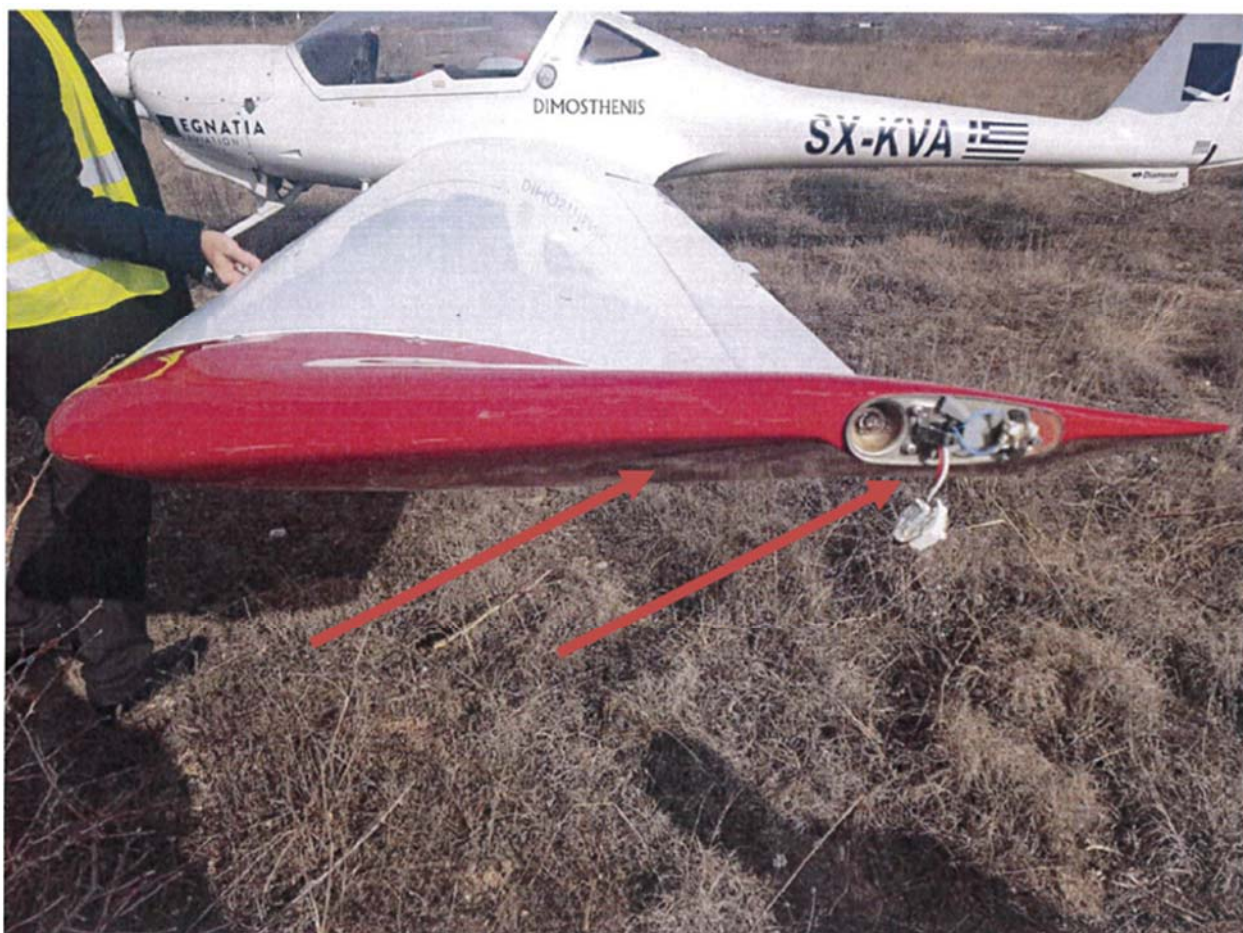
**Photo 4:** Left wing tip damages.
