**SERIOUS INCIDENT INVESTIGATION REPORT  
AIRCRAFT D-AICD AIRBUS A320-212  
IN THE CTR OF KAVALA AIRPORT  
ON AUGUST 16, 2018**

**E02 / 2021**

**Serious incident of Aircraft D-AICD in the Airspace of Kavala Airport  
on August 16, 2018**

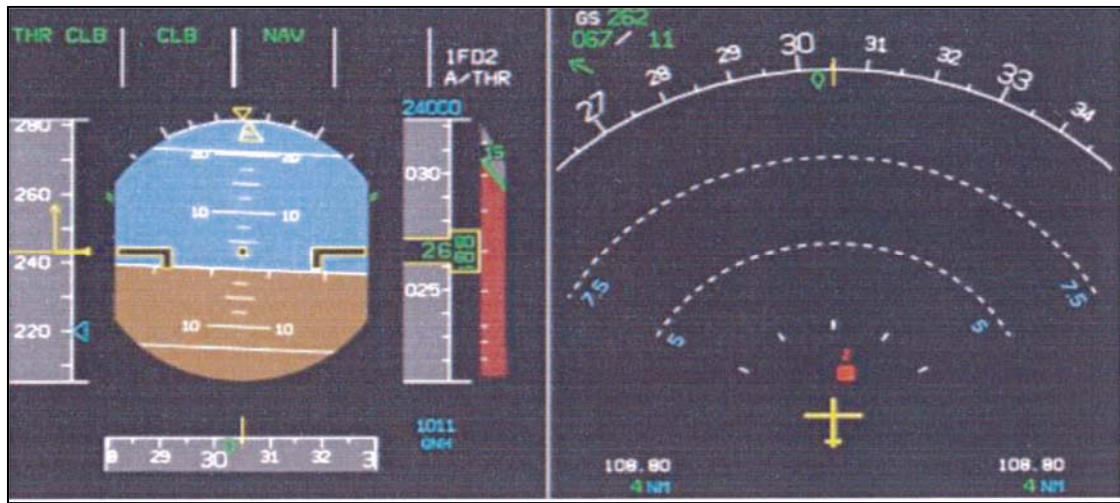
**Fig. 3:** ND/PFD display at the TCAS TA ‘‘MAINTAIN V/S’’.

Seven secs later at 07:09:51h and at attitude of 2,700 ft the TCAS having detected the reduction in rate of climb, commanded ‘‘MAINTAIN V/S’’ while the crew during the interview stated that they heard an audible warning for a climb. (Fig.3)

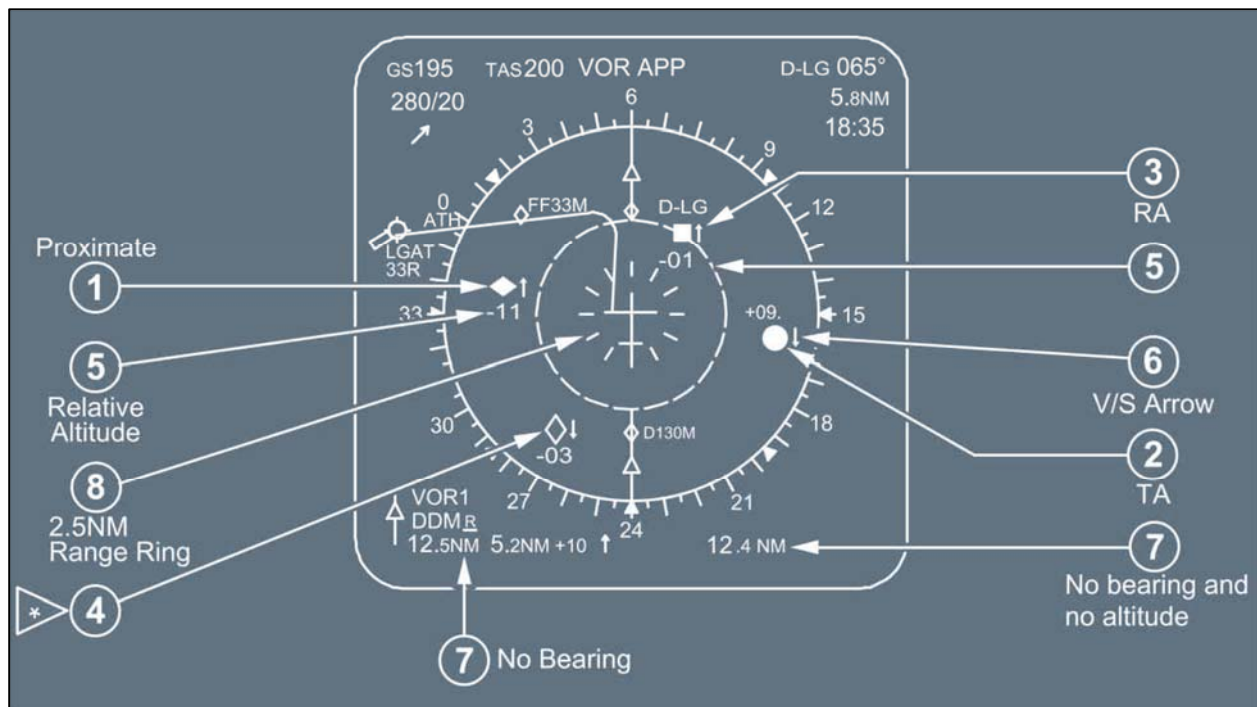
- 1) Proximate intruder  
Indicated by a white filled diamond.
- 2) TA intruder  
Indicated by an amber circle.  
Associated with the TRAFFIC-TRAFFIC aural message.
- 3) RA intruder  
Indicated by a red square.  
Associated with vertical orders displayed on the PFD and aural messages.
- 4) Other intruders  
Indicated by a white empty diamond.

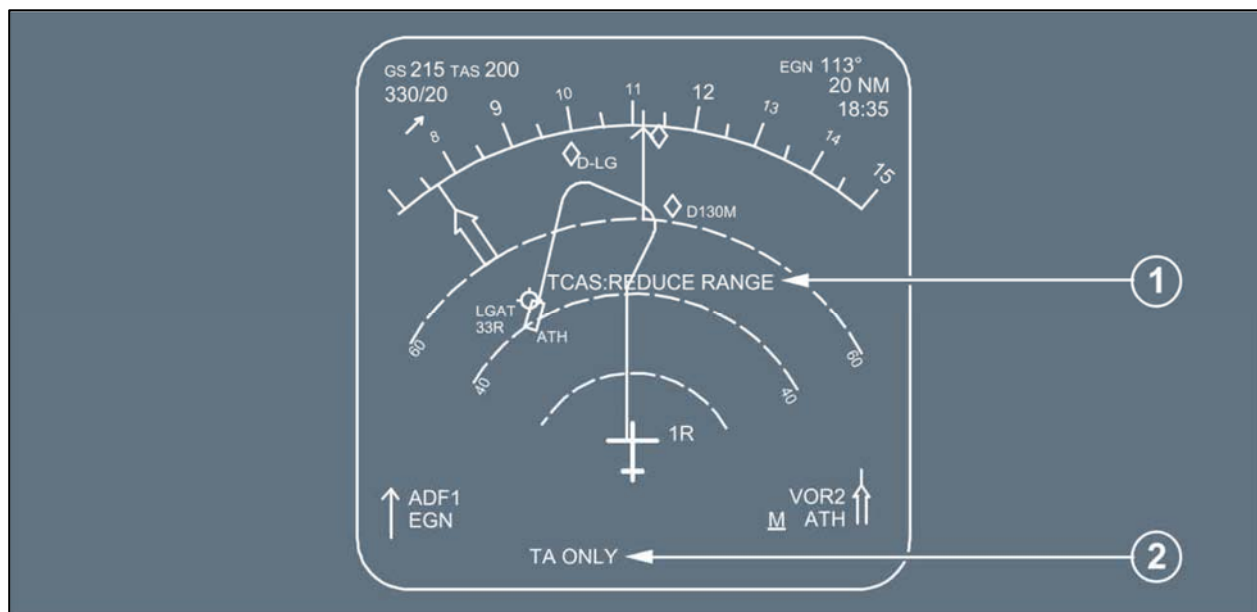
1) Mode and range messages

Following messages can be displayed to draw pilot's attention:

TCAS: Displayed in case of TCAS internal failure.

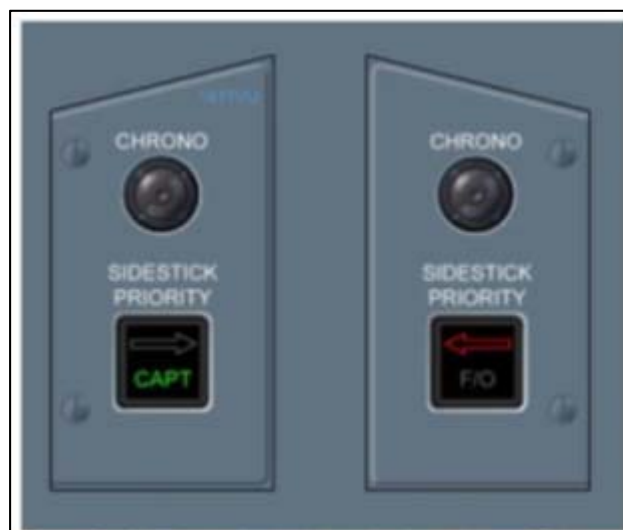
**Fig. 17:** The left-hand seat has priority. Usually the **Capt**

Fig.17 displays the indications when the right-hand seat Pilot intervenes on his sidestick by pressing the red pushbutton on his sidestick and that Pilot has priority. The red arrow indication and green indication disappear when the left-hand seat Pilot remove his hand from his sidestick.

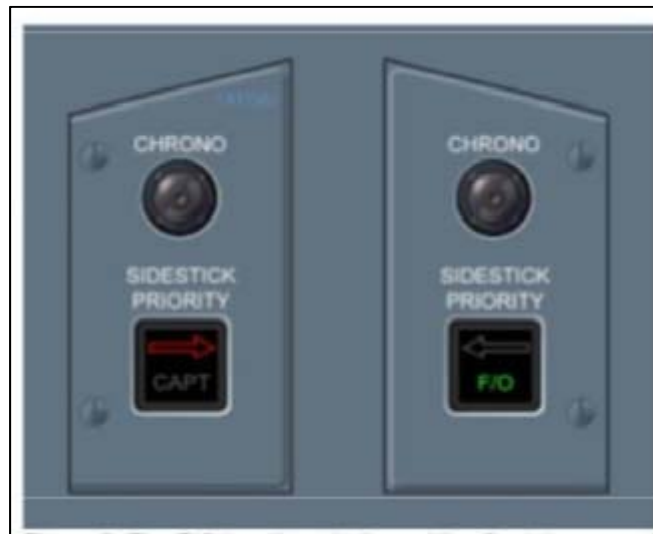
**Fig. 18:** The right-hand seat has priority. Usually the **F/O**.

Fig. 18 indicates dual side stick input. Both Pilots are moving their sidesticks without anyone having priority. Aural sound “DUAL INPUT” is heard.

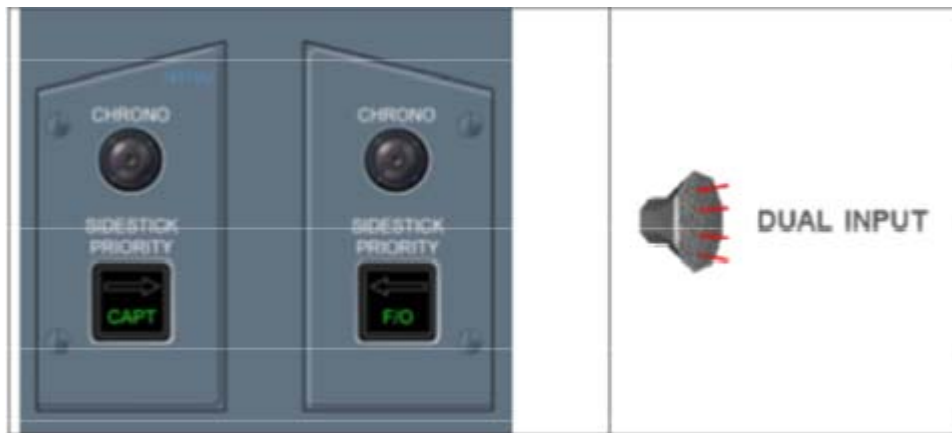
**Fig. 19:** both Pilots are moving their sidestick without anyone having priority with the activation of the aural sound “DUAL INPUT”
