**ACCIDENT INVESTIGATION REPORT  
OF THE AIRCRAFT SX-DIA  
AT THE AIRPORT OF RHODES 'DIAGORAS'  
ON 2 FEBRUARY 2015**

# **ACCIDENT INVESTIGATION REPORT**

**03/2018**

**Aircraft SX-DIA (Jetstream 41)  
at the Airport of Rhodes ‘Diagoras’ on 02.02.2015**

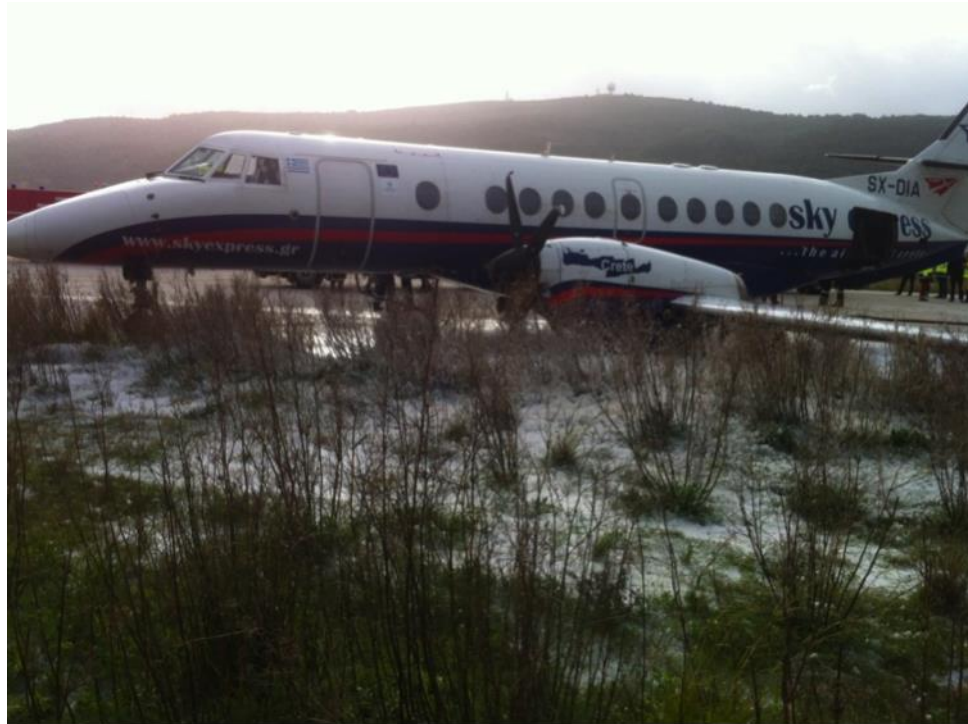
Fig. 3

The left main landing gear's folding rearward resulted in the blade tips of the left propeller of the aircraft coming into contact with the runway while the propeller was turning, which led to the blade tips sustaining serious structural damage (Fig. 4).
