**HELLENIC REPUBLIC  
MINISTRY OF INFRASTRUCTURE AND TRANSPORT**

**AIR ACCIDENT INVESTIGATION AND AVIATION  
SAFETY BOARD  
(AAIASB)**

**INVESTIGATION REPORT  
OF AIRCRAFT ACCIDENT 5B-CLB  
ON OCTOBER 16th, 2016,  
AT KALAVRYTA AREA**

**AIRPLANE C 172P, Reg. Nbr 5B-CLB**  
**ON OCTOBER 16th, 2016 AT KALAVRYTA AREA**

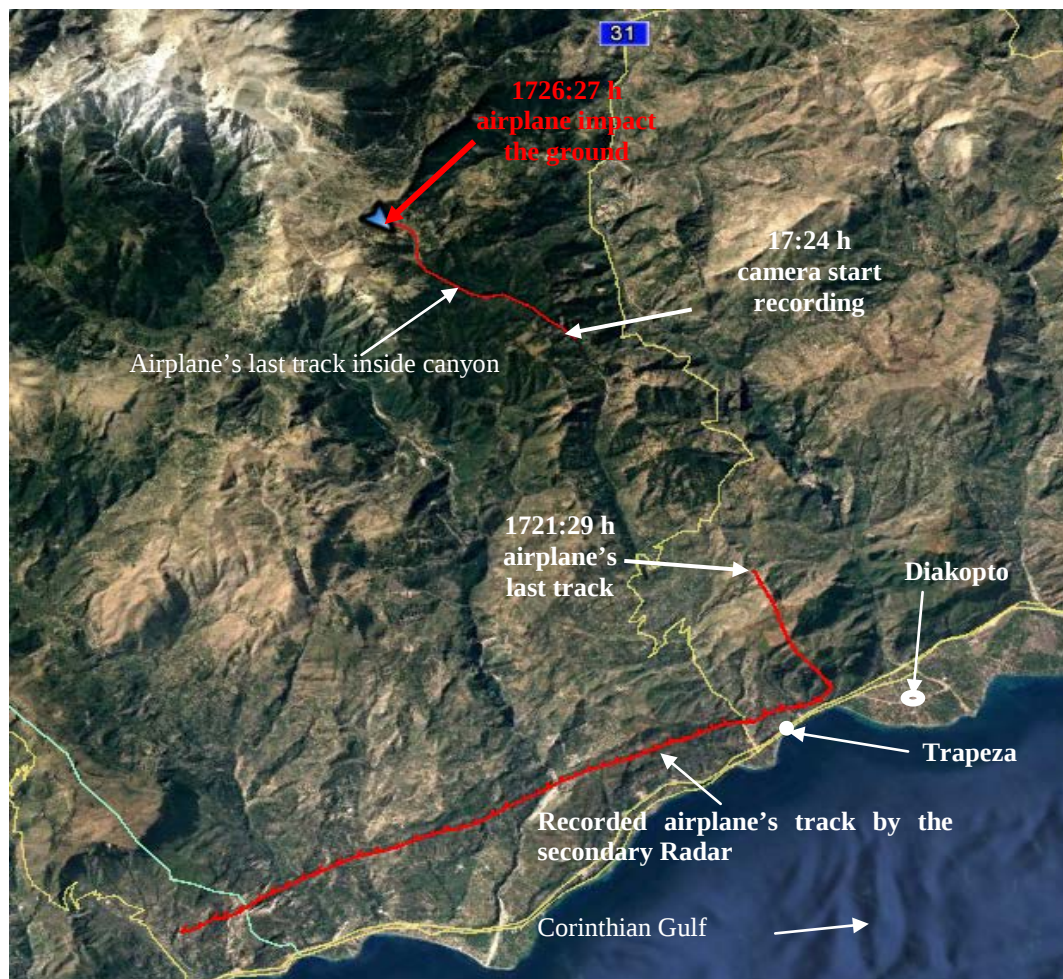
At 17:20 h at the point with coordinates 38° 10' 33.5'' N, 22° 12' 58.7'' E and between the areas TRAPEZA and DIAKOPTO the airplane turned southerly towards KALAVRYTA mountainous terrain at 4500 ft. (fig.2)

At 17:26:27 h in daylight conditions, the airplane struck the terrain at an elevation of about 4965 ft, with 75 kt airspeed, 2000 ft rate of descent and 30° bank at the point with coordinates 38° 01' 46'' N, 22° 11' 52.4'' E. The terrain slope at the impact point was 40° and the airplane struck the ground with an angle of about 65°, while the angle between the airplane longitudinal axis and the horizontal level was 73°.

**Fig 2. Airplane's track and the point of impact**

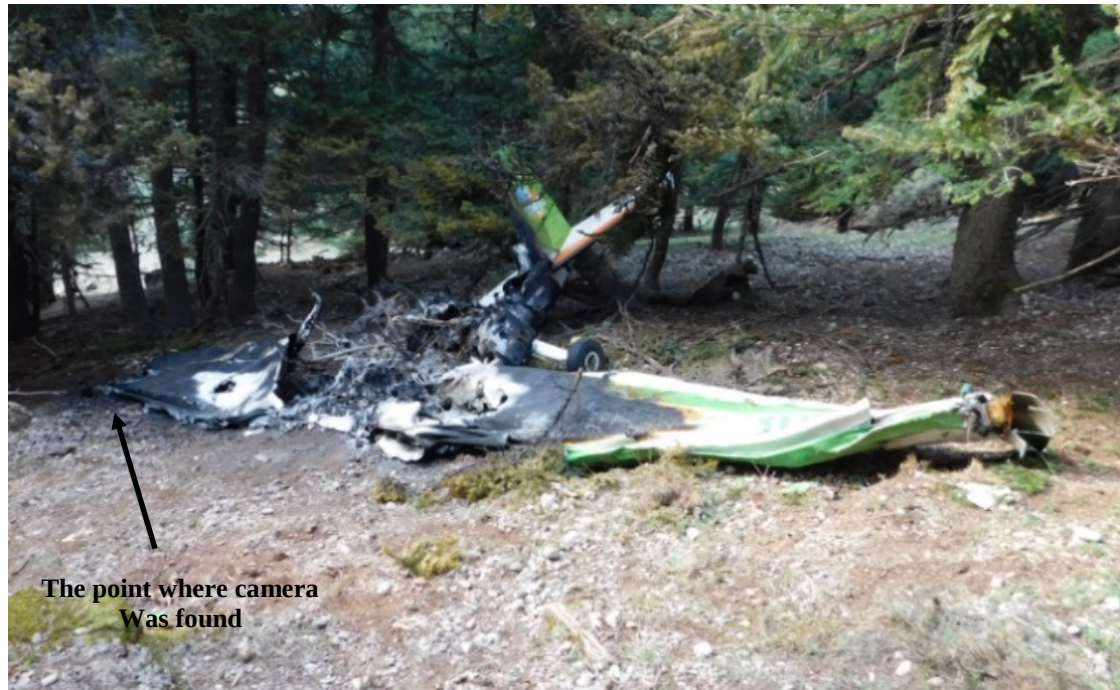
The flight track of the airplane after its departure from LGMG airport has been recorded from Air Force (primarily) and Athinai Area Control Center (AACC) Secondary Radar. Also a video camera was mounted inside the aircraft and in the top of the cockpit which recorded the aircraft's last 2 min and 27 sec. The above camera was found within the wreckage close to the starboard's wing leading edge. All damage to the camera protective cover and especially to the installation point is attributed to the postcrash fire while no damage was found to the camera's frame and memory chip.

**Fig 3. The point where camera was found**

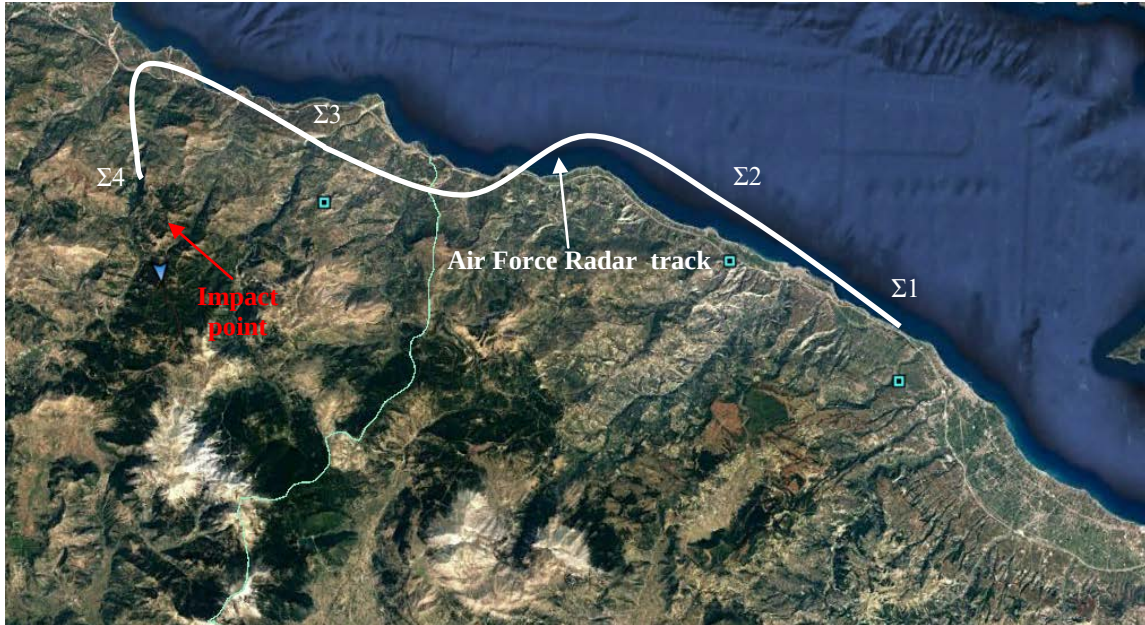
There are no data available for the point S4, apart from the time that the point S4 was recorded and it is the last recorded position of the airplane from this radar. Airplane's estimated track according to the above radar data is shown in Fig 3.

Fig 3. Airplane's possible track according to the above radar data

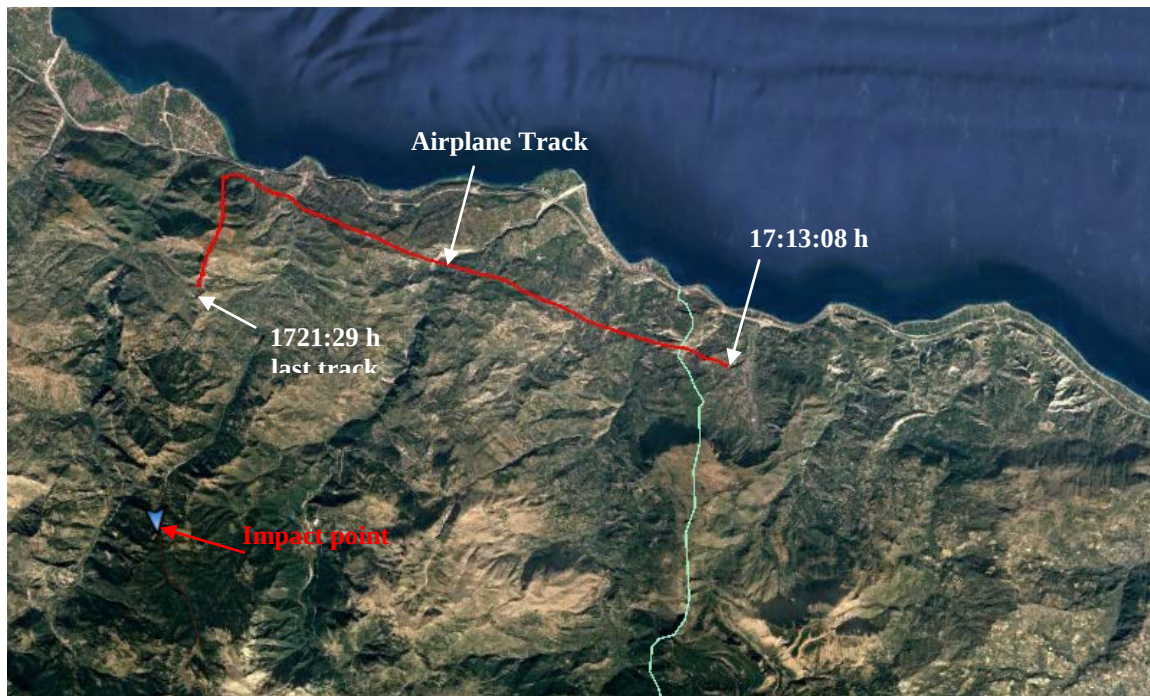
System PALAS data indicate the flight track of the airplane after its departure from LGMG airport, for its last 08:21 min, as fig 4 shows (from 17:13:08 h until 17:21:29 h where was the last recording)

Fig4. Airplane's possible track according to the above radar data

After 17:21:29 h we have not any further data from AACC Radar.

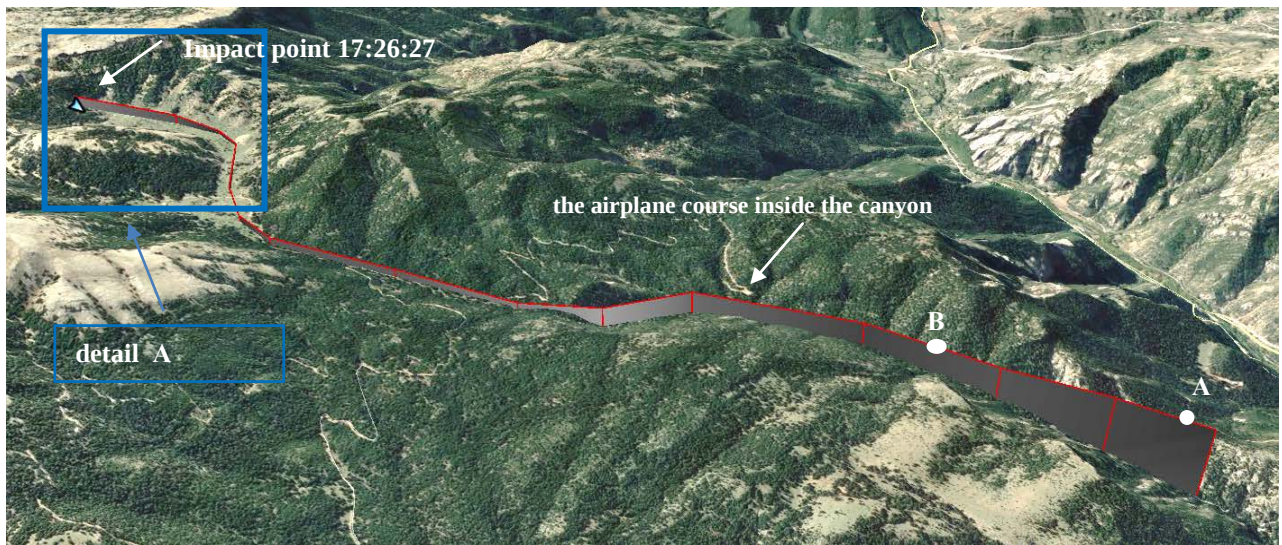
- At 17:24:00 h, point A: The instructor turned on the camera and began recording. 38° 04' 42.17'' N and 022° 11' 8.49'' E were the airplane's Coordinates at that point, at an altitude of 4540 ft and with an indicated airspeed of 90 kt.
- At 17:24:22 h, point B: The instructor turned on and started taking pictures with his cellphone while the trainee pilot had the control of the airplane. The airplane was at an altitude of 4550 ft with an indicated airspeed of 80 kt.

Fig. 3 the airplane course inside the canyon

- At 17:25:57 h, point C: the instructor shows the exit point from the valley to the trainee pilot.
- At 17:25:59 h, point D: the engine's rpm was increased; the rate of climb and the altitude started progressively increasing while the indicated airspeed was decreasing. The airplane performed a 30° bank left turn into the valley. The indicated airspeed had a fluctuation of 10 kt.
- At 17:26:19 h, point E: The vertical speed indicator reached a maximum indication of 1000 fpm with an indicated airspeed of 65 kt at an altitude of about 5120 ft.
- At 17:26:20 h, point Z: The airplane reached a maximum altitude of about 5150 ft with an indicated airspeed of 65 kt and 800fpm rate of climb. The turn and slip indicator showed up the maximum lean toward right. The airplane started left banking.

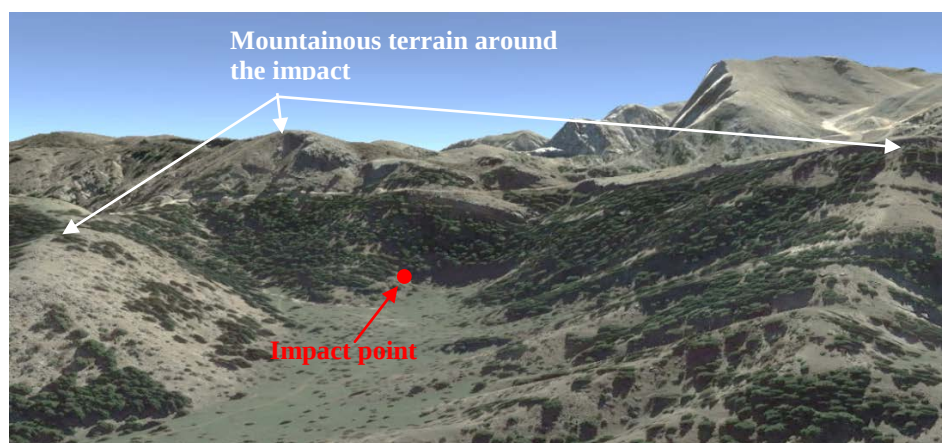
The airplane collided with Aroania (Helmos) mountain at an elevation of 4965 ft, with coordinates 38° 01' 46,0'' N and 022° 11' 52,4''E. At the impact point the terrain slope is 40 deg. The impact point was located approximately 2.38 km North of Kalavryta ski resort.

The airplane impacted a mountainous tree-covered terrain surrounded by mountaintops of 5276 ft westerly, 5663 ft northerly and 5511 ft easterly of impact point. (fig. 8)

**FIG 8 Airplane's accident area**

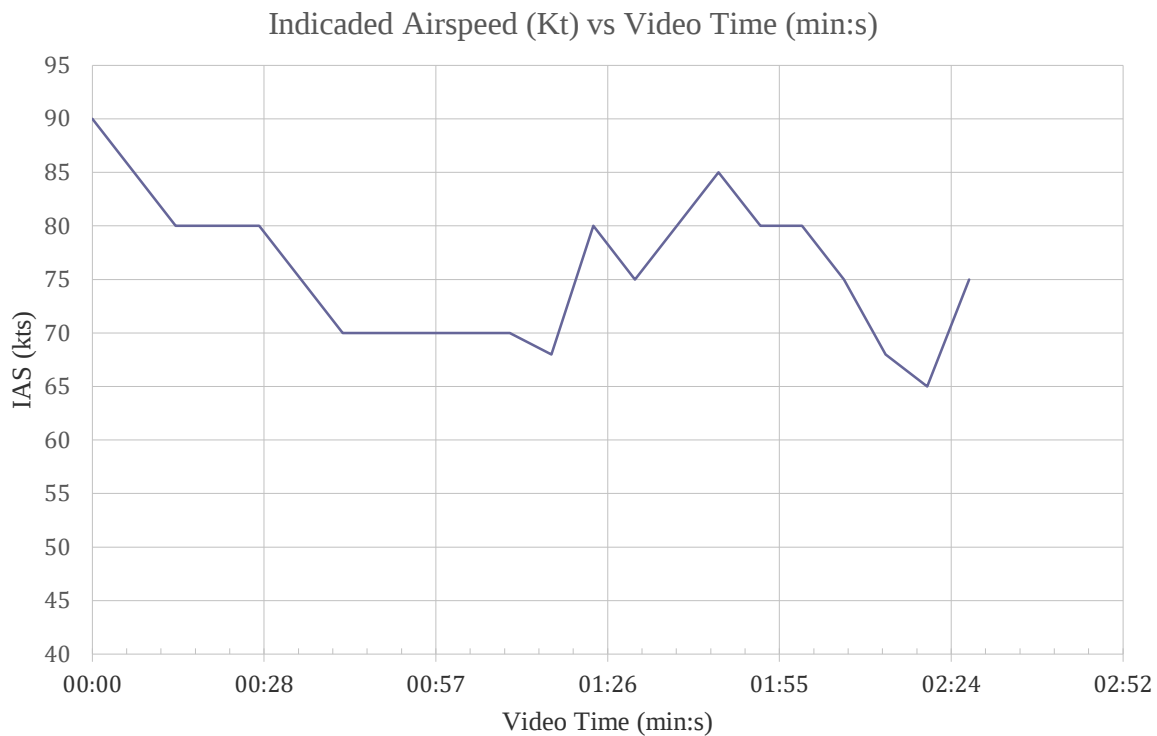
After the video examination where the aircraft's flight between the mountain terrains had been recorded, data of aircraft's flight had been recorded every 7 s and the following graphics had been arised.

**Fig. 1 Aircraft's airspeed variation in relation with video time.**

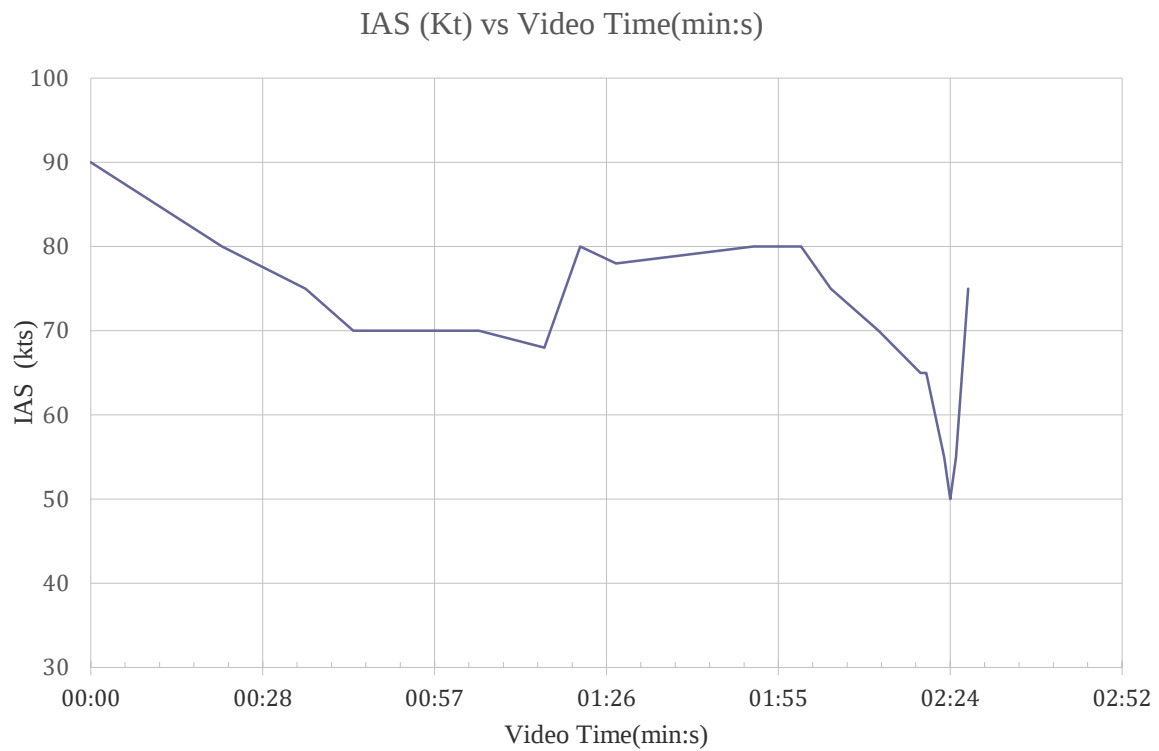
Additionally in Fig.2, the graph represents variations for the last seconds of the aircraft flight, of the indicated airspeed in relation with the video time, not every 7 s but at intervals were significant variations in the flight's condition took place.

**Fig. 2 Aircraft's airspeed variation in relation with video time**

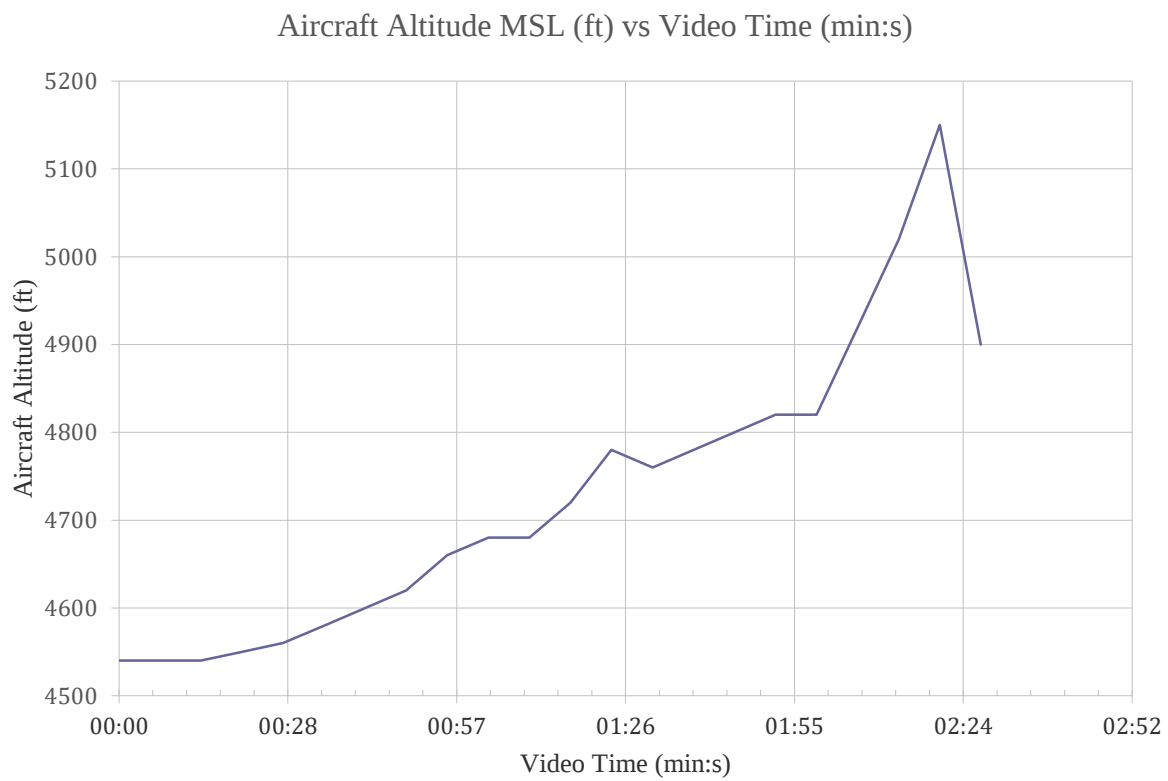
**Fig. 3 Aircraft Altitude Variation (MSL) vs Video Time.**

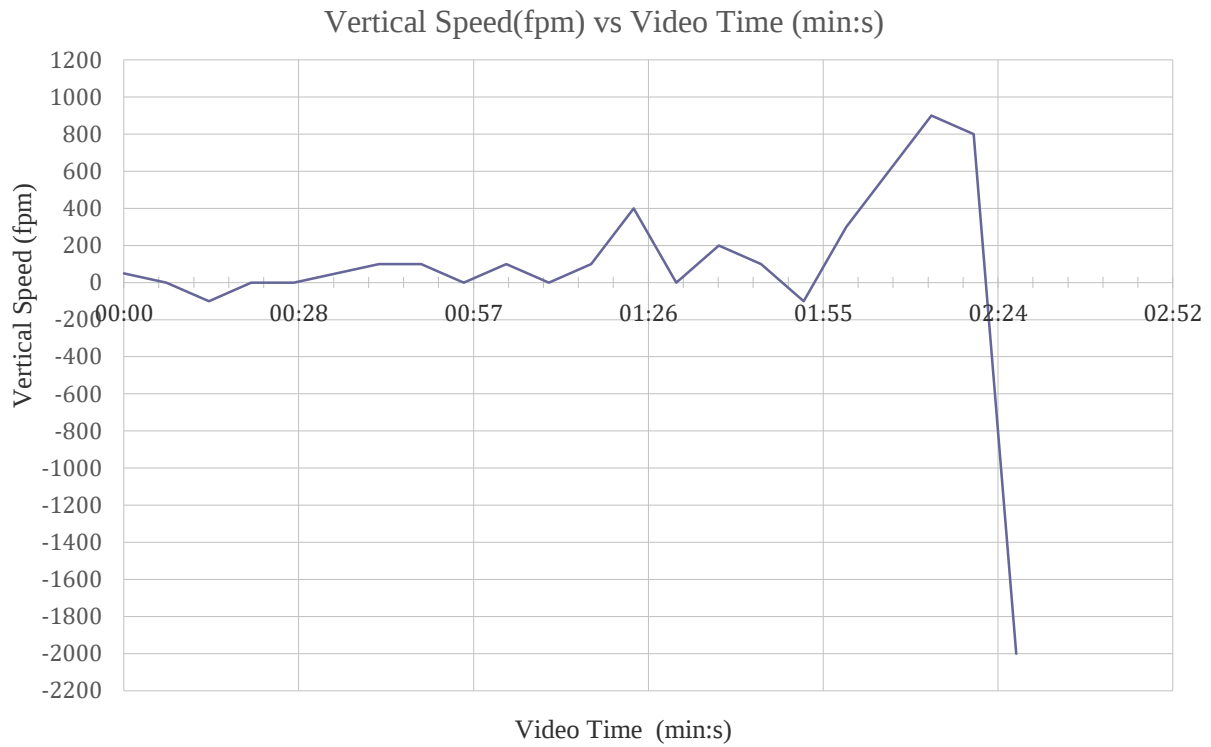
**Fig. 4: Vertical Speed Variation vs Video Time**

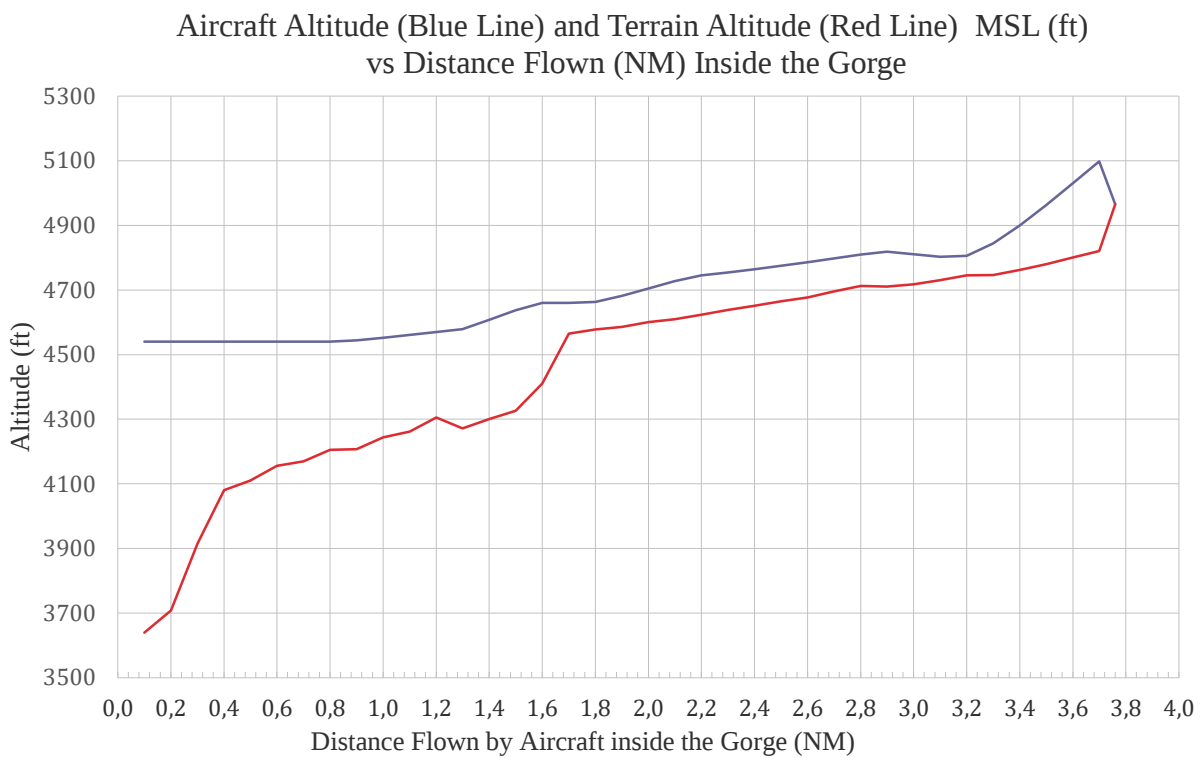
**Fig. 5: Altitude Variation of the Aircraft Altitude vs Distance Flown inside the Gorge. The Area Between the two Altitude Lines, Represents the Aircraft Altitude in Relation to the Ground (AGL)**

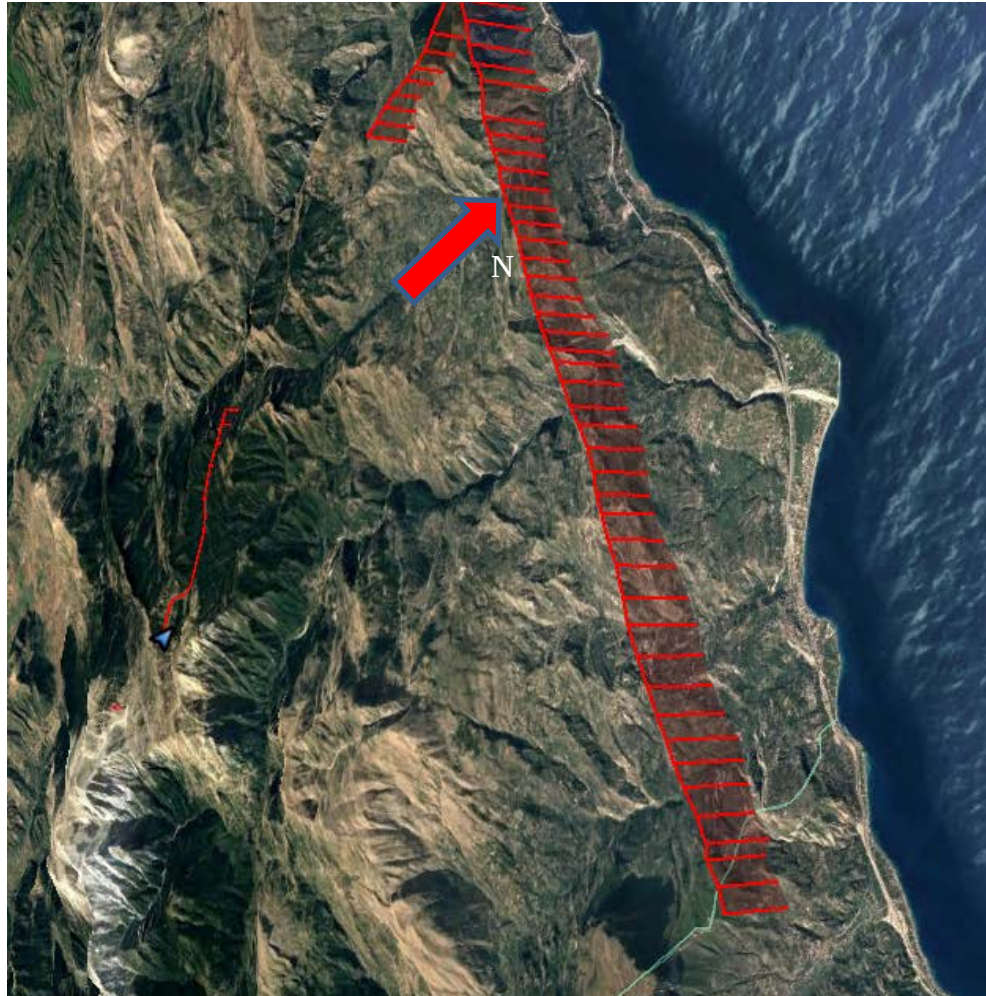
**Picture. 2: The Aircraft Flight Track Acc. to Data taken from AACC Radar and from the Onboard Video Camera**
