**AIR ACCIDENT INVESTIGATION AND  
AVIATION SAFETY BOARD  
(AAIASB)**

**ACCIDENT INVESTIGATION REPORT  
INVOLVING A PARAGLIDER  
AT THE AREA OF AGIOS SPYRIDONAS  
IN KOLIAKI, EPIDAUROS  
ON THE 23<sup>rd</sup> OF APRIL 2018**

**ACCIDENT INVESTIGATION REPORT**  
**03 / 2019**

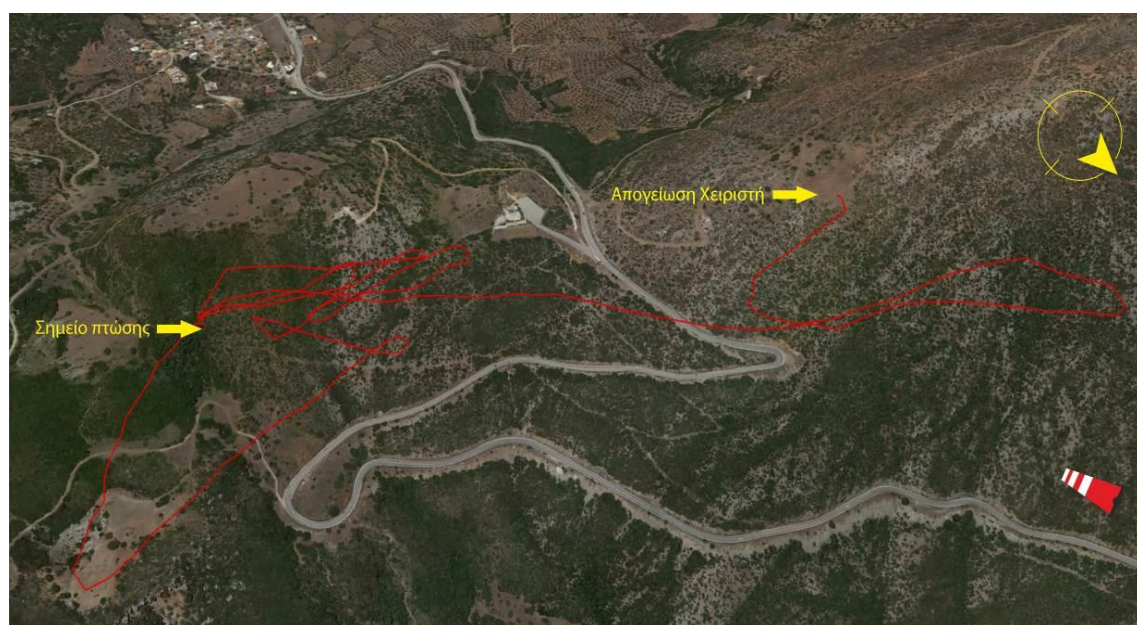
**Fig. 1:** The launching site, the flight track and the impact point

The duration of the flight of the said pilot was approximately 14 min and for its most part was confined to the east of the launching site and at a distance up to 1,000 m therefrom. The accident occurred at around 17:49 h and the impact point, located to the south-east of the launching site, is in a rough, rocky and bushy area about 88 m away from the nearest dirt road. The impact site coordinates are 37°35'57.3'N., 023°09'49.2'E and its elevation is approx. 387 m A.M.S.L. (see **Fig. 1** & **Fig. 14**). It is also pointed out that the pilot did not deploy his emergency parachute.

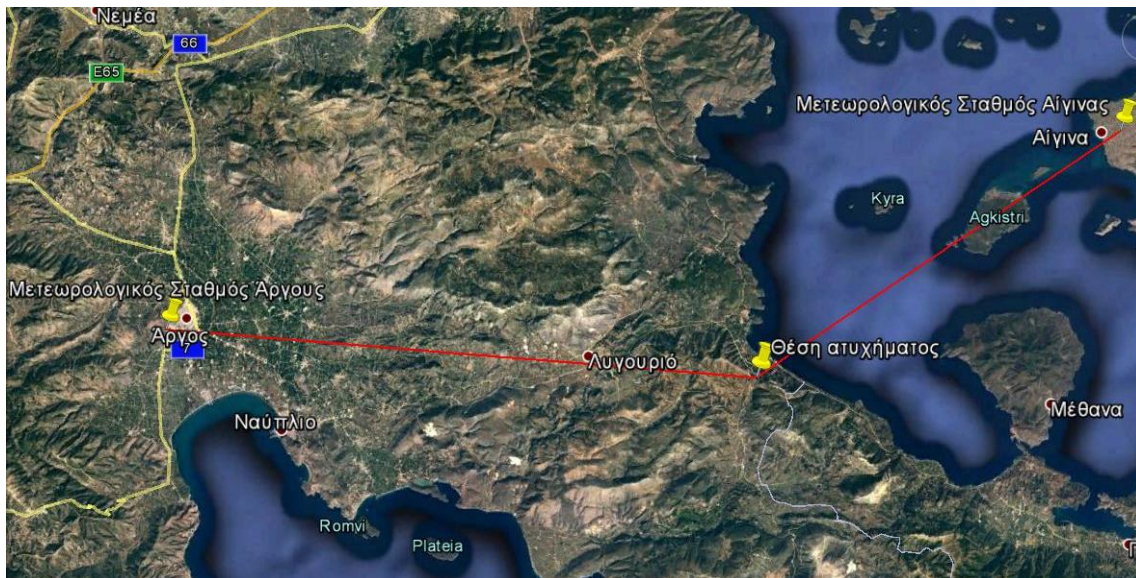
**Fig. 5:** The location of the weather stations on either side of the accident site

The weather stations of Aegina and Argos, within the Network of Weather Stations operated by the National Observatory of Athens, are those located closest on either side of the accident site. The former is approximately 30 km N/NE and the latter approximately 40 km NW from the site of the accident, at an elevation of 7 m and 38 m A.M.S.L. respectively (see **Fig. 5**).

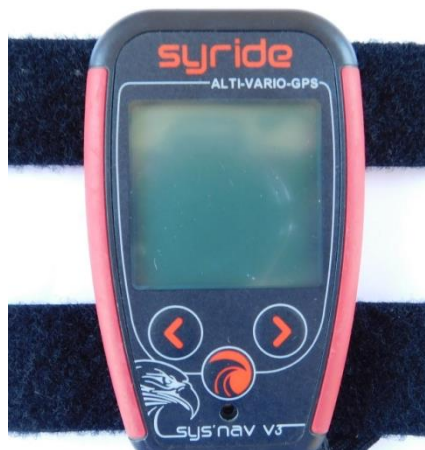
**Fig. 6:** The pilot's variometer

The equipment handed over to the Investigation Team included an altimeter-GPS unit manufactured by Syride, model SYS'Nav v3 variometer, with an integrated g-force meter (see **Fig. 6**). This unit provides worldwide airspace data, worldwide topographical data on ground elevation above mean sea level (A.M.S.L.) and thus supports worldwide Above Ground Level (A.G.L.) function which means that the pilot's altitude above the ground can be obtained at all times. Naturally, above ground level is given with a  $\pm 20\text{m}$  accuracy, to which the GPS accuracy is added, i.e. a few additional meters (m) of error. Moreover, the unit supports navigation features and its memory is 1500 flight hours at a rate of 1 point per second.

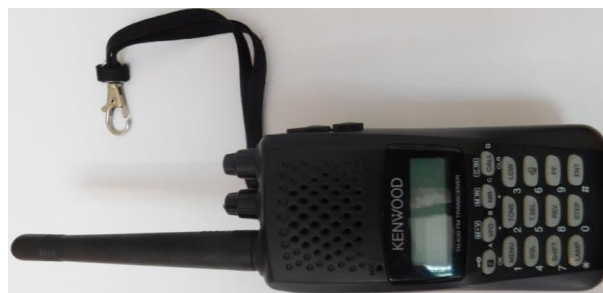
**Fig. 7:** The pilot's communication unit

The pilot carried a V.H.F. transceiver manufactured by KENWOOD, model TH-K20 FM TRANSCEIVER (see **Fig. 7**).

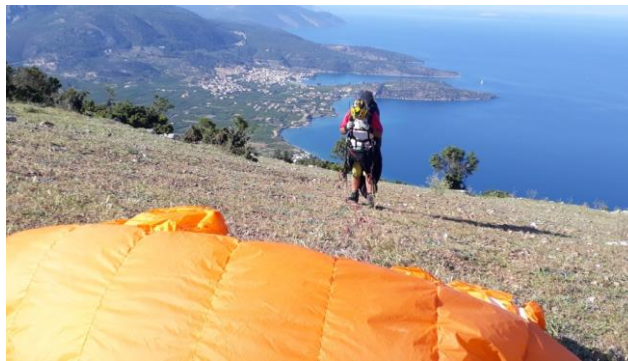
**Fig. 8:** The takeoff site

The takeoff site was in the area of Koliaki, local community of Trachia, municipal unit of Epidaurus, Municipality of Epidaurus; its coordinates are  $37^{\circ}36'12.23''\text{N}$  and  $23^{\circ}9'15.63''\text{E}$  and its elevation approximately 470 m A.M.S.L. (see **Fig. 1** & **Fig. 8**). The site is approximately 3.8 km from Palea Epidaurus and approximately 2.0 km from the selected landing site. This particular site had been chosen for paraglider launches both for its size, being larger than  $950\text{ m}^2$ , and its good sloping ground, making it safe for takeoffs; and its length enabled a timely and safe abortion of the takeoff process in the event of any problem arising.

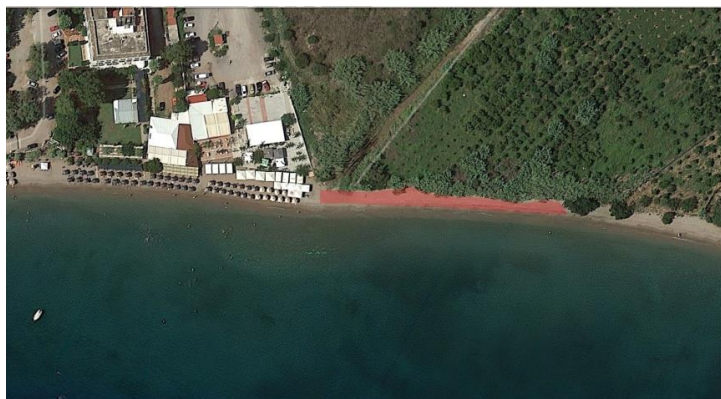
**Fig. 9:** The landing site marked in red

The landing site coordinates are  $37^{\circ}37'16.78''\text{N}$  and  $23^{\circ}9'22.75''\text{E}$  (see **Fig. 1** & **Fig. 9**). It was practically a narrow strip of land naturally formed by the beach, approximately 100 m long and 3m to 5 m wide. In contrast to the spacious takeoff site, the narrow landing site combined with the NE crosswind common in the area required of pilots to exercise caution in the approach and show a high skills level for a smooth landing.

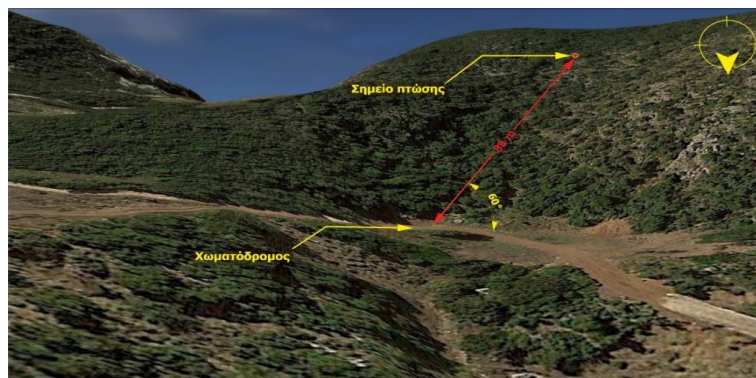
**Fig. 10:** Distance of the fall site from the nearest dirt road

A factor that hindered rescue operations on the part of the parties involved and the emergency services was the steep (ground inclination  $60^{\circ}$ ) and rough terrain (rocky with dense bush coverage). The said features made the impact site hard to approach, even though the nearest dirt road at the toe of the hill was only 88 m away (see **Fig. 10**). Furthermore, the area where the accident occurred was far away from the base of the respective departments that were called to assist the operations.

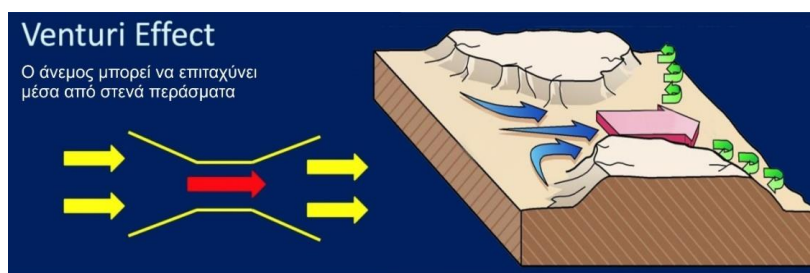
**Fig. 12:** Venturi effect in gliding

In gliding, the Venturi effect is observed when wind flowing above a landscape meets a constriction to its flow, for example a pass between two mountains, and all this airmass is forced through the constriction. This results in an increase of wind velocity and decrease in wind pressure as the pressure-related dynamic energy is converted into kinetic energy (see **Fig. 12**). As air flows through the narrowing at an increased speed, low pressure is a force that causes the surrounding air to be sucked in as well. This concentration of flow through the narrowing can adversely affect a F.F.A.'s speed forward. Moreover, the increased air speed through the narrowing may be greater than the maximum speed of the F.F.A., stopping in practice its horizontal forward movement in relation to the ground. One other element is that air speed value in the narrowing depends on the latter's width but also on air's initial speed.

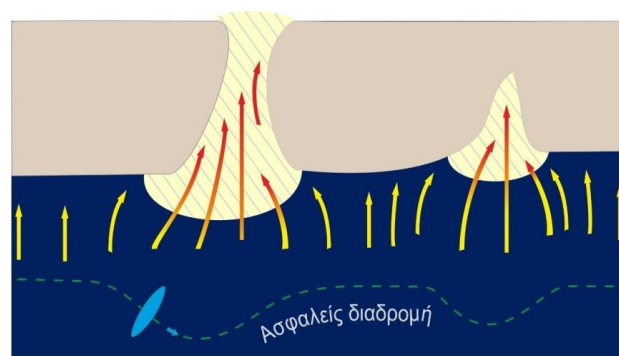
**Fig. 13:** Safe flight path to avoid the Venturi effect

When conditions favor this phenomenon, F.F.A.'s pilots must modify their trajectory to avoid the respective areas (see **Fig. 13**). However, if they do find themselves in such circumstances the problem they will have to tackle is the decrease or loss of the F.F.A.'s forward speed in relation to the ground and not problems having to do with F.F.A.'s stability.
