**AIR ACCIDENT INVESTIGATION  
AND AVIATION SAFETY BOARD  
(AAIASB)**

**ACCIDENT INVESTIGATION REPORT  
HELICOPTER SX-HTO  
AT THE SEA AREA BETWEEN POROS ISLAND - GALATA  
ON AUGUST 20, 2019**

**Accident Investigation Report**  
**04 / 2022**

**Accident of Helicopter Agusta A109C with registration SX-HTO**  
**at the sea area between Poros Island – Galata**  
**on August 20, 2019**

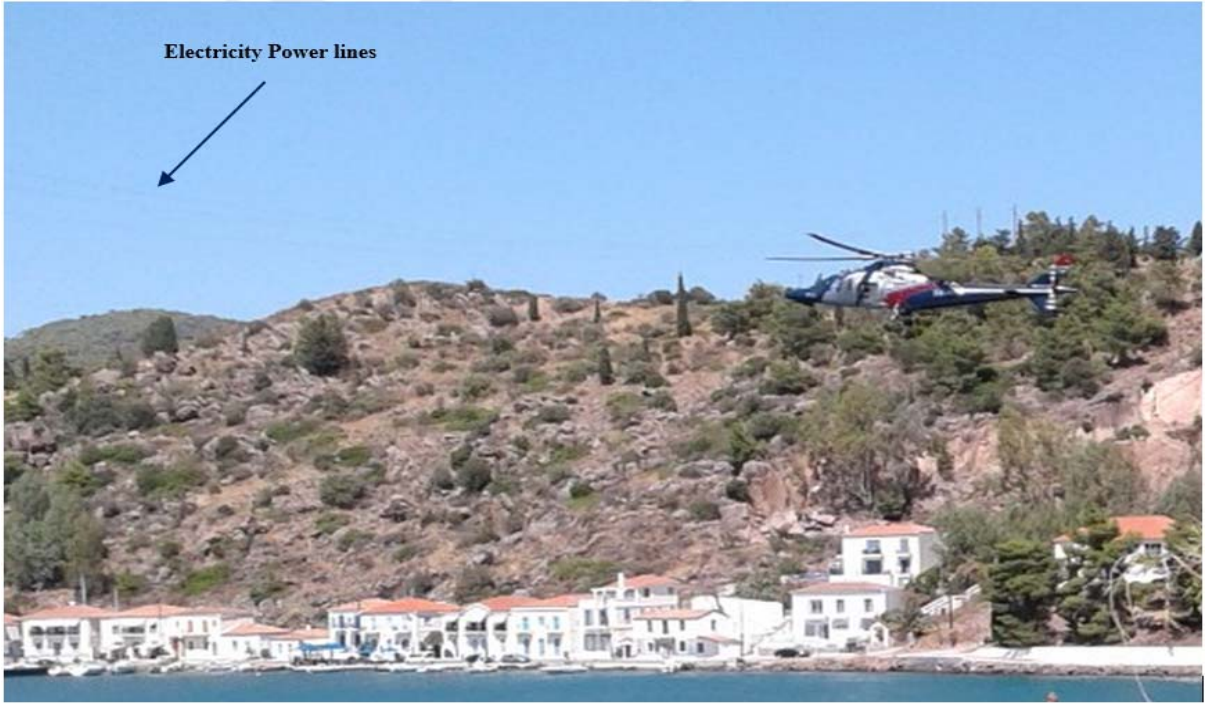
**Photo 1: The flight of the Helicopter under the Power Cables during its approach to Galata LF.**

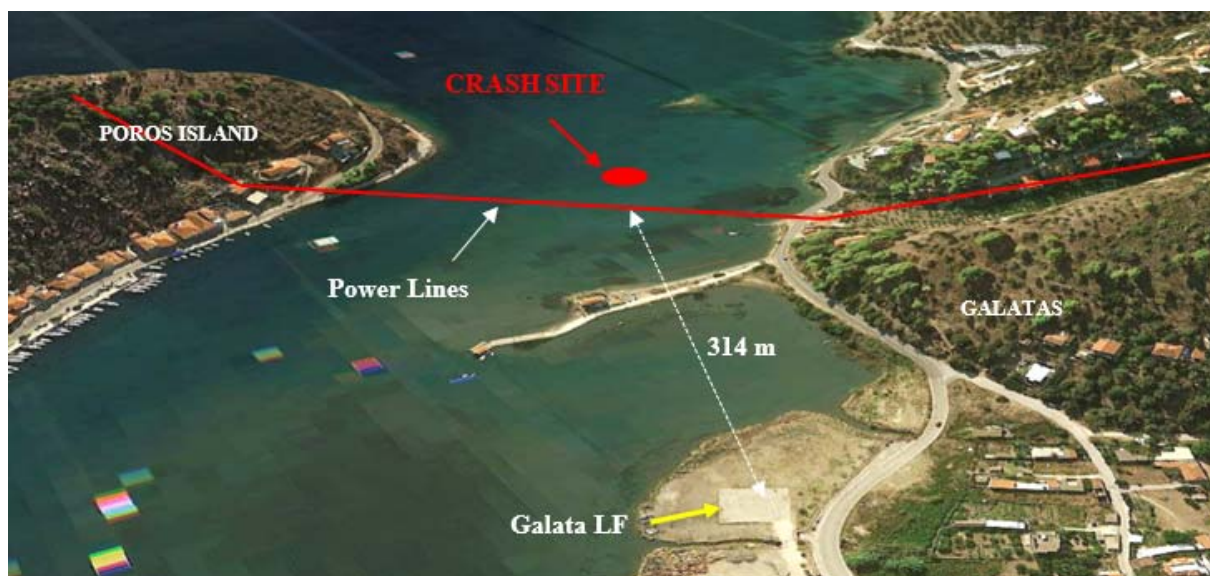
The Crash site is in the sea Channel between Galata and Poros island. At the Crash site the sea depth is 4,5 m and the sea Channel is 246 m wide.

Above the sea Channel, there are three medium voltage (20 kV) Power Cables crossing horizontally over it, suspended to the air between poles placed at a height of 73 m in Galata and at a height of 64 m in Poros. The LF from where the Helicopter took-off, is approximately 314 m from the point of impact on the three Power Cables.

**Fig 2: The Crash site in the sea Channel between Poros Island and Galatas.**

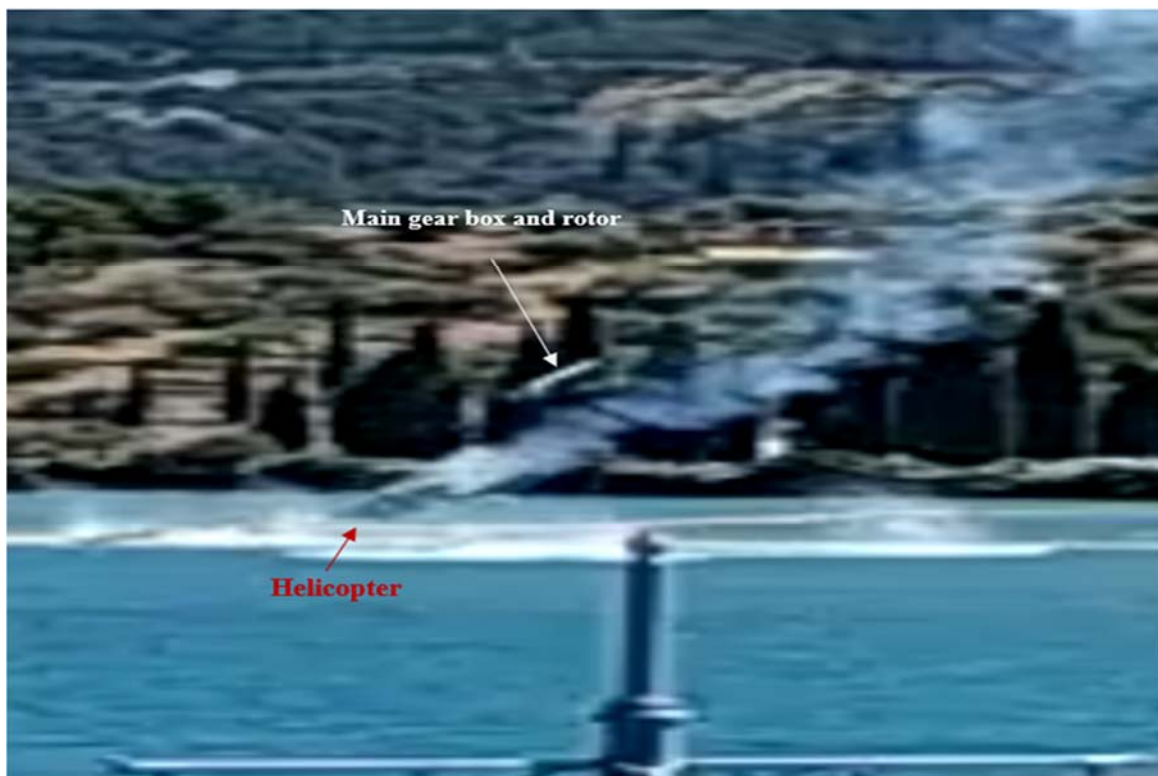
After the collision with the third Power Cable, instantaneous ignition appeared in the area of the main Gear Box and the Main Rotor was detached from the Helicopter while the Tail part was detached and was found at a distance of 35 m from the fuselage. The Helicopter crashed into the sea Channel with a negative pitch while the Main Rotor and Gear Box ended up a short distance from main Helicopter fuselage (Photos 2, 3, 4).

**Photo 2: The Helicopter, main Gear Box and Rotor during their fall into the sea channel.**

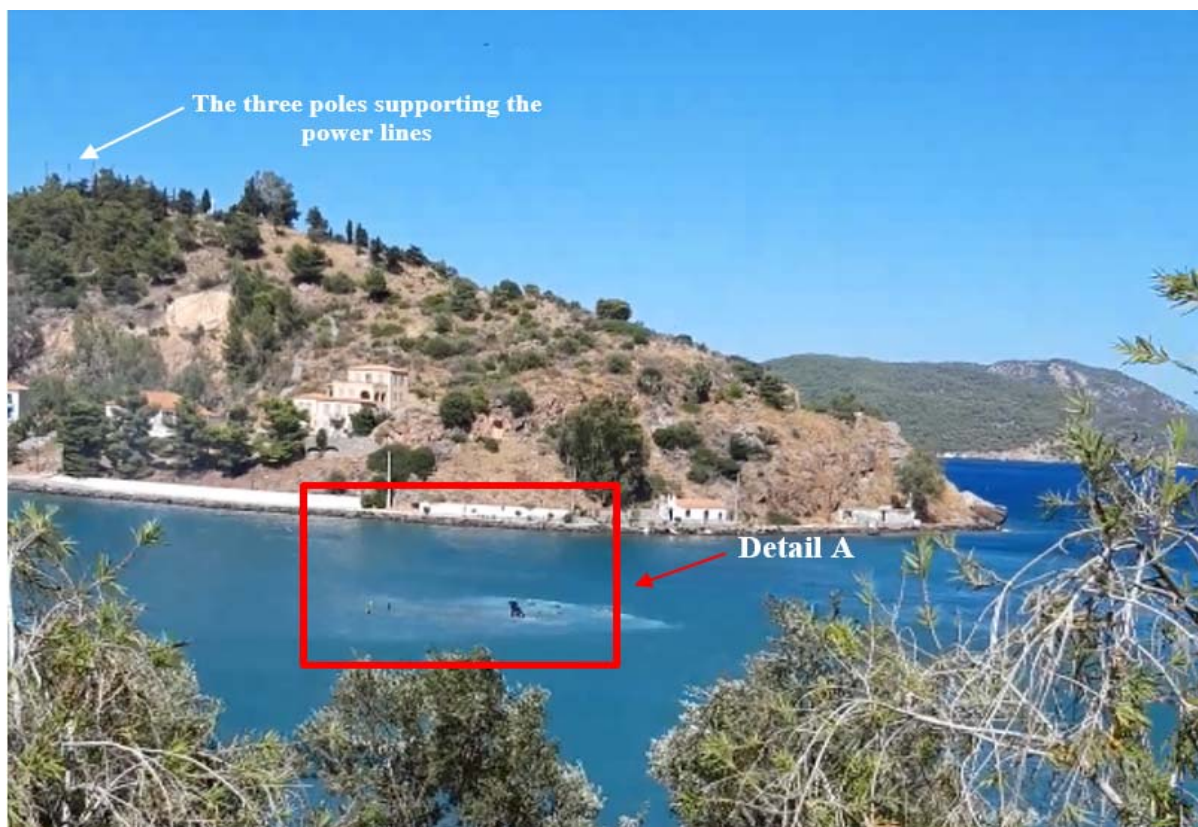
**Photo 3: The Helicopter after its impact with the sea before it is submerged.**  
**The three poles of the Power Cables on the side of Poros can be seen.**

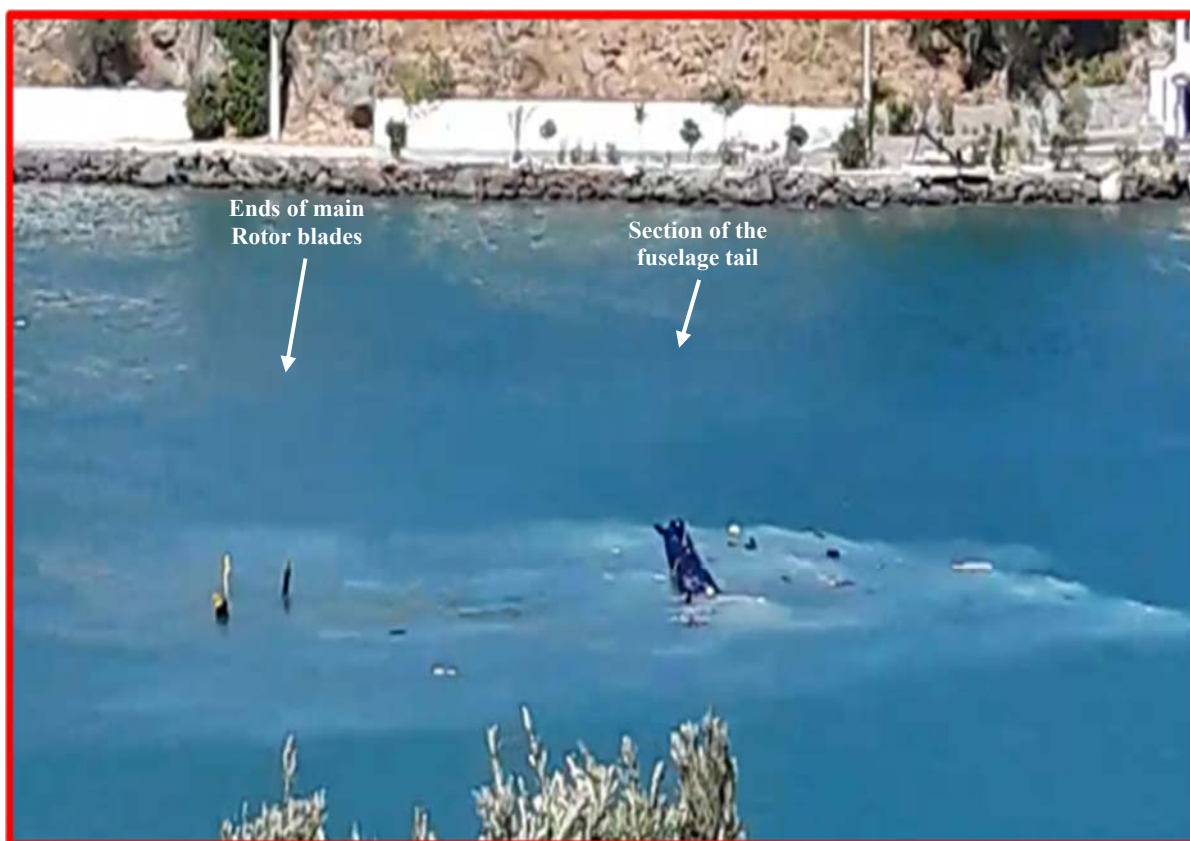
**Photo 4: Detail A. The ends of the blades of the Main Rotor as well as the rear of the fuselage.**

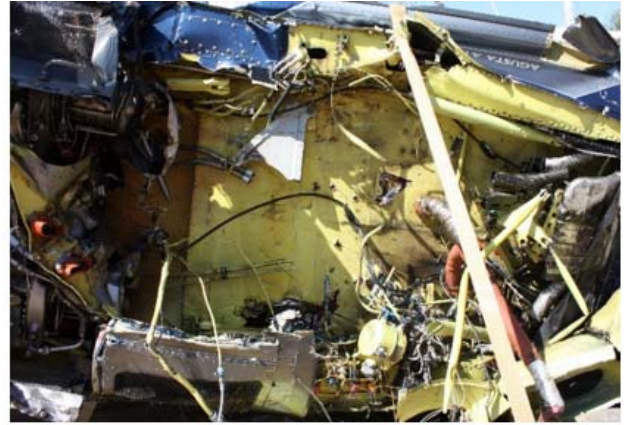
**Photo 7: Gear box section**

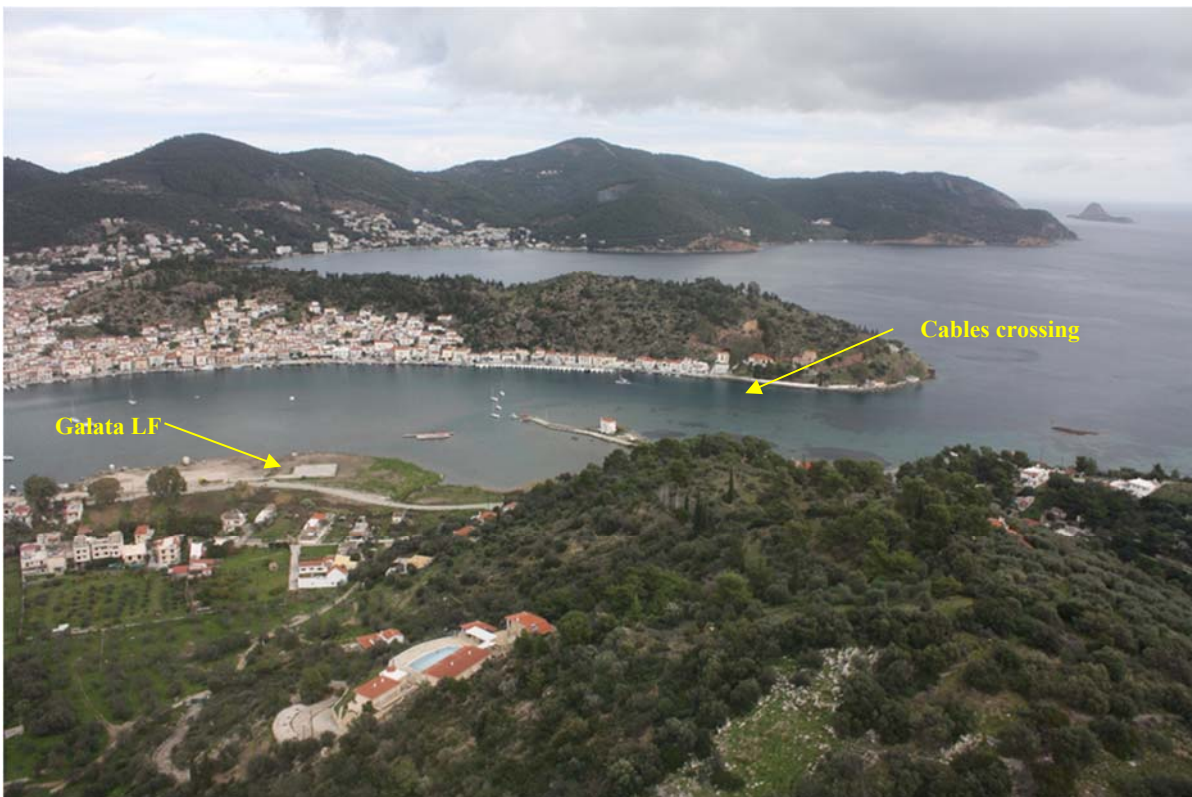
**Photo 19: The Helicopter during the simulation flight following the estimated course of the accident Helicopter. In this photo, the Power Cables are not visible.**

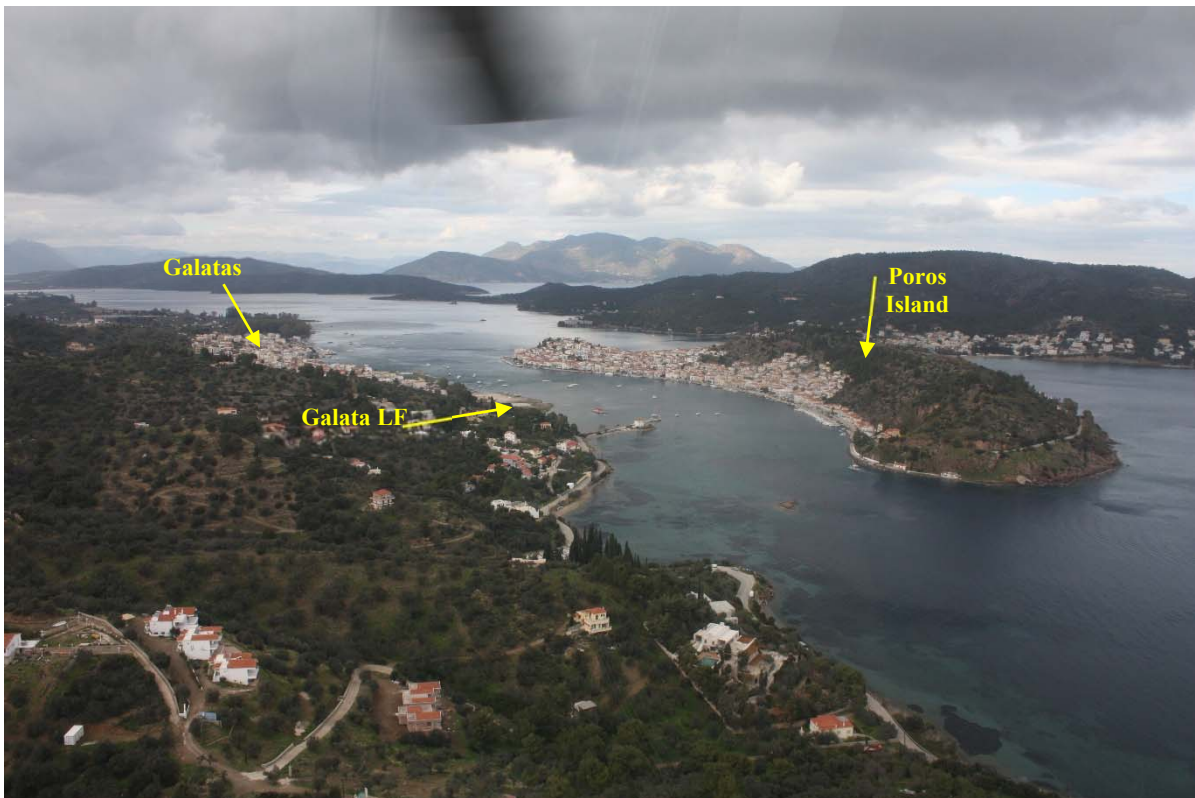
As recorded in the simulation flight (App. 5.2, Photo 20), from point B where the Captain started the landing procedure, except for the existence of Power Cables that were not visible, the approach from east – southeast to the LF seemed free of obstacles.

**Photo 20: The Helicopter during the simulation flight near the point of the accident Helicopter at 14:50:30.**

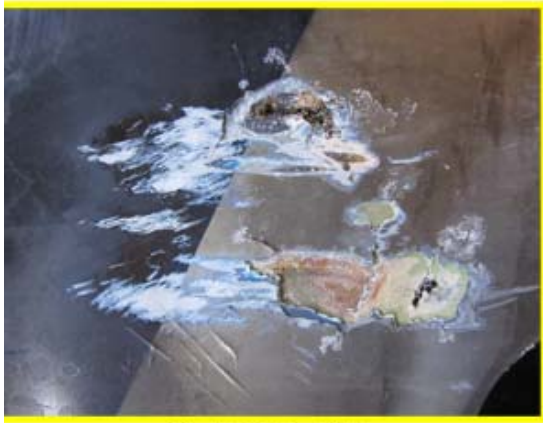
**Phot. 24: Detail A**

Photo 23: The points of contact and fracture of the outer oil coolers cover.

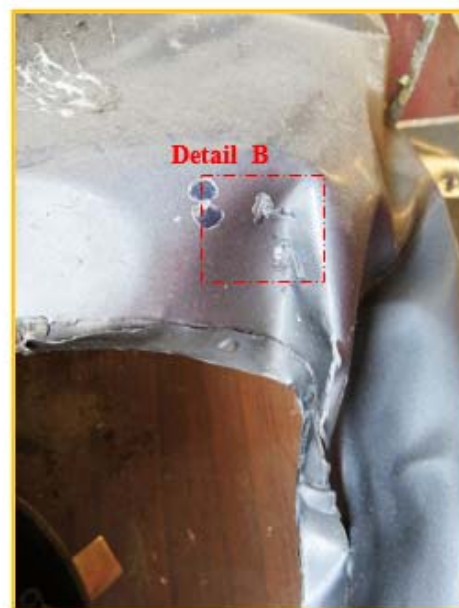
**Phot. 27: Detail A.**

- The forward Fuselage Section was deformed upwards, consistent with the impact angle at sea (Photo 6).
- Traces of contact with the Power Cables were observed on the metal cover of the Right Engine, while at the point where the metal cover surrounds the exhaust of the Right Engine, traces of an electric arcing were observed from the contact of the metal cover with the Power Cables (App. 5.3, Photos 26, 27, 28).

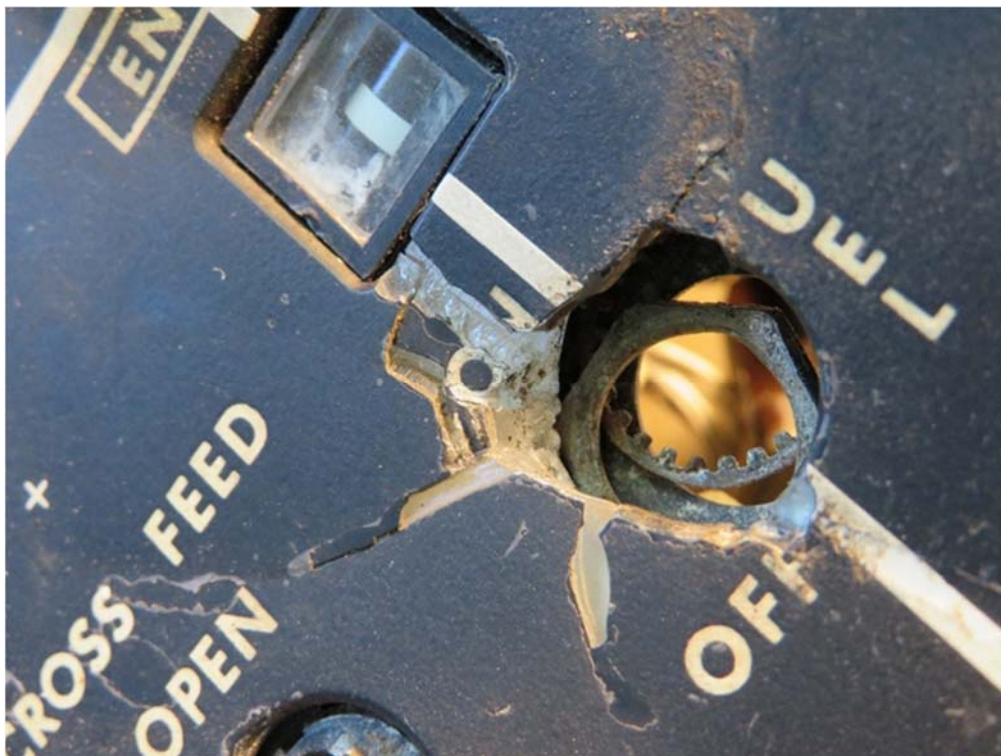
- The right Engine Fuel Shut off Valve Switch was found inside the Switch Socket. From the position indicator of the valve, which was in the open position, to the Socket of the Switch and to the left of the Socket, abrasions and cracks were created on the control surface (Photo 5 and App. 5.6, Photos: 34, 35).
- On the right side of the above control panel, a deformation had been created upwards, while its structural frame had been distorted to the left (App. 5.6, Photo. 36).
- The rear of the mounting thread of the right Engine Fuel Shut off Valve on the control panel, was damaged (App. 5.6, Photos 37 and 38).
- The Collective Control Lever had a perforation measuring 3.0 x 3.5 cm at its bottom (App. 5.6, Photo 40).

Photo 35: The control panel after removing the switch.

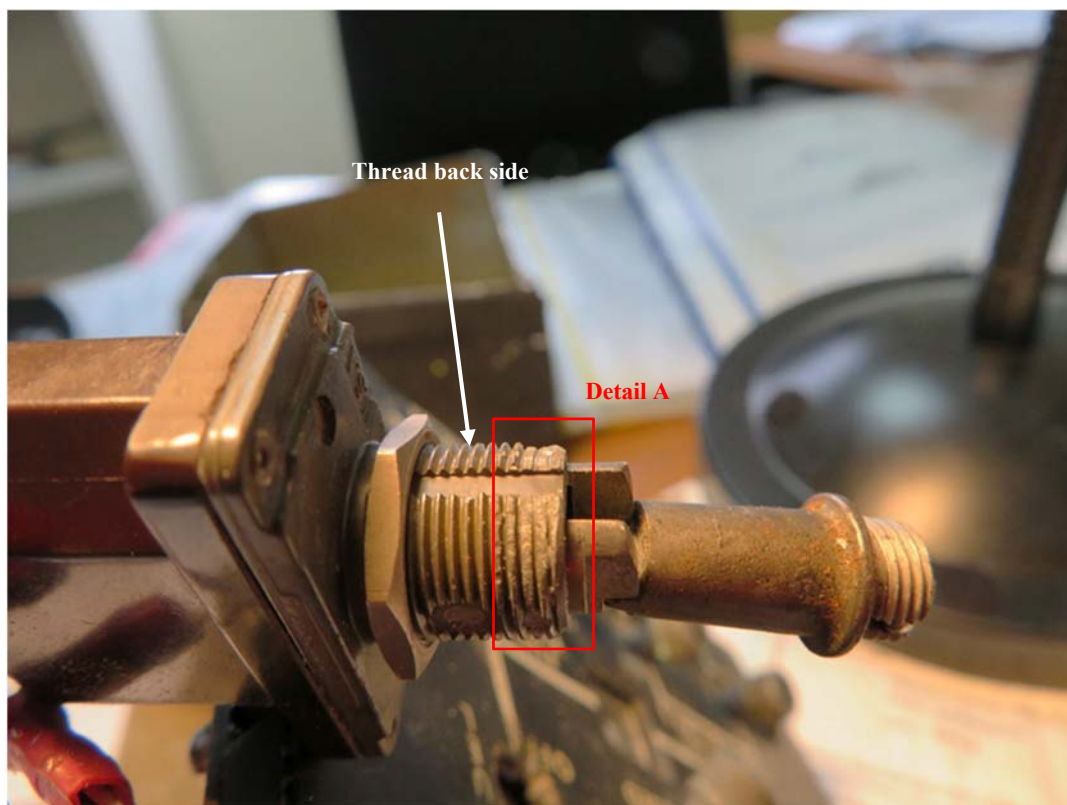
**Photo 37: The thread on the rear section of the right engine fuel shut off valve switch.**

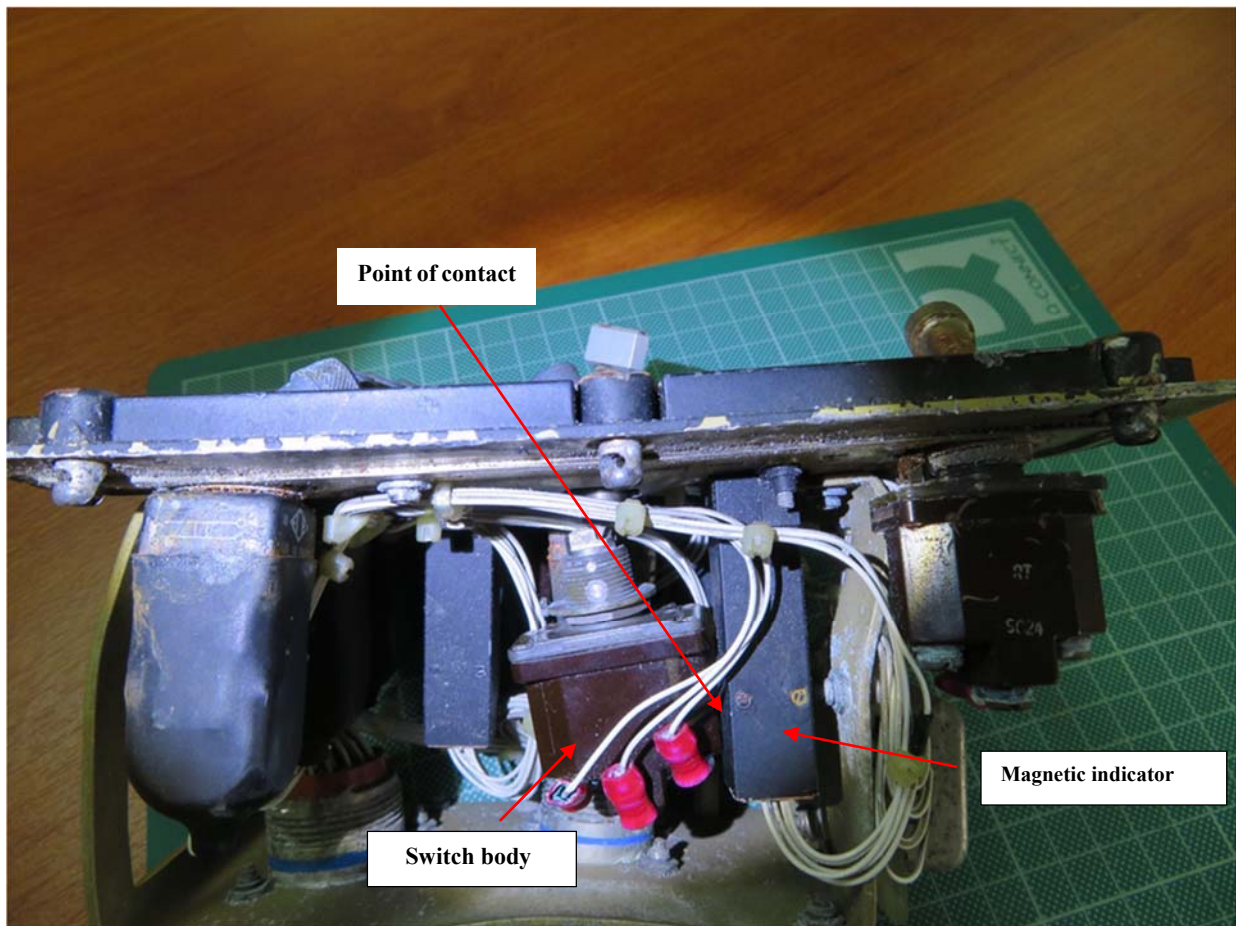
**Photo 39: The body of the right fuel shut off valve control switch and its contact with the body of the valve's position magnetic indicator.**

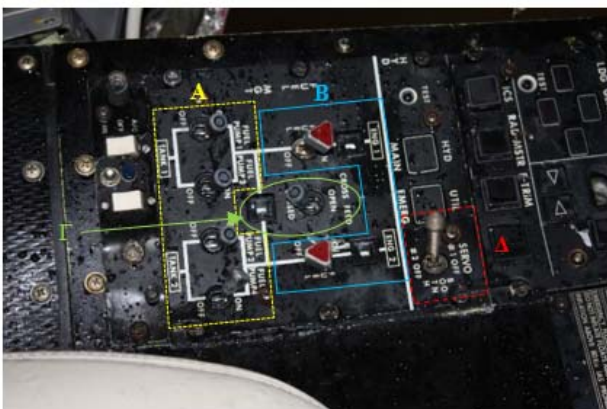
- The landing gear lever was in the down position.
- The four fuel pumps switches were in the "open" position, while the No. 4 fuel pump switch was distorted to the left (Photo 48).

- The left engine's fuel shut off valve switch was in the 'open' position as well as its position indicator. (Photo 48 B).
- The cross-feed valve switch was in the off "closed" position as well as its position indicator (Photo 48 C).

- The actuation switch of the hydraulic systems 1 and 2 was in "Both On" position, Photo 48 D and was distorted to the left.
- The switches of the two shut-off valves for the flow of air from the Engine Shutoff valve to the cabin heating system were in the 'open' position, while the mixing valve switch was in the 'closed'" position.

Photo 48: Cockpit view showing the positions of the fuel system switches and the hydraulic systems.

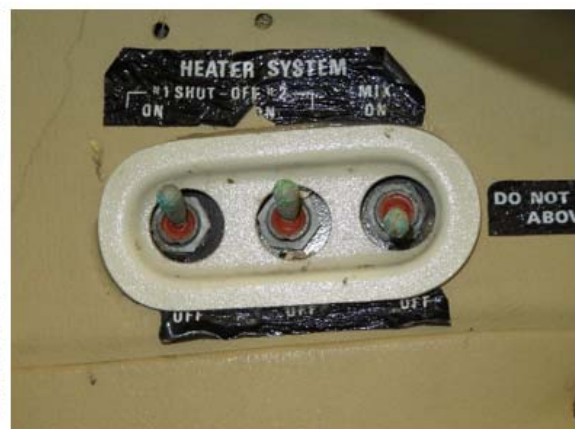
Photo 49: The cabin heating system switches.
