**ACCIDENT INVESTIGATION REPORT  
AIRCRAFT FLIGHT DESIGN CTSL SUPRA LIGHT  
REGISTRATION UR-STAS  
AT KERASIA AREA OF RODOPI  
ON SEPTEMBER 22, 2017**

**ACCIDENT INVESTIGATION REPORT**  
**06 / 2022**

**Aircraft Flight Design CTSL Supra Light**  
**Registration UR-STAS**  
**At Kerasia area of Rodopi**  
**On September 22, 2017**

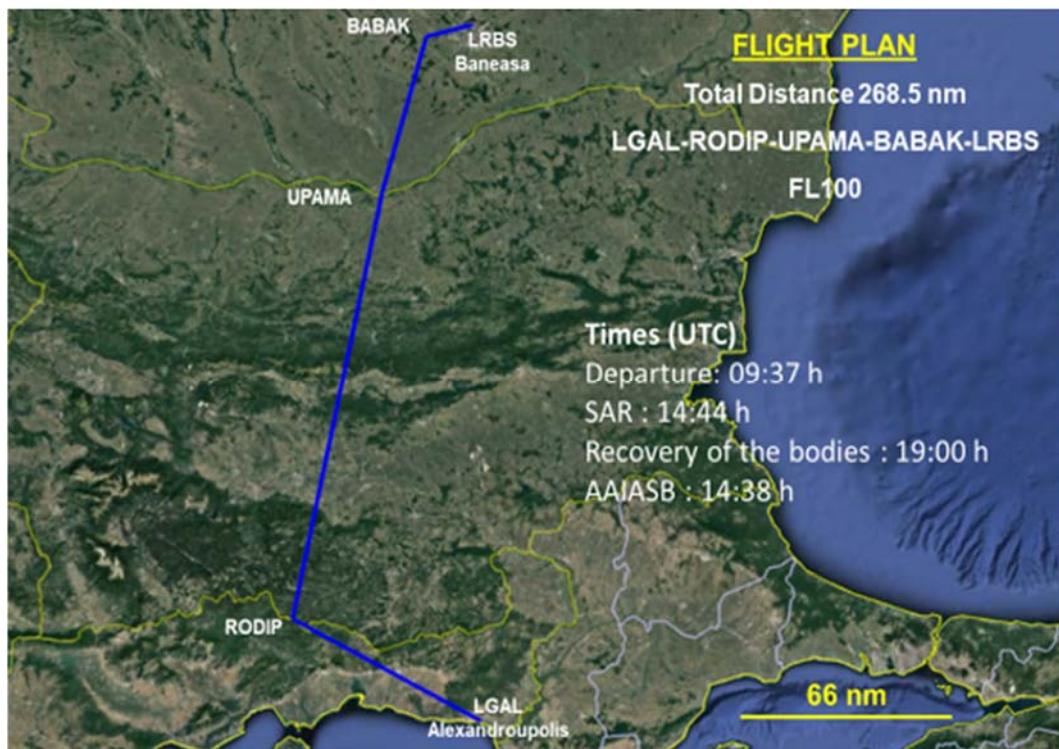
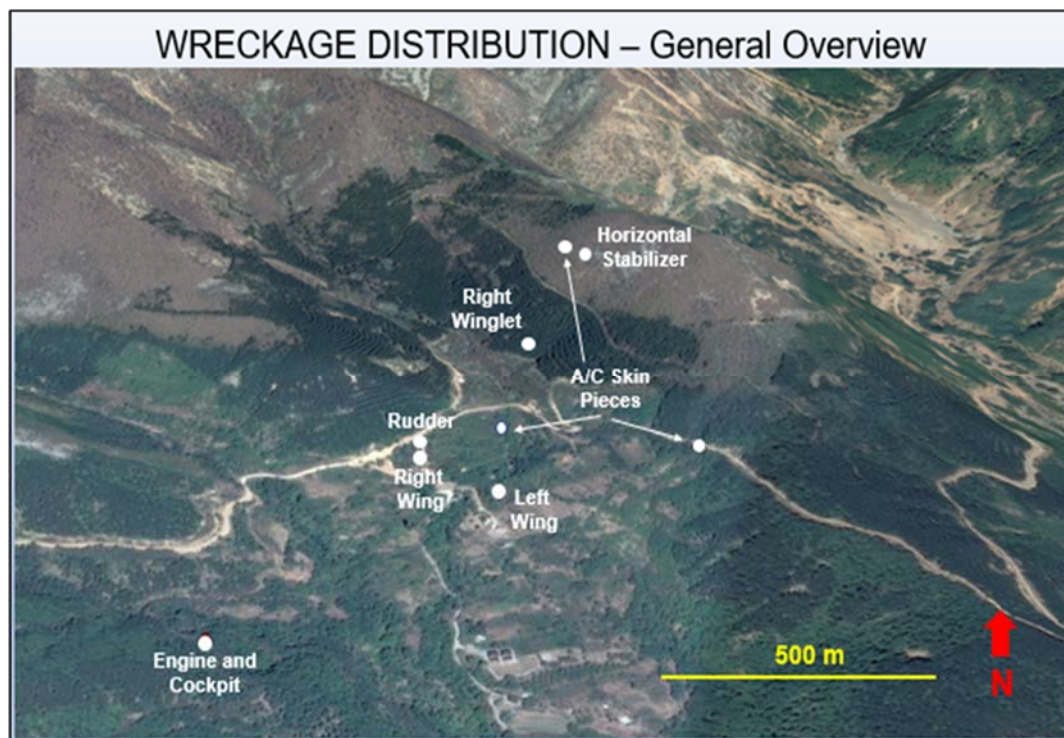
#### **INFORMATION OF ACCIDENT SITE**

- 6.5 nm Northwest from the city of Komotini
- Mountainous Area about 1900 ft height

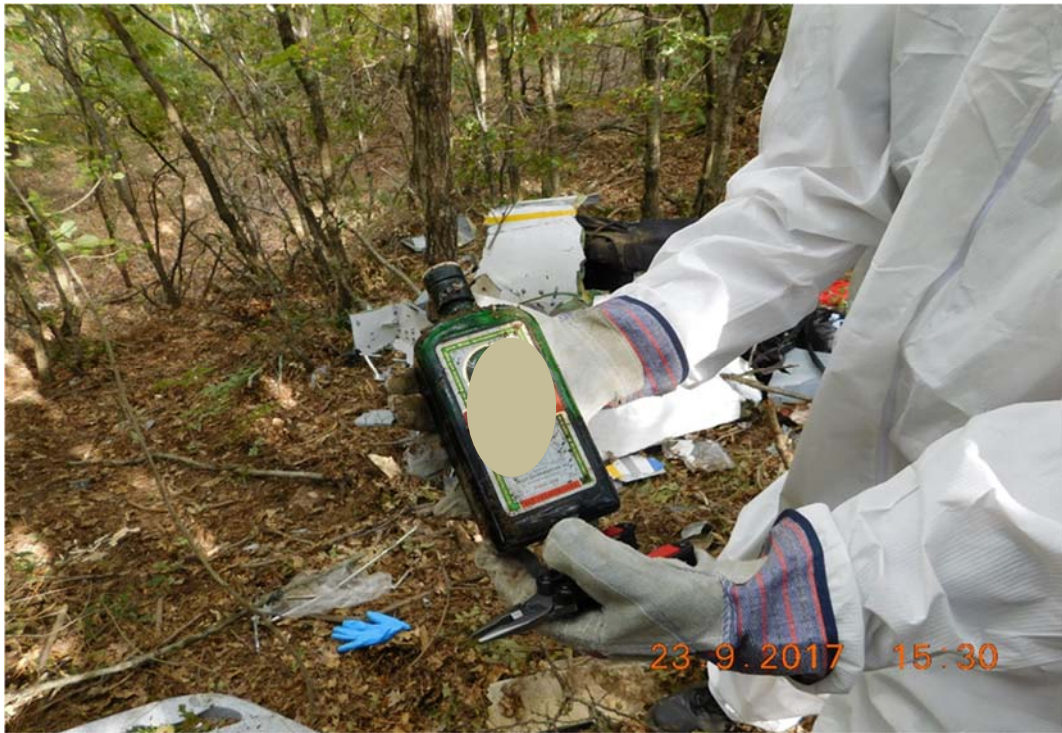
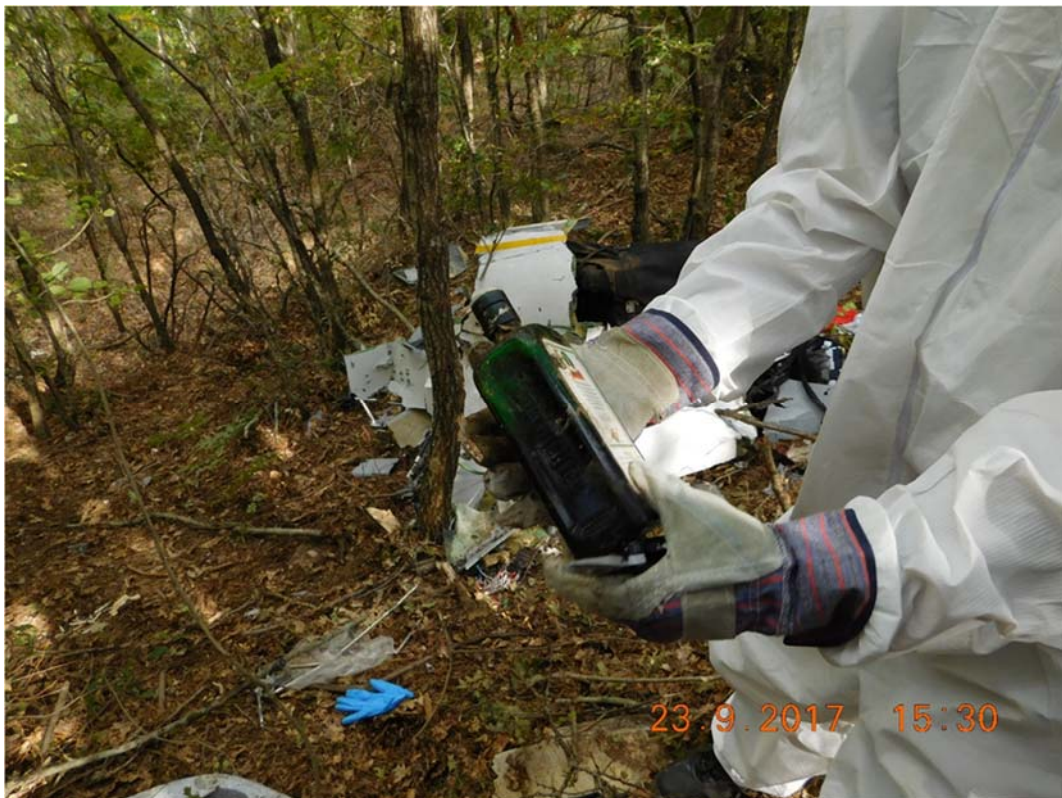
## Blood Test Results

- Date of blood sampling : 24/09/2017
- Examination Method : Gas Chromatography (GC-MS)
- Results: Alcohol 2.24 g/l or 2.24 ‰
