**AIR ACCIDENT INVESTIGATION AND  
AVIATION SAFETY BOARD  
(AAIASB)**

**ACCIDENT INVESTIGATION REPORT  
ULTRA-LIGHT AIRCRAFT P2008 JC SX-IRN  
AT PROTI SERRON ON AUGUST 03, 2020**

**Ultra-Light Aircraft P2008 JC SX-IRN**

**At Proti Serron on August 03, 2020**

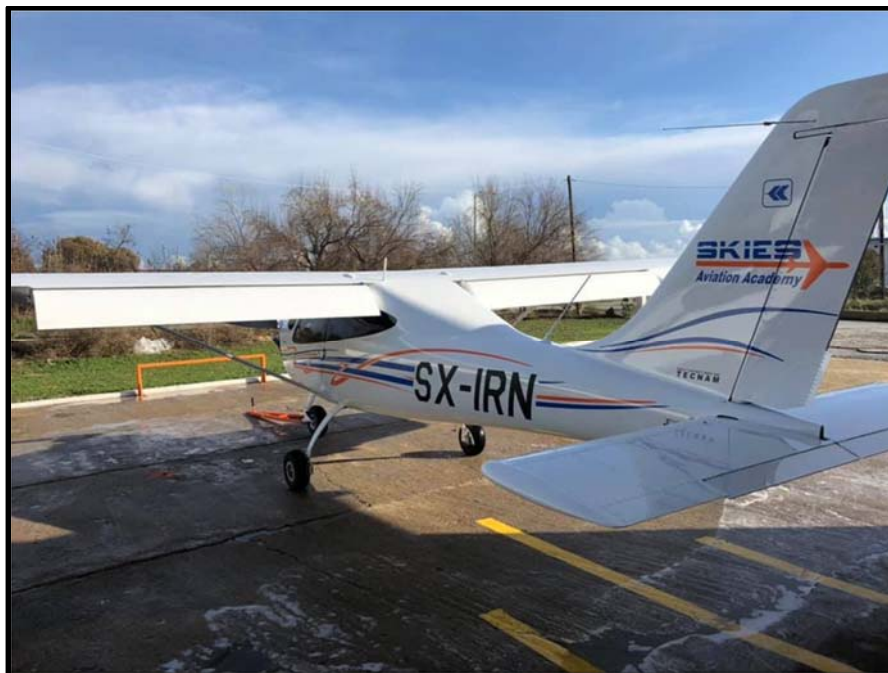
**Photo 1: SX-IRN Aircraft.**

There is no information of any malfunctions before the Accident.

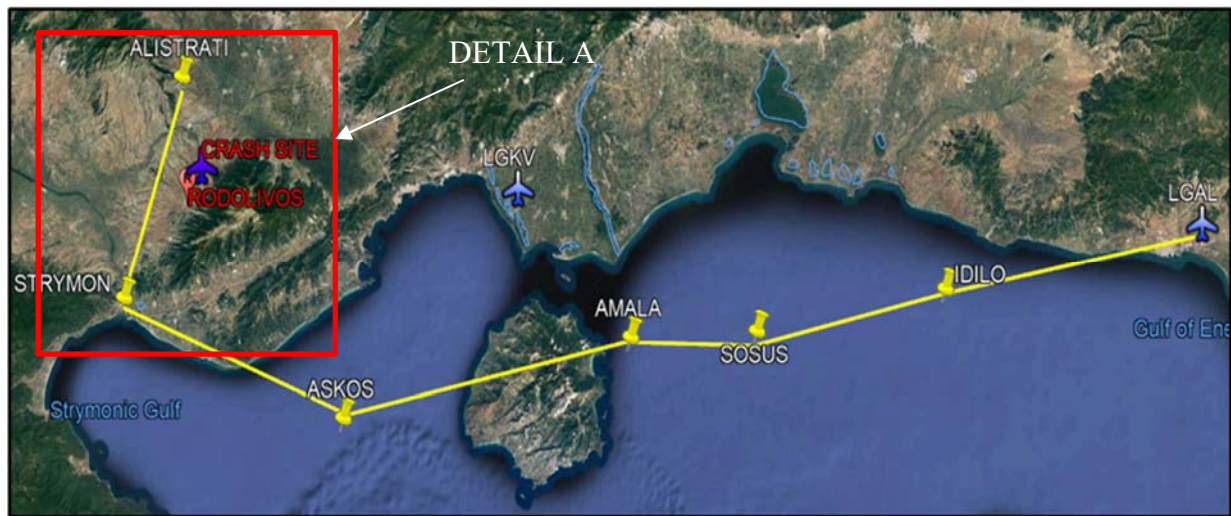
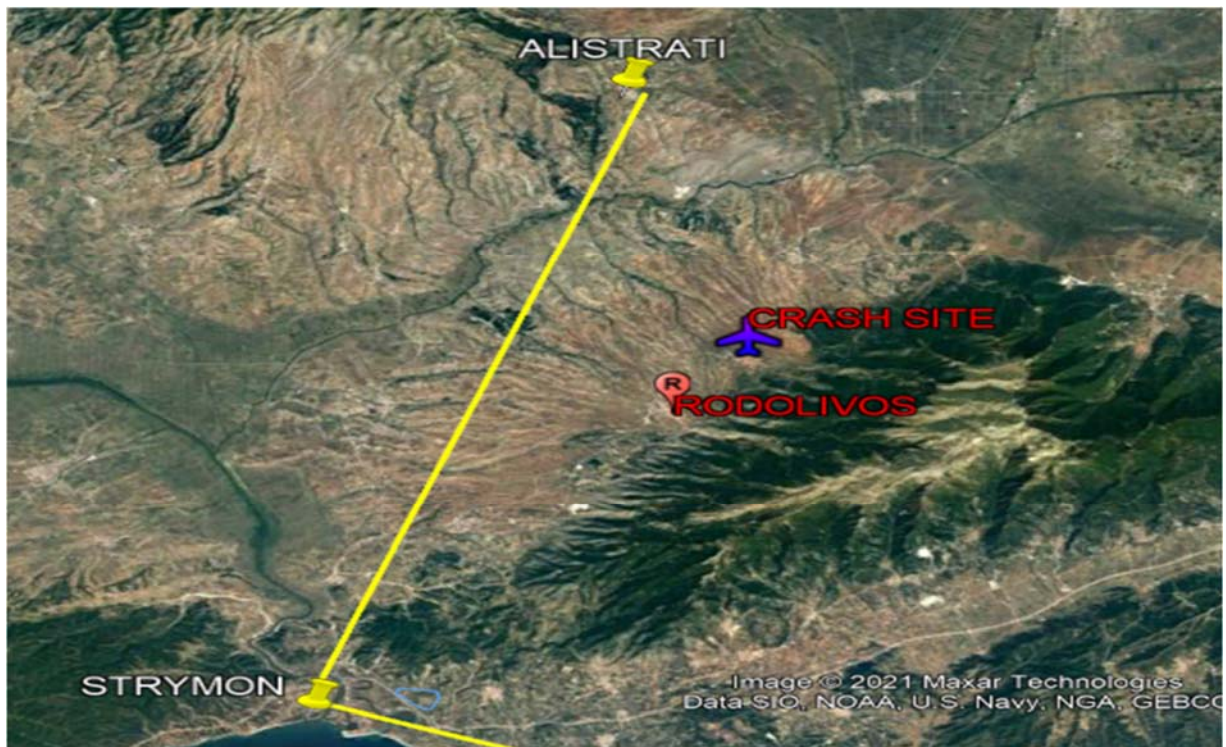
DETAIL A: Last Flight Track.

The Aircraft SX-IRN with call sign SKIES 05 took-off from Alexandroupoli Airport (LGAL), at 04:55 UTC, to conduct a SOLO visual Navigation Flight in VMC conditions according to the Flight Plan.

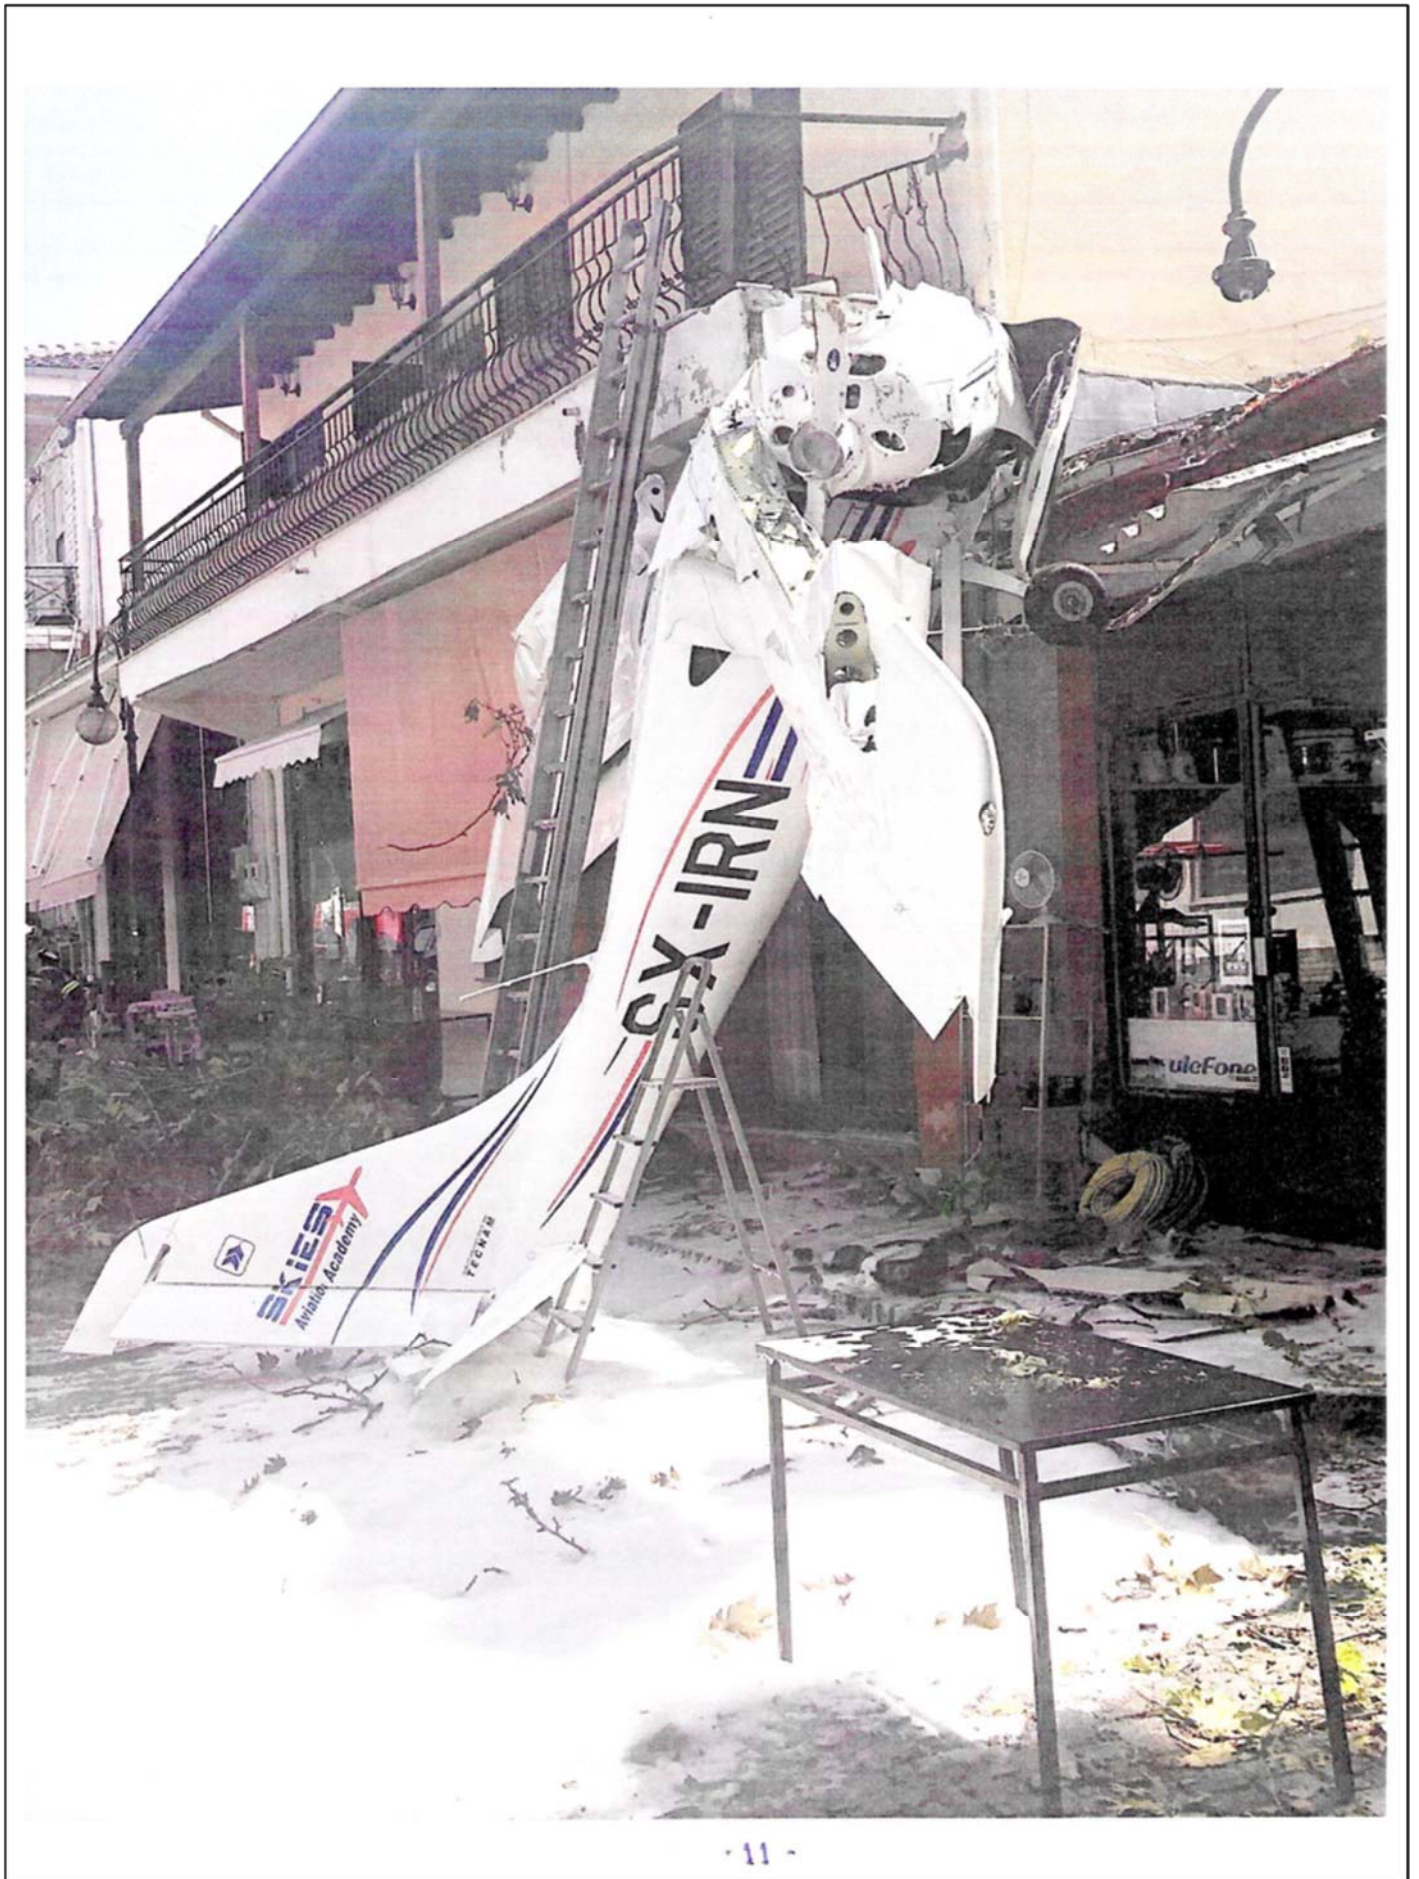
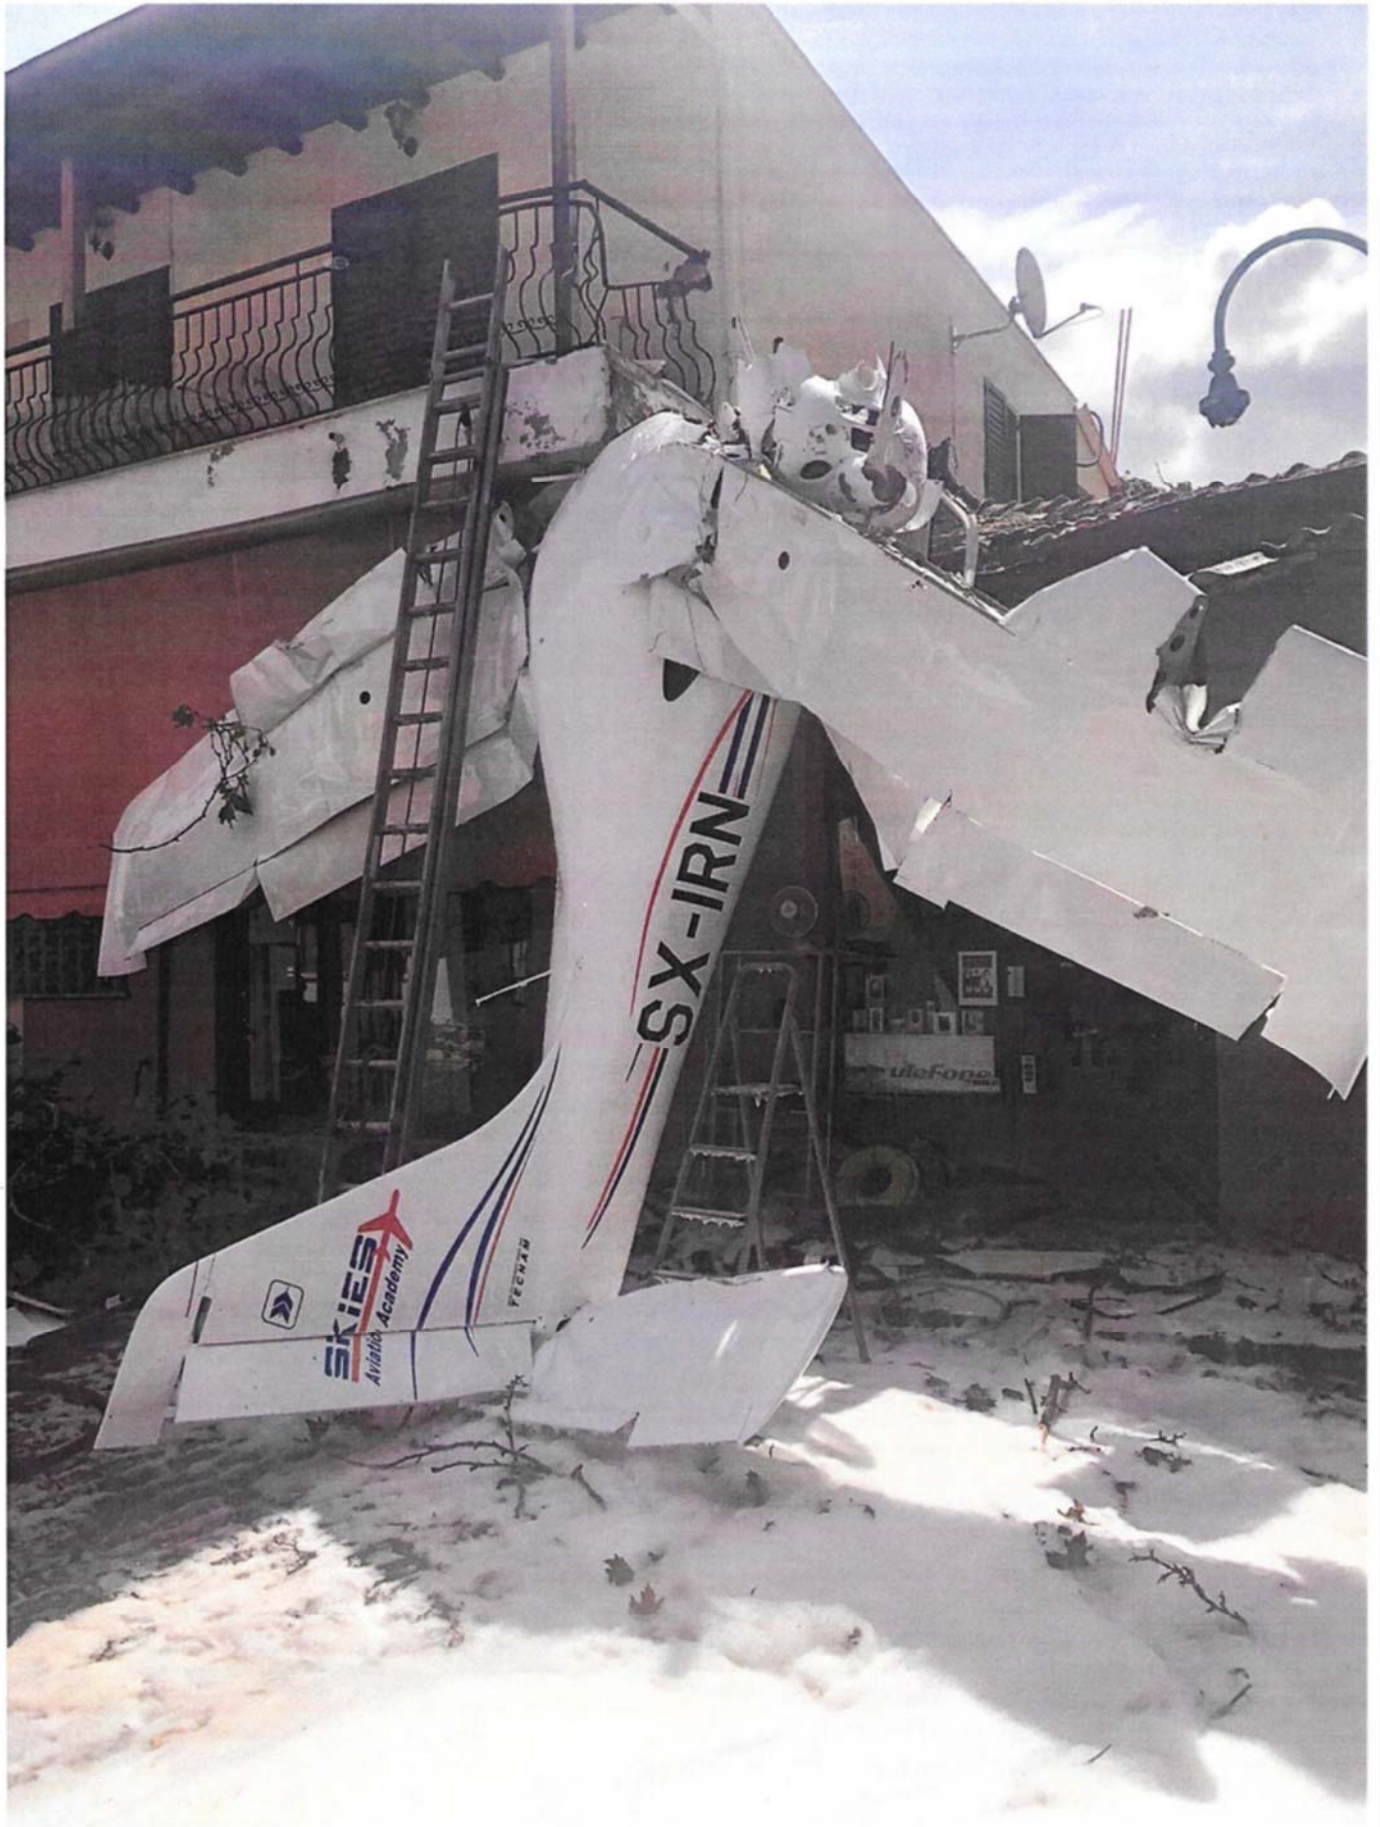
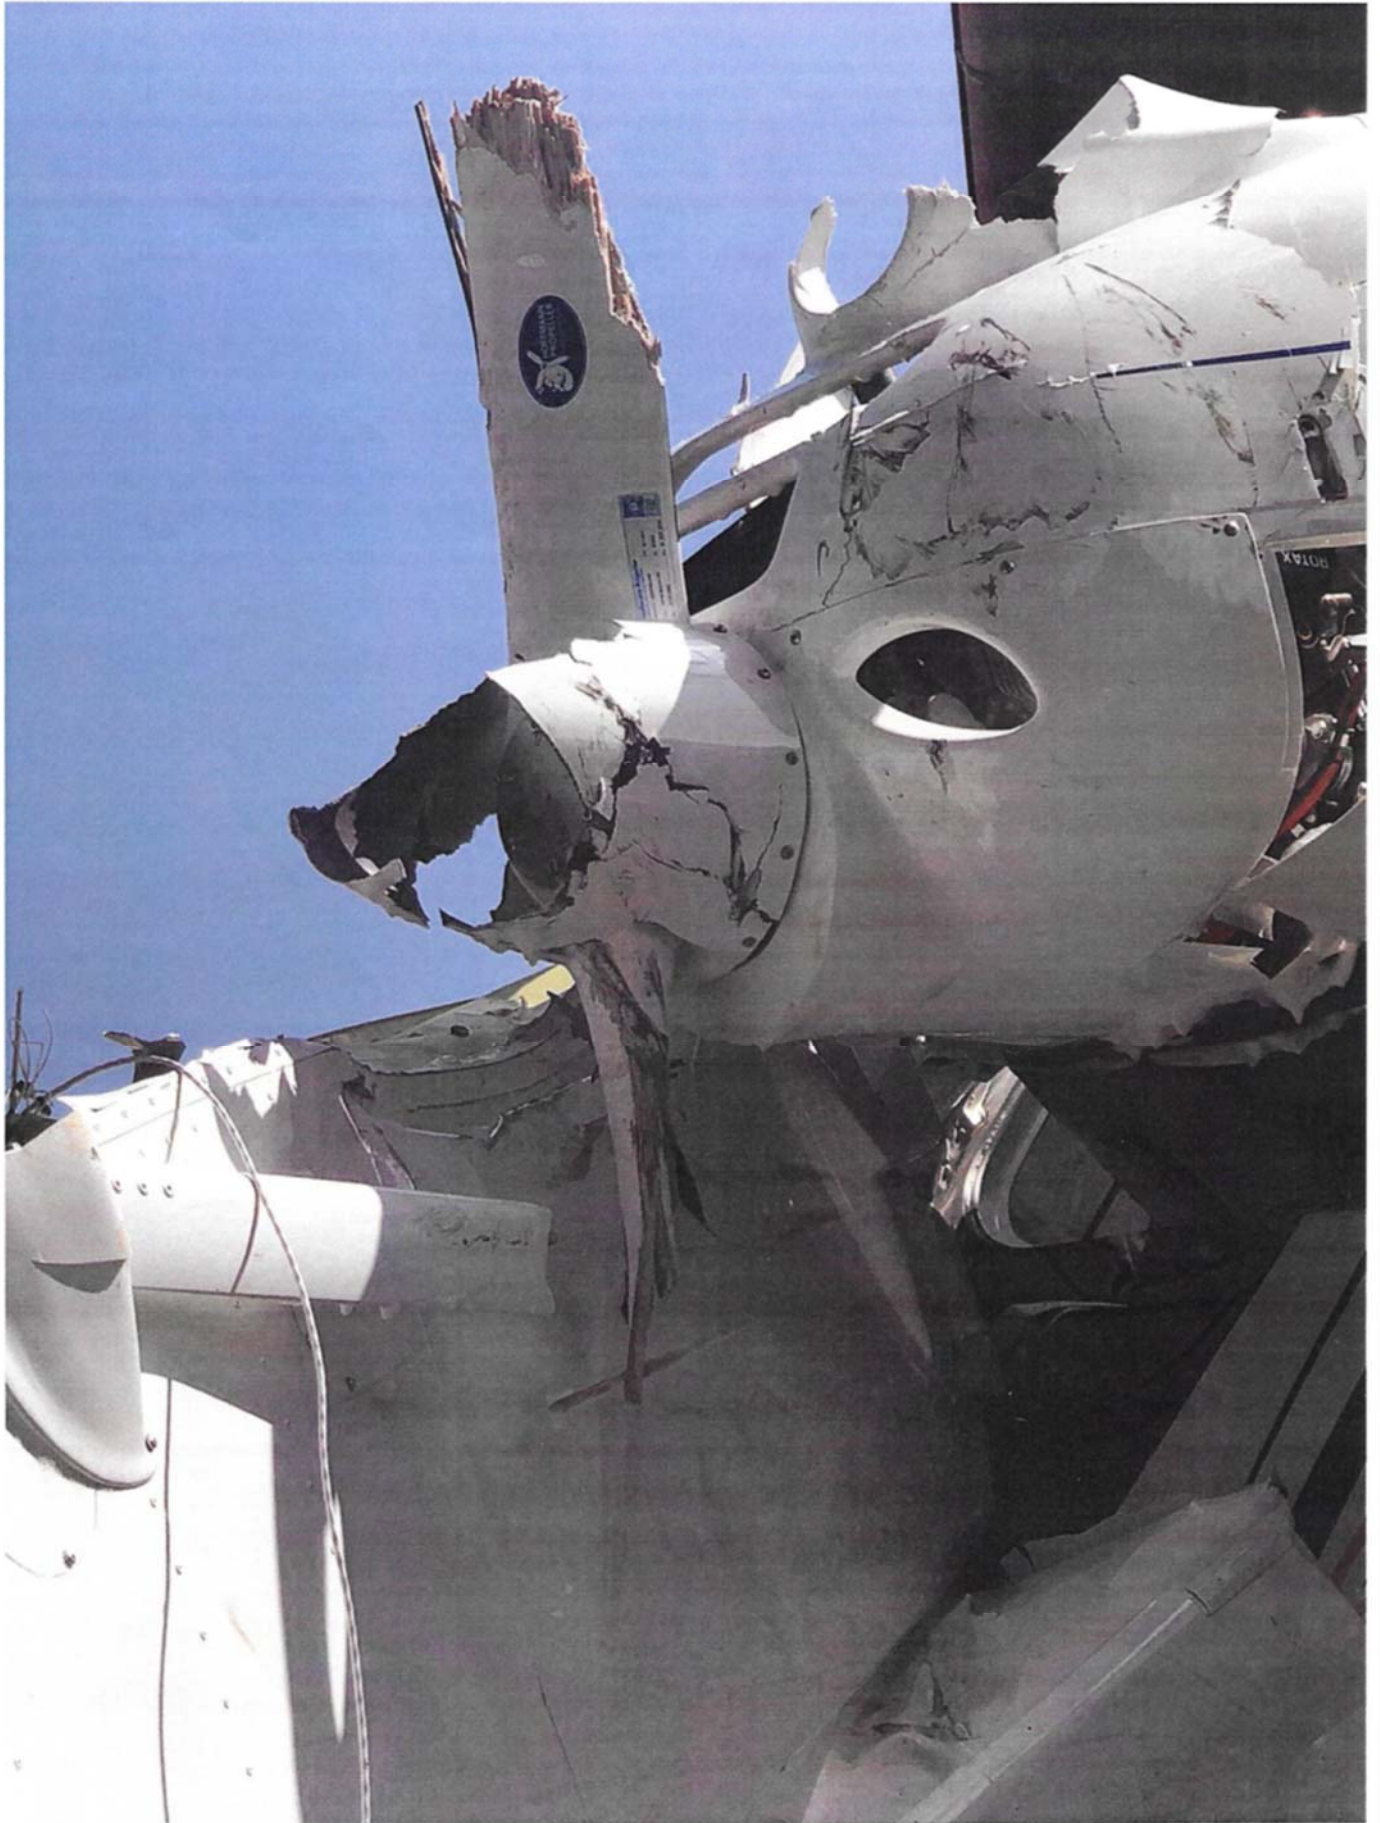
### 5.3 Wreckage Photos

The Stall Warning Circuit Breaker was found in the disconnect position (Photo 5).

4. The remaining obvious marks on the fuselage are the result of the Aircraft colliding with obstacles. As part of the investigation, many photos of the findings were captured. Among them were found and captured:
