AIR ACCIDENT INVESTIGATION AND AVIATION SAFETY BOARD  
(AAIASB)

ACCIDENT INVESTIGATION REPORT  
INVOLVING THE AIRCRAFT HA-TAH  
AT AXIOS RIVER, 2NM SOUTHWEST OF POLYKASTRO,  
ON 22<sup>nd</sup> MARCH 2015

involving the Aircraft HA-TAH

on 22<sup>nd</sup> March 2015

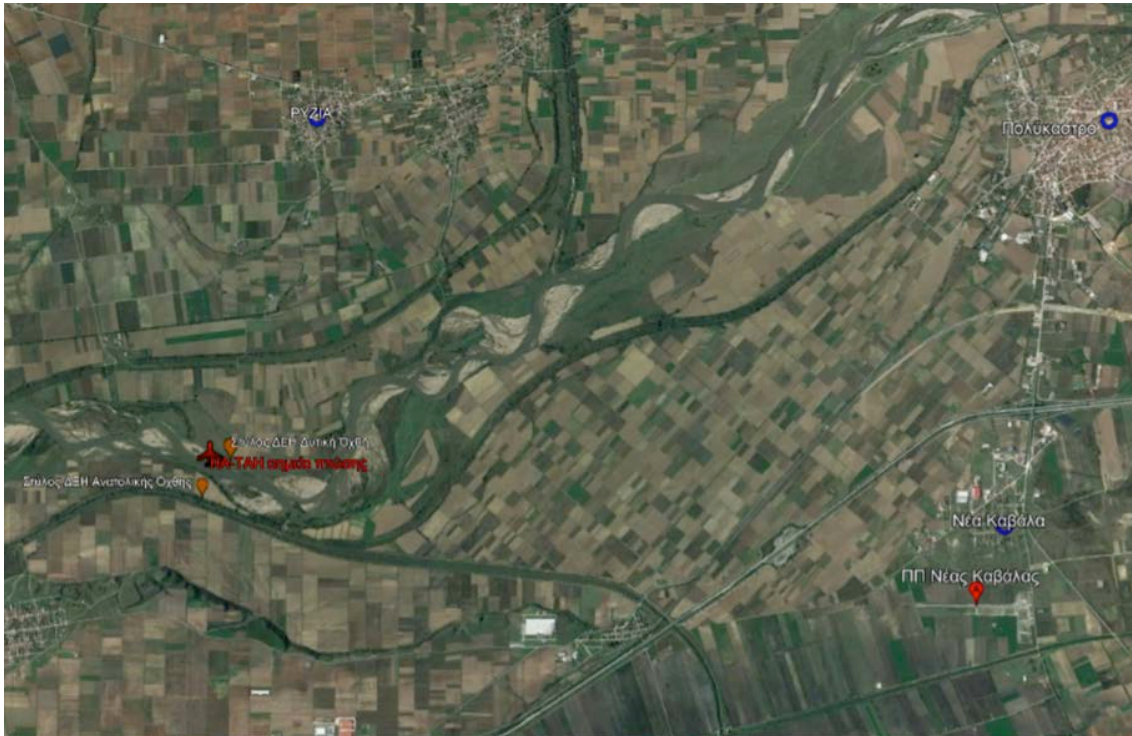
Takeoff was at about 14:30 h with the instructor flying the aircraft, from runway eighteen (18) of the Airfield of Nea Kavala headed south to Thessaloniki. The aircraft initially climbed to 1000 ft and then descended lower until it struck overhead medium voltage power lines that ran across the stream bed of Axios river. After striking the power lines, the aircraft continued uncontrolled on its course for about 100 m until it crashed in the stream bed of Axios river, onto a mudflat (river island) with coordinates 40° 55'10.34''N 022° 36'40.17''E (Pictures 1 and 2).

Picture 1. Nea Kavala Airfield, crash site, projected course

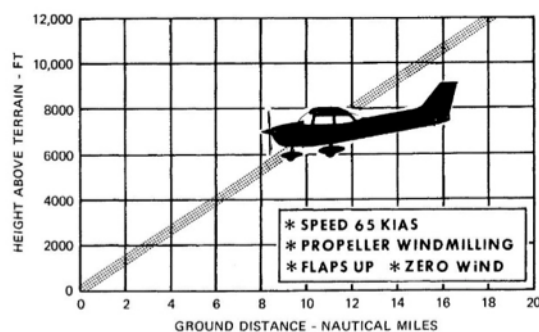
In respect of 'maximum glide', the '*Pilot's Operating Handbook Cessna model 172N*' gives the following chart (Maximum Glide) to calculate the glide distance in case of engine failure. As per the said chart, it is calculated that at a speed of 65 kt the glide ratio is 9:1 meaning that the aircraft travels 1.5 nm per 1000 ft height above terrain.

Figure 3-1. Maximum Glide

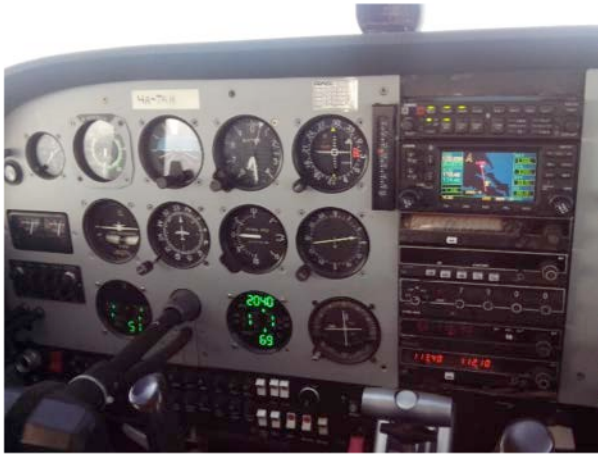
The engine power, in rpm, as well as the respective % value are digitally displayed on CED (Compact Engine Display), an instrument located below the ‘Vertical speed indicator’, between the steering-wheel and the ‘Course Deviation Indicator’ and in this particular case the reading is 2040 rpm and 69% respectively.

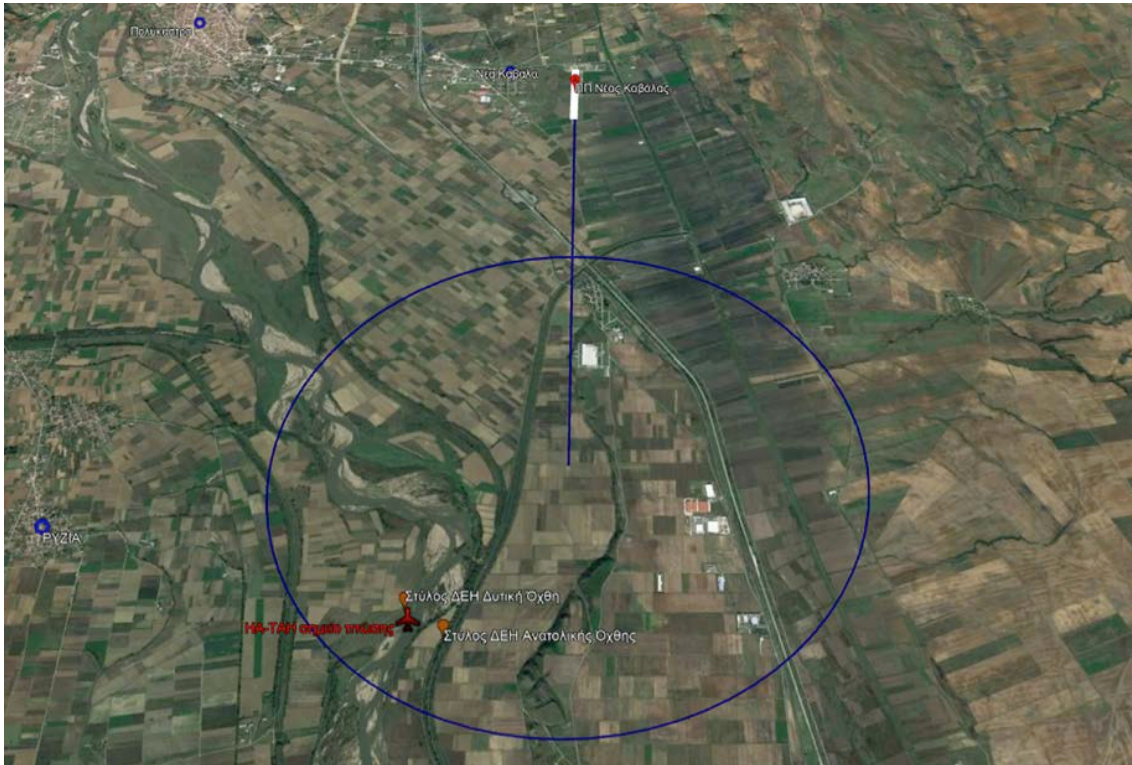
If aircraft performance was in conformance with the Pilot's Operating Handbook (POH) and the rate of climb was 500 ft/min and airspeed 70 kt then, after takeoff and within a time period of two minutes the aircraft would have attained a flight altitude of 1000 ft and covered a distance of 2.2 nm.

Picture 3. Distances to the aircraft crash site
