**AIR ACCIDENT INVESTIGATION  
AND  
AVIATION SAFETY BOARD  
(AAIASB)**

**ACCIDENT INVESTIGATION REPORT  
AIRCRAFT BEECHCRAFT HAWKER 850XP  
TC-MAN  
AT MYKONOS STATE AIRPORT  
ON JULY 26, 2017**

**ACCIDENT INVESTIGATION REPORT**  
**02 / 2021**

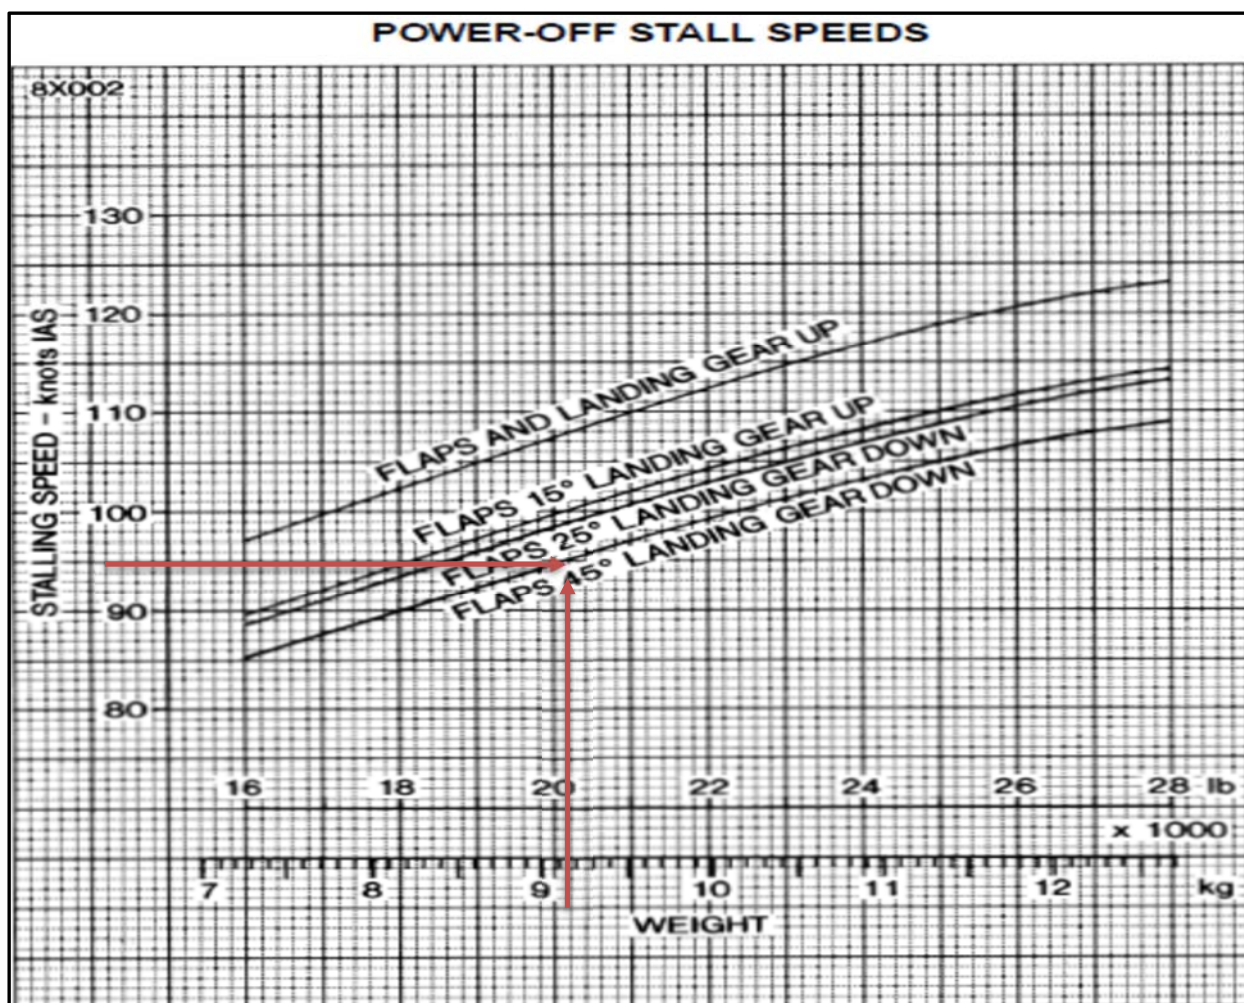
Fig. 3: Stalling Speed Graf

The A/C had an indicated Air speed of 100 knots at touchdown, an IAS lower than the recommended Vref of 121 knots, Approach speed of 131 knots and close to the Stalling speed of 97 knots at actual landing weight with landing configuration.

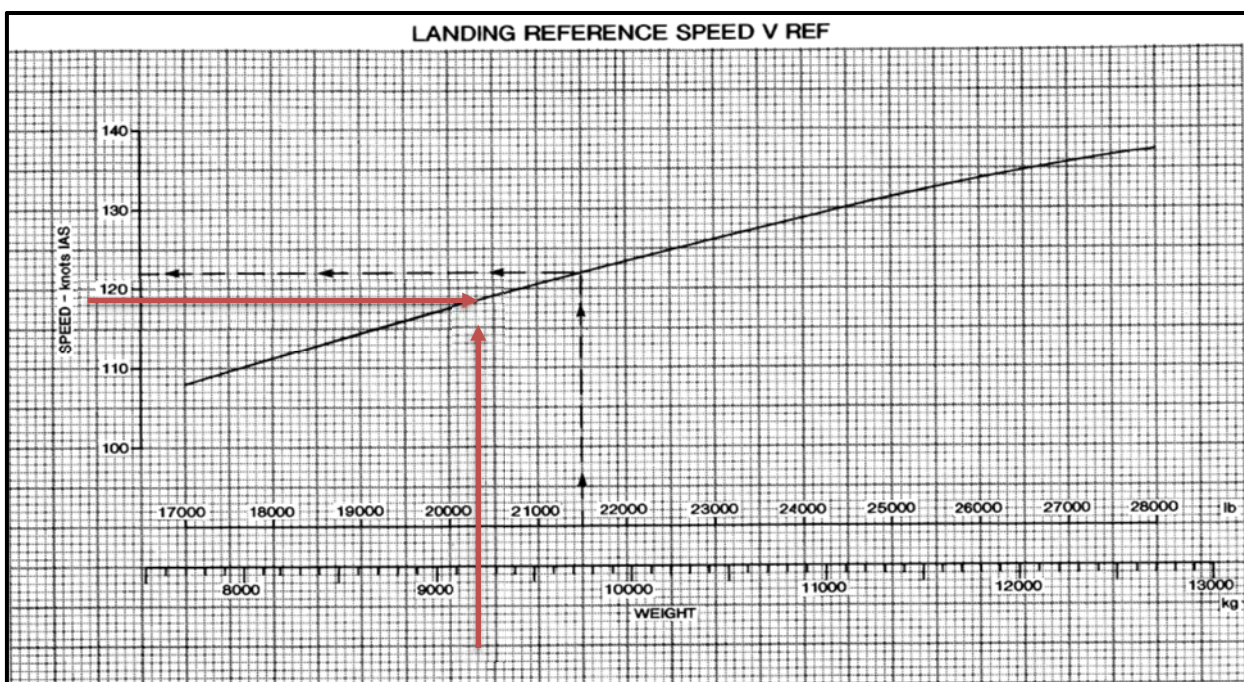
Fig. 4: Vref Graf

Vref: The Landing reference speed is the speed at which the Pilot should aim to cross the R/W threshold at landing flaps. The Approach speed is (Vref+10 kts). At the ALM of 9.462 kg, Vref equals to 121kts. Thus, Approach speed equals to 131kts.

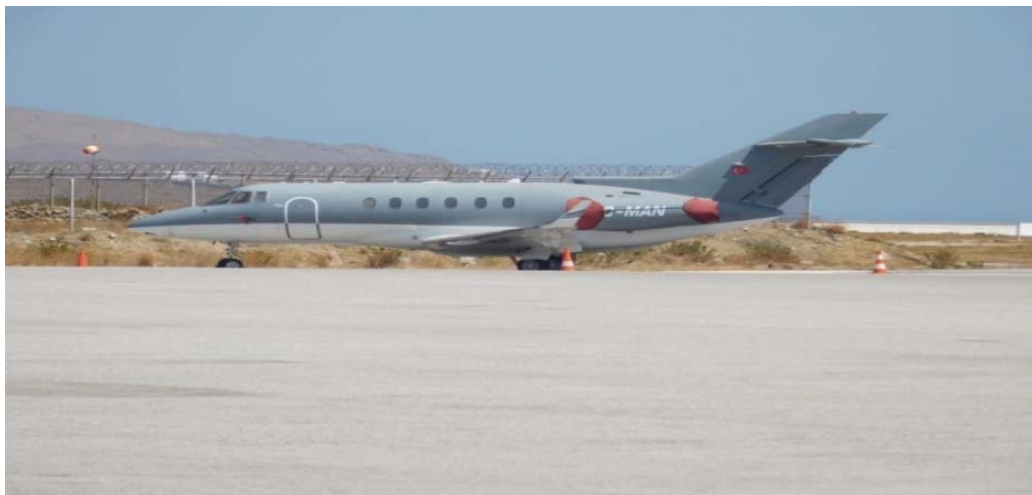
**Photo 5: The Aircraft parked at Mykonos State Airport.**

After previously parking in an appropriate position at the Airport (Appendix: Photo 5), both Pilots and the passenger disembarked the aircraft without being injured.
