**AIR ACCIDENT INVESTIGATION  
AND AVIATION SAFETY BOARD  
(AAIASB)**

**ACCIDENT INVESTIGATION REPORT  
AIRCRAFT PIPER CHEYENNE PA 31T  
SX-AVC  
AT THESSALONIKI INTERNATIONAL AIRPORT “MACEDONIA”  
ON AUGUST 14, 2013**

**ACCIDENT INVESTIGATION REPORT**  
**03 / 2021**

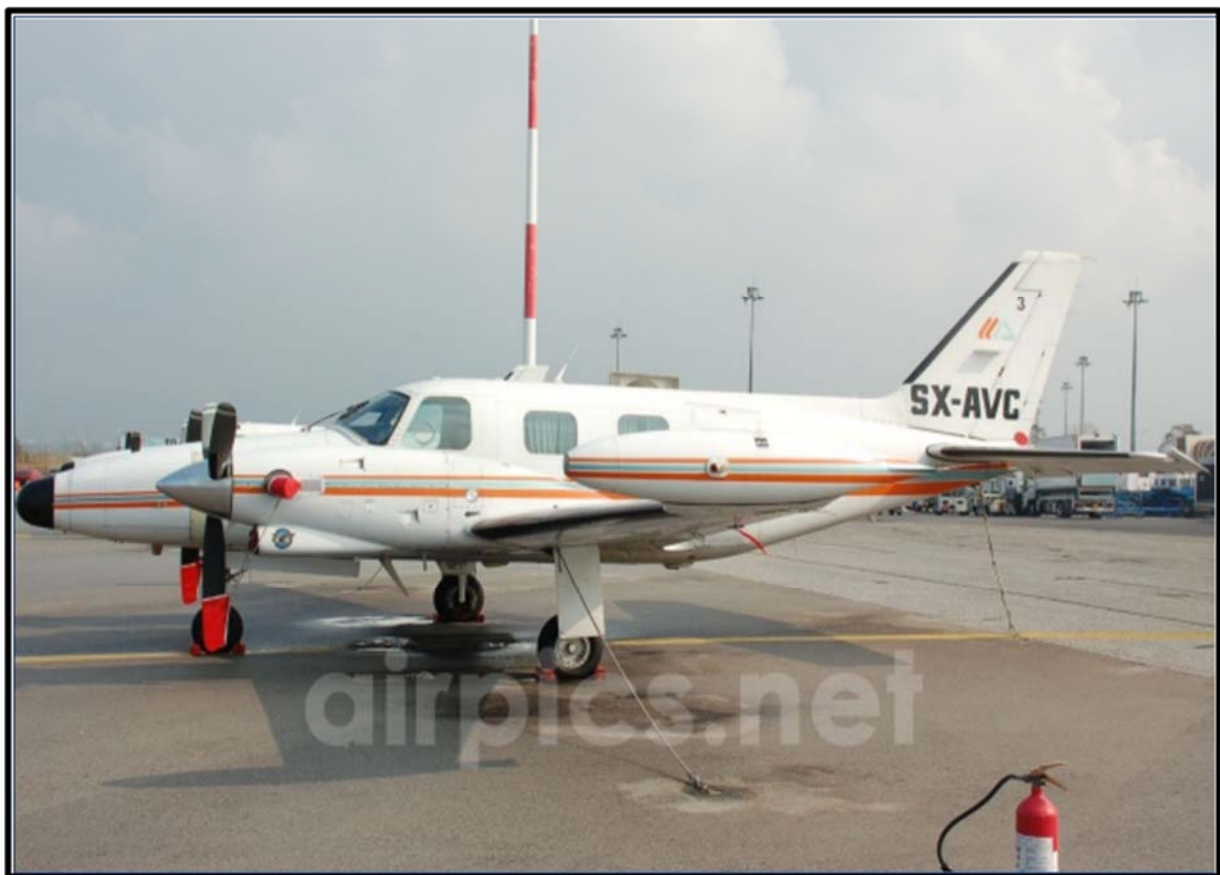
The aircraft suffered extensive damage and was declared as a total loss.

**Photo 1:** The Piper PA-31T Cheyenne SX-AVC.
