**AIR ACCIDENT INVESTIGATION  
AND AVIATION SAFETY BOARD  
(AAIASB)**

**ACCIDENT INVESTIGATION REPORT  
AIRCRAFT SX-AGE SOCATA TB9  
IN THE AREA OF MEGARA AIRPORT (LGMG)  
ON NOVEMBER 08, 2013**

## Accident of Aircraft SX-AGE in the Area of Megara Airport (LGMG) on November 08, 2013

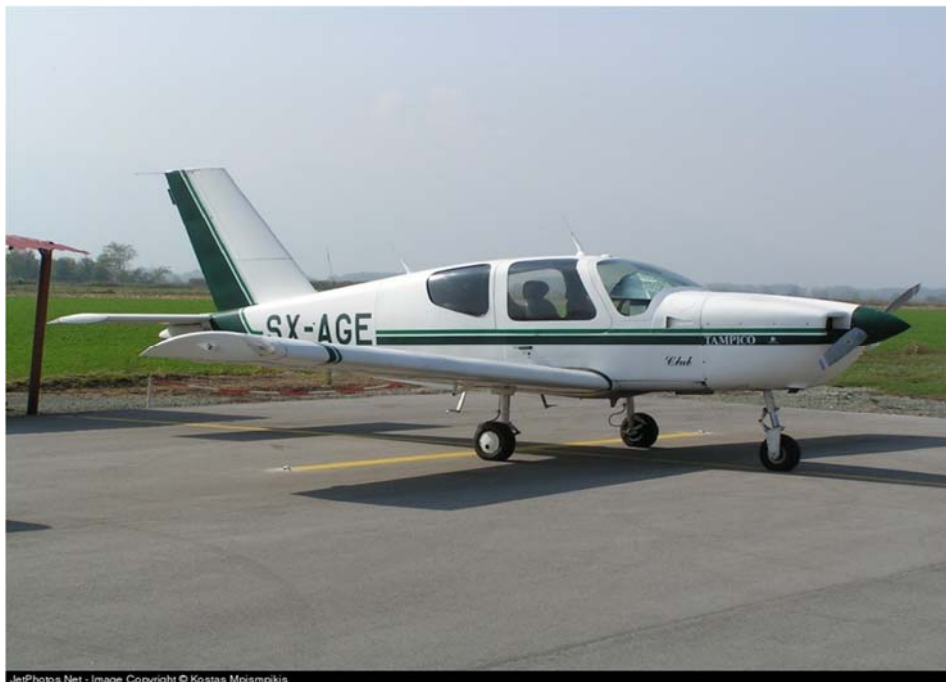
**Photo 1:** Picture of SX-AGE aircraft.

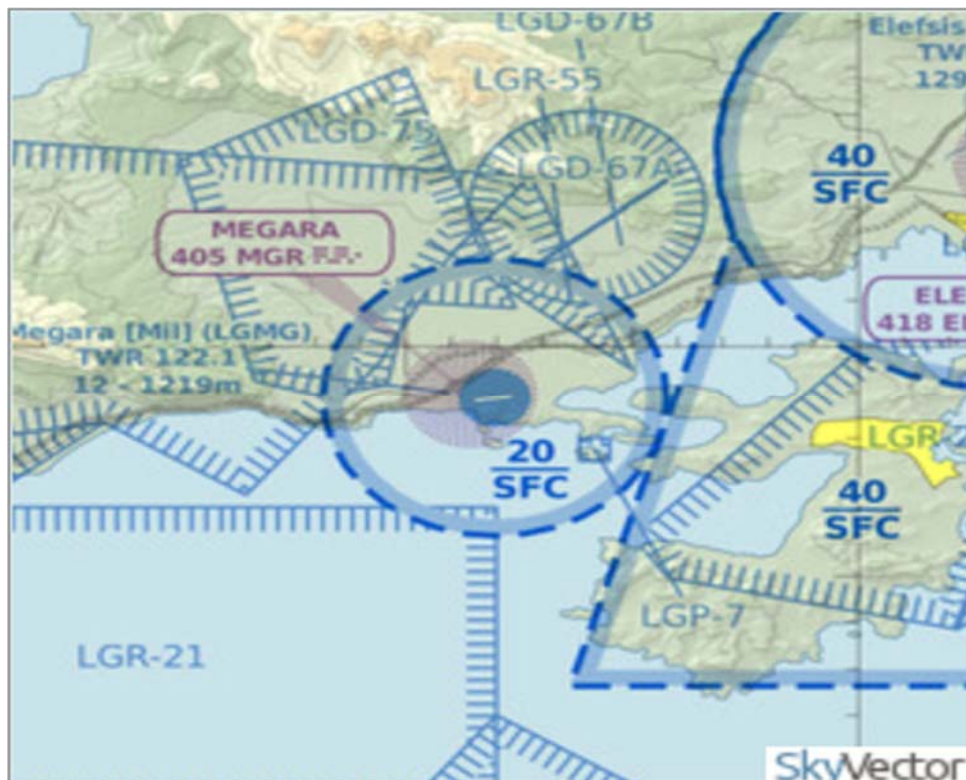
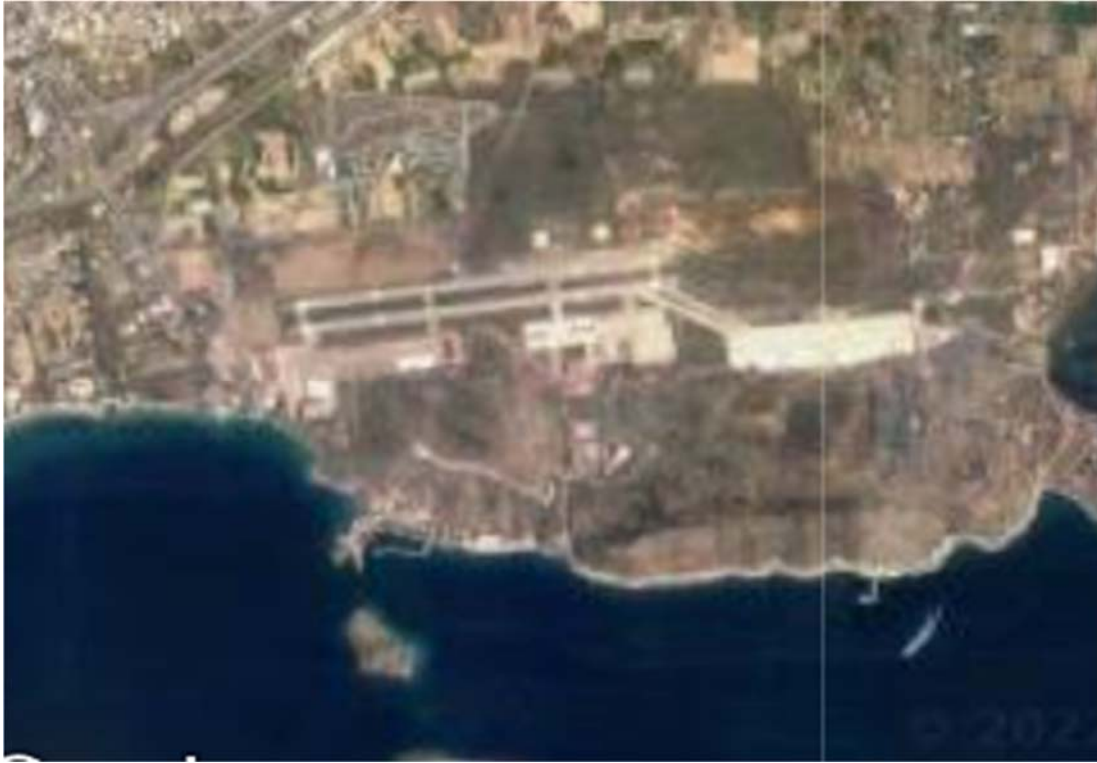
Picture 1: Megara Airport (LGMG).

**Picture 1 (cont):** Runway: 08R/26L is 3953 ft x 125 ft (1205 m x 38 m). Elevation: 12 feet MSL (4 m MSL).
