**AIR ACCIDENT INVESTIGATION AND  
AVIATION SAFETY BOARD  
(AAIASB)**

**ACCIDENT INVESTIGATION REPORT  
AIRCRAFT ATR 42-500 SX-GRI  
AT ATHENS INTERNATIONAL AIRPORT  
ON OCTOBER 07, 2017**

**01 / 2022**

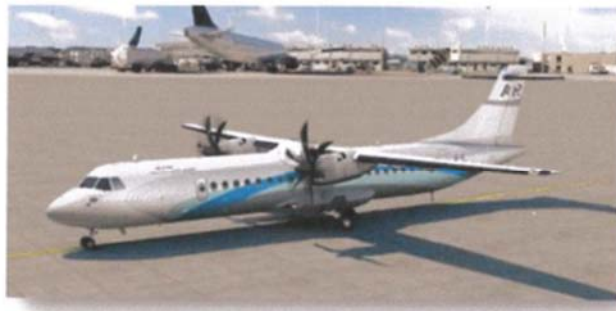
The ATR aircraft is not fitted with an Auxiliary Power Unit (APU) but has propeller brake (named as “hotel mode”) that stops the propeller #2 (right engine), allowing the turbine (high & low turbine) to run and provide air conditioning and electrical power (DC) to the aircraft without the propeller spinning. The propeller brake system is a hydro-mechanical system installed on the right engine reduction gearbox enabling immobilization of the propeller and power turbine.

ATR authorize to walk around and operate near and around the engine (Hotel Mode) for ground operations. It must be considered as an Auxiliary Power Unit (APU). **When Hotel mode is running, at least one crew member must remain in the cockpit.**

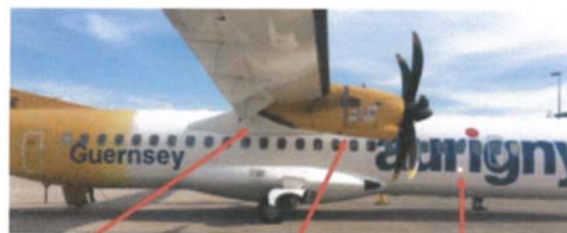
How do I know "hotel mode" is running?

Heat Haze

Engine Noise
